ORE DRESSING AND METALLURGICAL LABORATORIES.

Investigation No. 1203.

Investigation of a Dominion Foundries and Steel Limited Towing Hook.

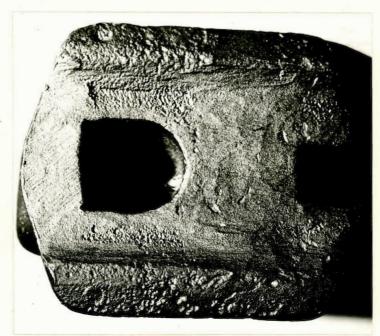
### Figure 1:

The base of the casting submitted for examination was badly pitted. This is shown in Figure 1.

PHOTOGRAPH OF BASE OF TOWING HOOK. (About & size).

# Note pits.

The appearance of the casting, however, leaves much to be desired. It would indicate that their might be some carelessness in moulding or pouring. While in this case it (Discussion of Results, cont'd) -

did not affect the quality of the casting, there is always greater risk of producing defective castings when such conditions exist.
