R E P O R T
of the
ORE DRESSING AND METALLURGICAL LABORATORIES.

Investigation No. 1211.

Examination of Broken Universal
Carrier Track Pins.

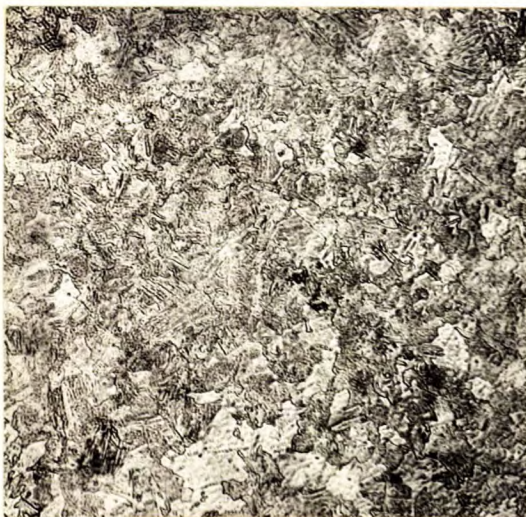
X500, nital etch.
CORE OF CANADIAN ACME PIN.
Figure 3.

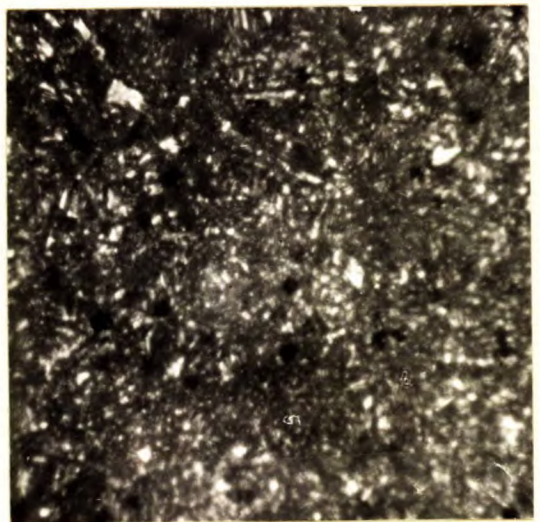
X1000, nital etch.
CASE OF CANADIAN ACME PIN.
Figure 4.

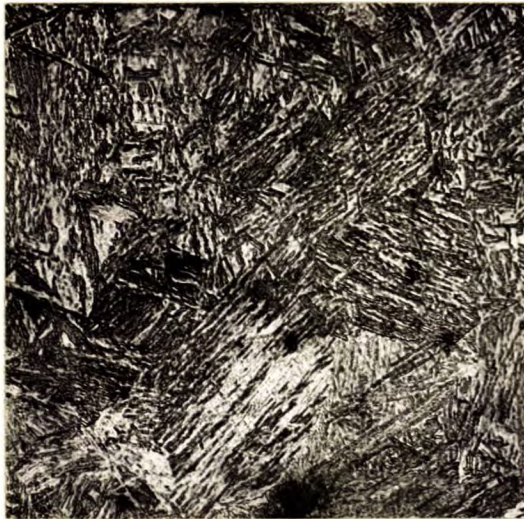
X500, nital etch.
CORE OF PIN NO. 2.
Figure 5.

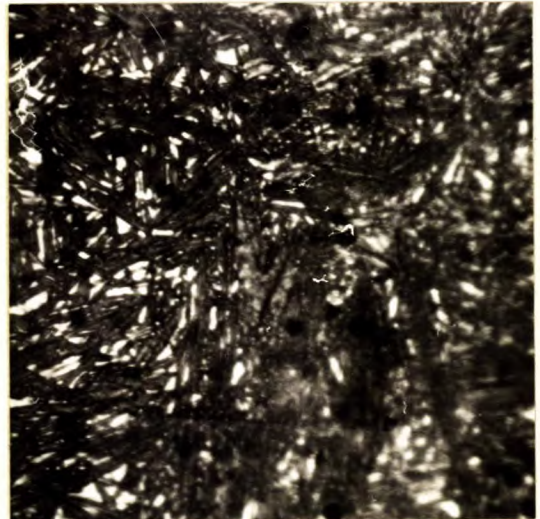
X1000, nital etch.
CASE OF PIN NO. 2.
Figure 6.

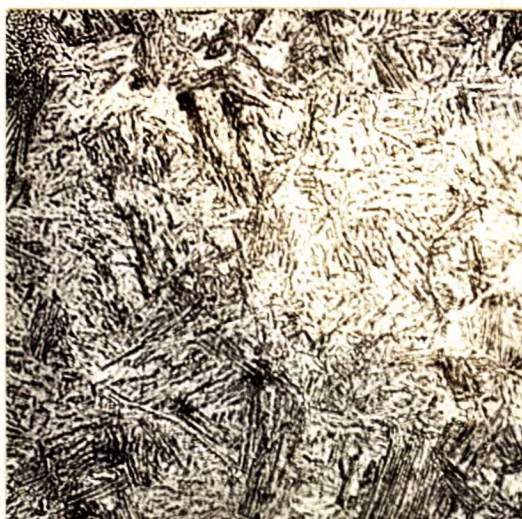
X500, nital etch.
CORE OF PIN NO. 3.

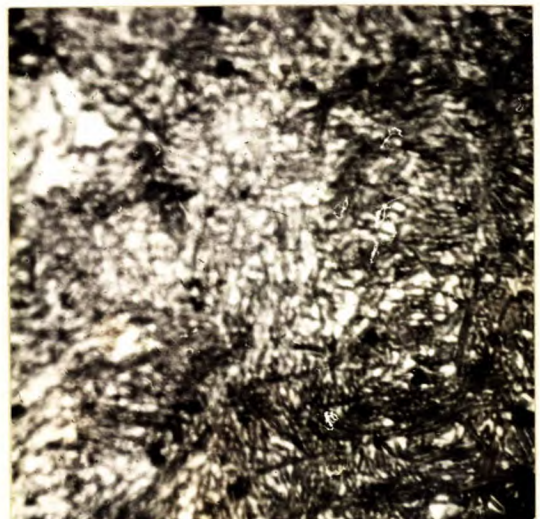
X1000, nital etch.
CASE OF PIN NO. 3.
