ORE DRESSING AND METALLURGICAL LABORATORIES.

Investigation No. 1236.

Examination of Broken Allied Products Limited  
Universal Carrier Pins.

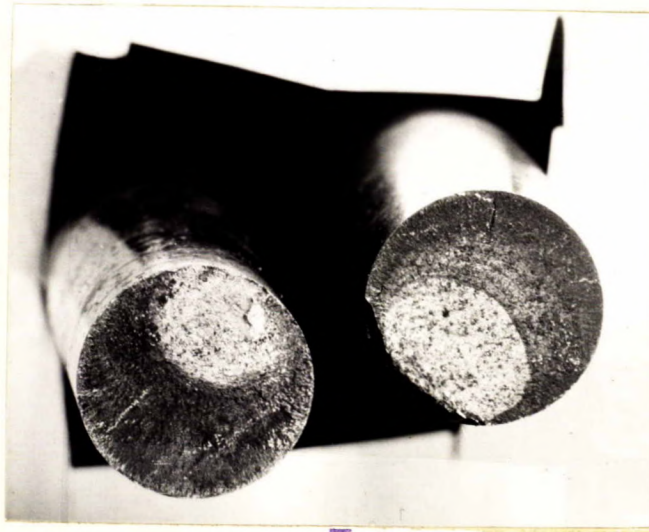
The fractures of the pins were examined and a definite duplex structure was observed. These are shown in Figure 1. The diameters of the pins were measured, using a micrometer. The averages of ten readings for each pin are listed below:

The duplex structure of the fractures, shown in Figure 1, is of the well-known "fatigue" type.

1. The chemical analysis corresponds to specification for S.A.E. 3115 steel.
2. The duplex fractures are of the "fatigue" type.
3. Case depths should not exceed 0.020 inch, otherwise a lowering of the safety factor results.
4. Variation in core hardness is probably due to

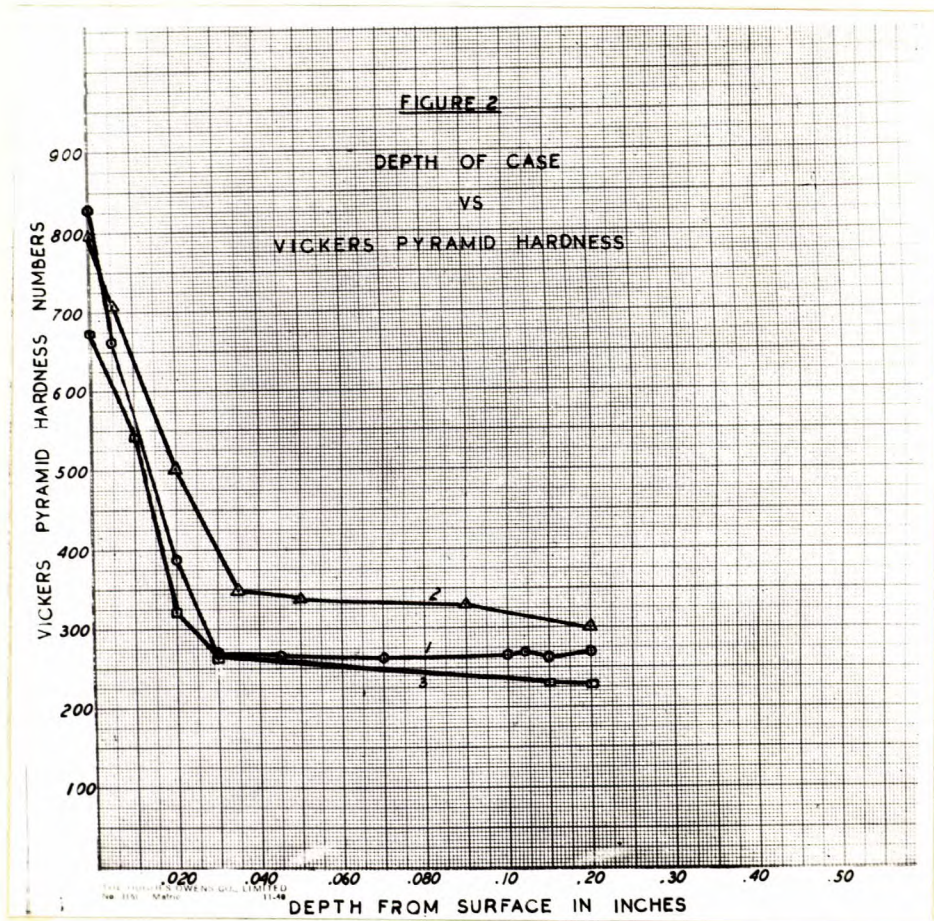
Figure 2.

Hardness readings were taken on polished micro-specimens, using the Vickers hardness machine and the 10-kilogram weight. Table I and Figures 2 and 3 show the depth-hardness relationship for each of the five pins:

The case depth results show that Pins Nos. 2 and 5 are over the limits set by the specification, 0.012-0.020 inch. The initial case depth is unknown, but it would be still greater than the figure quoted, since the pins have been subjected to a certain amount of wear. It is felt that increasing

the case depth beyond the specification limit means decreasing the margin of safety of the pins.

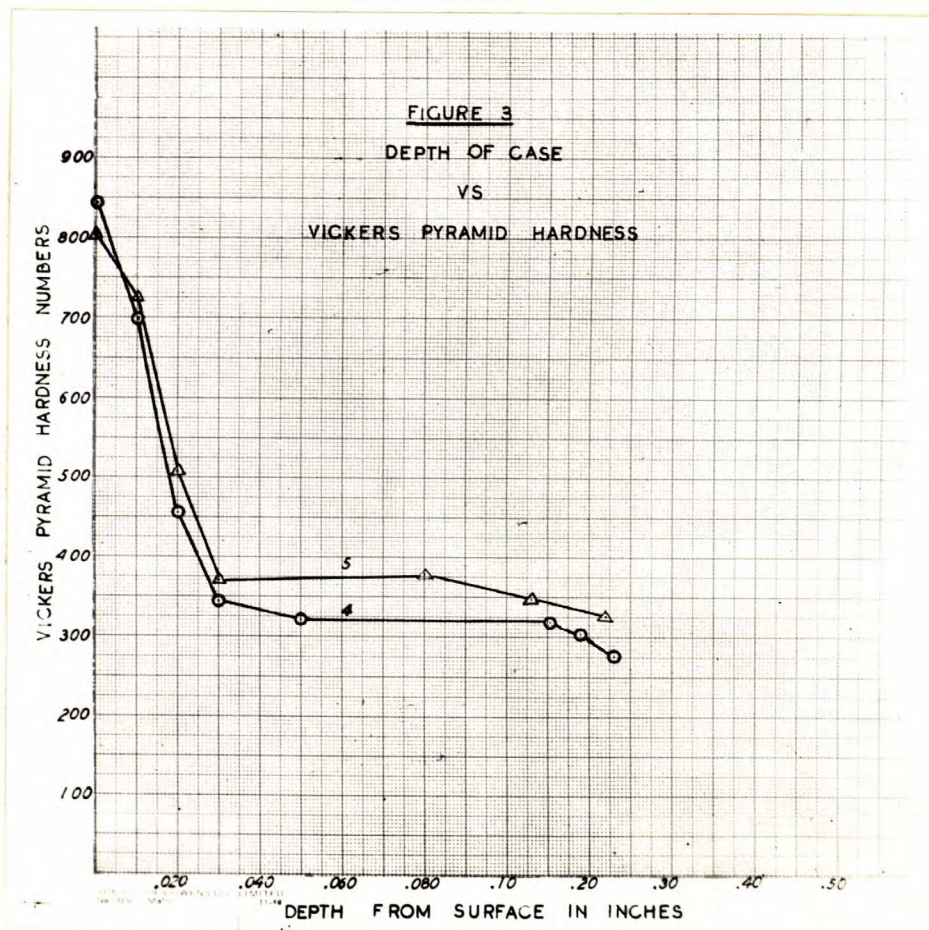
Figure 3.

From Table I it can be seen that the core hardnesses (at 0.2 inch from the surface) vary considerably, e.g. 228 to 330. This is probably due to a non-uniform quenching temperature. Visual examination of the core structures confirmed this, since varying amounts of ferrite were observed in the different pins. Figure 4 is a photomicrograph of a pin containing an intermediate amount of ferrite.

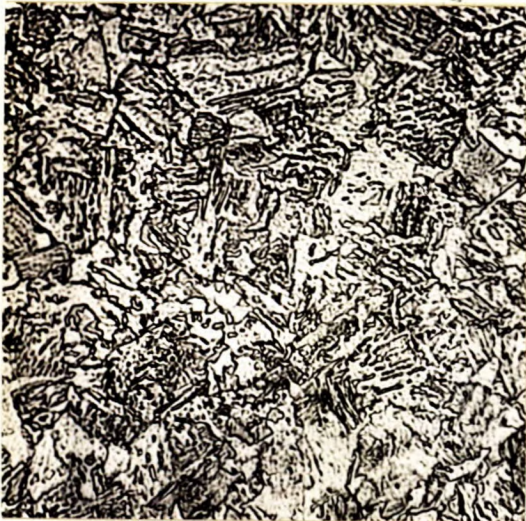
Figure 4.

X500, nital etch.  
TYPICAL CORE.

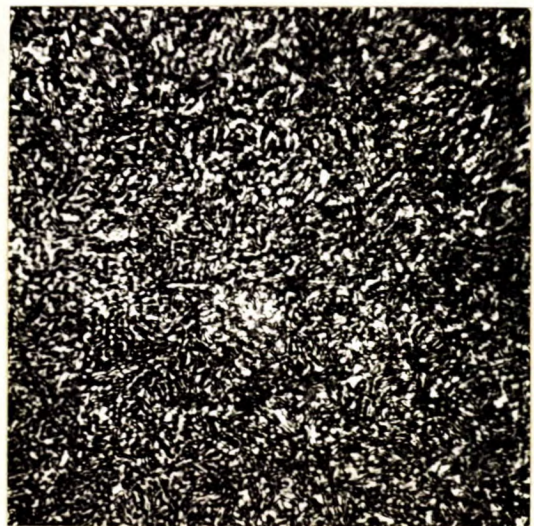
Figure 5.

X1000, nital etch.  
TYPICAL CASE.
