Investigation No. 1240.

Examination of Steering Knuckle Flange Casting.

BUREAU OF MINES  
DIVISION OF METALLIC MINERALS  
—  
ORE DRESSING AND  
METALLURGICAL LABORATORIES

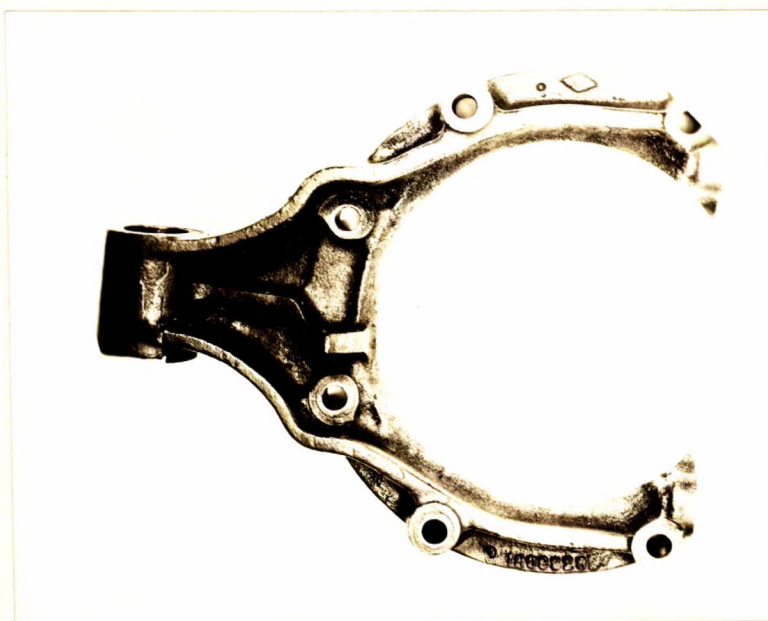
Figure 1.

No defects could be observed by visual examination except the fracture shown at "A".

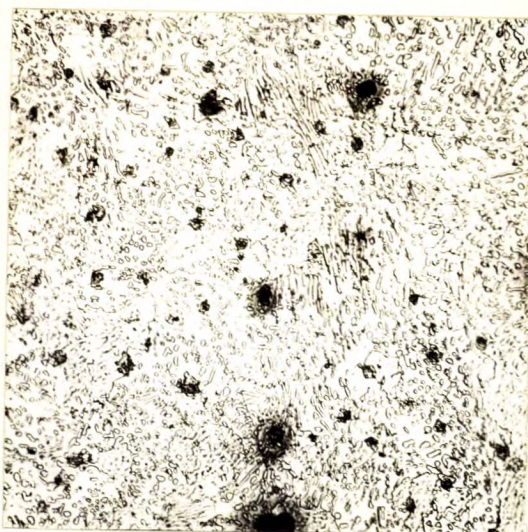
Figure 2.

The structure of the metal as revealed after an etch in 2 per cent nital is shown in Figure 2 (X500 magnification). It may be seen that the cementite is spheroidized and that the steel also contains dark spots which are probably graphite. Spheroidization has only just been effected, as there are some areas of lamellar pearlite also visible.

X500.  
Etched 2 per cent nital.

The spheroidized structure of the steel indicates that it has received the proper heat treatment. This heat treatment puts the steel of this analysis in its toughest form. Even in this form there is danger of impact failure in such a high carbon material.

1. The steel has not the specified composition.
2. The steel had a spheroidizing heat treatment similar to that specified.
3. The failure of this part may be attributed to its composition but it is thought it more probably indicates that the steel specified has not high enough physical properties for the service. In order to obtain a tougher material it would seem that a lower carbon steel would be in order.
