ORE DRESSING AND METALLURGICAL LABORATORIES.

Investigation No. 1242.

Examination of Broken Companion Flange
from Ram Tank.

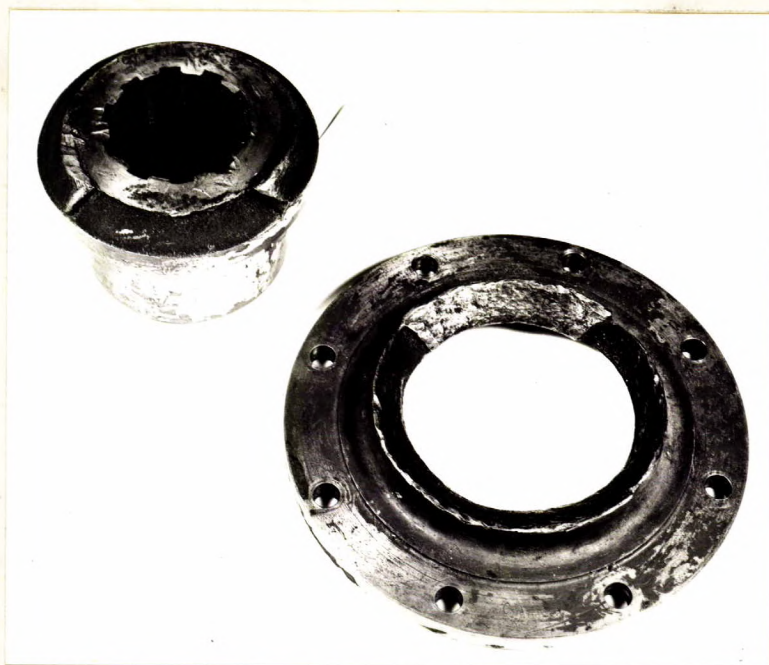
Figure 1.

Figure 1 is a picture of the parts as received, showing the type of fracture and the general shape of the part.

A visual examination of the fracture indicates a failure due to fatigue. It also appeared that the inside corner where the hub joins the flange is cut very sharp. Such a sharp change in direction could cause a high concentration of stresses and could result in a fatigue failure.

This part failed due to fatigue, probably caused by a lowering of the fatigue limit by a large number of inclusions and/or poor machining practice.

Photograph, $\frac{1}{4}$ size, of broken parts of companion flange.

1. Efforts should be made to obtain a steel with a maximum of 0.05% S.
2. Care should be exercised to avoid any sharp corners. Even a radius of 0.05 in. would be helpful.

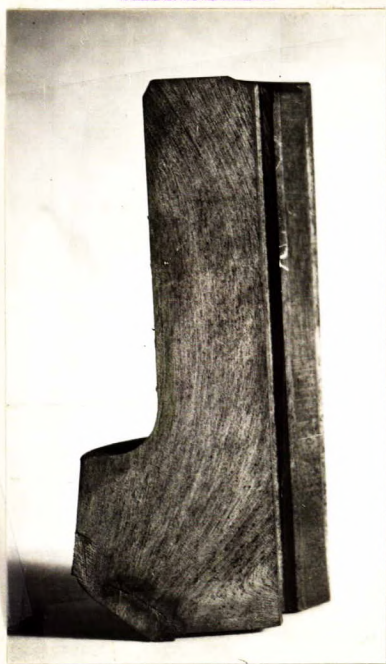
A section of the hub was etched in hot 38% HCl, 12% H₂SO₄. The resulting structure is shown in Figure 2. A sulphur print was made of this same surface. Figure 3 is a photograph of this sulphur print. Note that both Figures 2 and 3 show the lines of forging to be perpendicular to the direction of fracture.

Macro-etch of section of hub of broken flange.

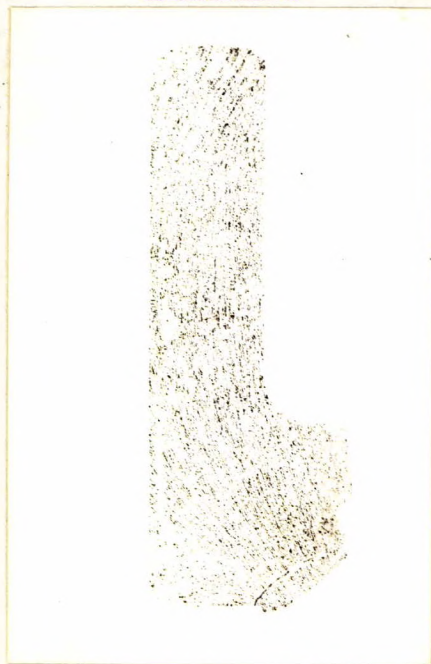
Figure 3.

The sulphur print, Figure 3, indicates a good distribution of the sulphides. This, combined with the high manganese (1.44%), could be a reason why the high sulphur (0.11%) has not caused the steel to become brittle.

Photograph of sulphur print taken from section of hub.

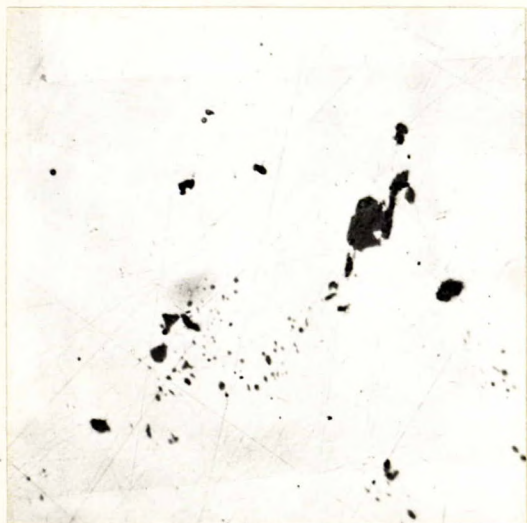
Figure 4.

Figure 4 is a photomicrograph, at 250 diameters, of the steel in the polished condition, before etching. Note the cluster of sulphide inclusions.

As will be seen from Figure 4, there are a great number of sulphide inclusions in the steel. Inclusions behave in very much the same way as do sharp corners in affecting the fatigue resistance of the steel. Their edges are regions of high stress concentrations and are often

Therefore, in this part we have two conditions that could lower the fatigue limit of the steel. The first is a sharp corner due to machining and the second is a large number of inclusions due to high sulphur content. Both conditions should be avoided where the frequency of stress reversals is high.

Photomicrograph, X250,
polished to show inclusions.

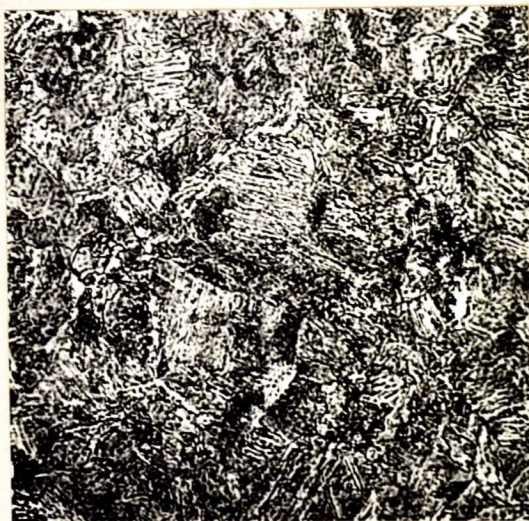
Figure 5.

Figure 5 shows the etched structure at 500 diameters.

Photomicrograph, X500,
picral etch.
