July 2nd, 1942.

ORE DRESSING AND METALLURGICAL LABORATORIES.

Investigation No. 1255.

Examination of Defective Ball Bearings.

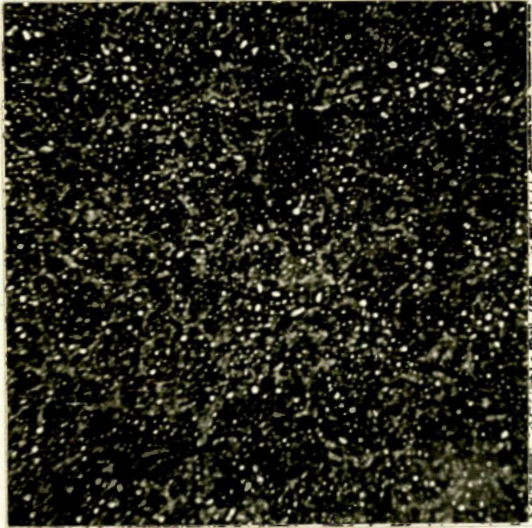
Figure 1.

Sections were cut which included the material which was hardness tested. These sections were given a metallographic polish and etched in a 4 per cent picral solution. Figure 1 (X1000 magnification) shows the structure of the "standard" ball. It consists of fine spheroids of cementite (the white iron chromium carbide constituent) in a background of dark etching drawn martensite. Figures 2 and 3 (X2000 magnification) were obtained from the outer area of the broken ball. In both figures the white particles are iron chromium carbide, the black background fine pearlite. In Figure 3 it may be seen that the carbide has segregated into a large cluster which is rounded off at the end by the forging operation. Figure 4 (X2000 magnification) shows the structure of the surface of the broken

The "standard" ball has the structure and hardness expected in good ball bearings, as such bearings should be quite hard and have the chromium carbide present in the form of spheroids. The pieces of Marlin ball examined were all in poor condition. All pieces are too low in hardness, while only the extreme outer surface of the broken ball contains carbides in the proper spheroidal form. This outer surface, however, contains an area which shows a large amount of carbide segregation.

X1000, picral etch.
"STANDARD" BALL.

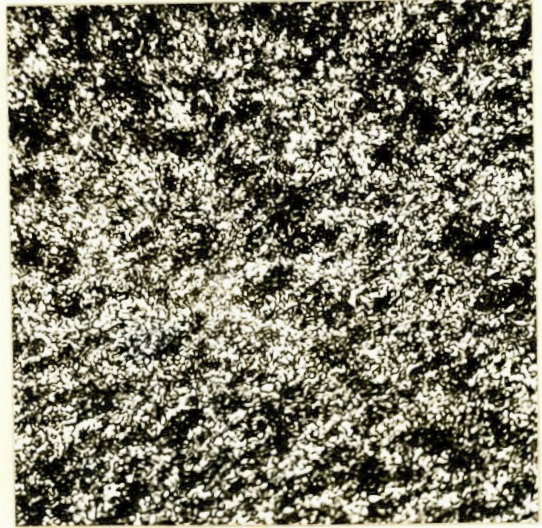
Figure 2.

X2000, picral etch.
OUTER EDGE OF BROKEN BALL.

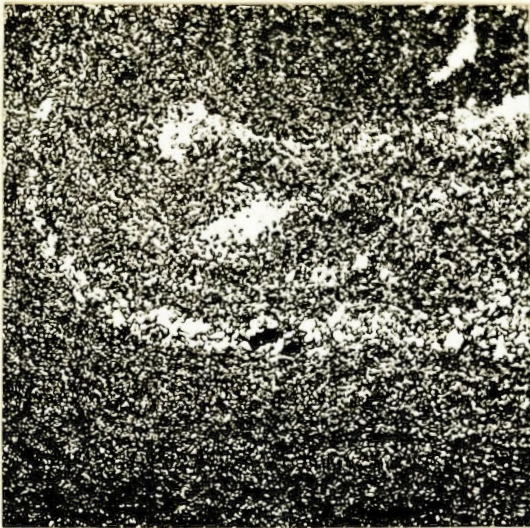
Figure 3.

Certainly the segregation of carbides shown in Figure 3 cannot have occurred as a result of improper treatment in service. This segregation must definitely be considered as a defect in the steel as supplied to the ball manufacturer.

X2000, picral etch.
OUTER EDGE OF BROKEN BALL,
SHOWING SEGREGATION.

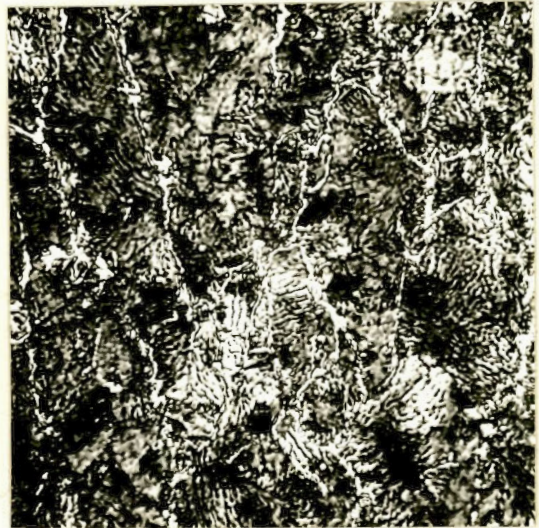
Figure 4.

ball that faced the hollow inside. The white material, which again is cementite, is present in stringers at grain boundaries rather than in spheroids. The dark background material is pearlite, the lamellar iron--iron carbide constituent produced when steel that has been heated over the critical temperature is cooled fairly slowly through that critical. The loose piece in the centre of the broken ball has practically the same structure.

Leaving the outer surface of the ball out of consideration, from the lamellar pearlite structure of the steel it can definitely be concluded that the final heat treatment

the steel has received is a heating over the lower critical followed by a relatively slow cooling. A properly made ball bearing, however, is quenched from its upper critical, so if it be assumed that structure faults were produced in service this would mean that the heat of friction was sufficiently high to heat the ball to at least 1400° F. This is manifestly absurd, as the bakelite retainers would be completely destroyed at a very much lower temperature and balls working at such a temperature would be in the plastic condition and consequently would work out of shape. It is our definite opinion, then, that the ball was supplied in an unsatisfactory condition and we cannot visualize any service conditions which would allow a ball to "work" hollow while still keeping its external dimensions.

It would seem that the balls have been given a normalizing treatment and then not re-heat-treated, probably because they were found to be defective. By some mischance this defective material was mixed with regular production.

X2000, picral etch.
AVERAGE STRUCTURE OF
BROKEN BALL.
