R E P O R T
of the
ORE DRESSING AND METALLURGICAL LABORATORIES.

Investigation No. 1259.

Examination of Oxford Undercarriage
Micro Switch Springs.

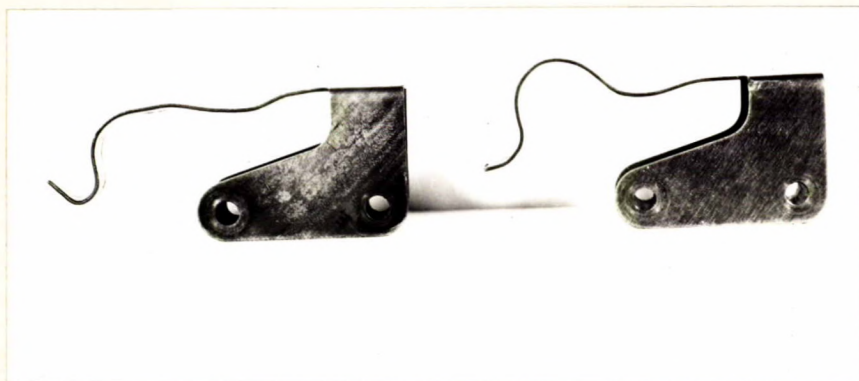
Figure 1.

Figure 1 shows two springs, marked "A" and "XX", as received. The picture shows the deformation of the spring "A" from crashed aircraft.

SPRINGS AS RECEIVED.

Left - "A"
Right - "XX"

The results of the examination showed no defects in the spring submitted from the "crashed" aircraft. It would seem that the deformation of spring (Figure 1) was caused during the crash.

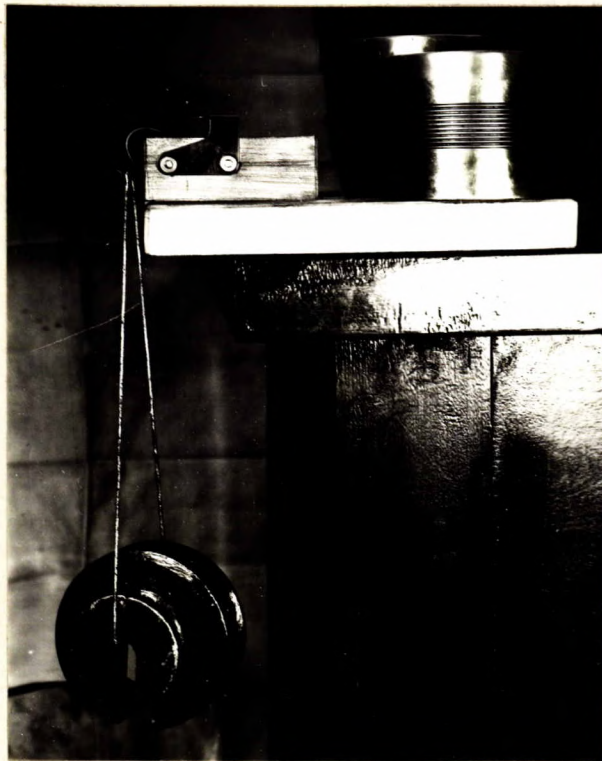
Figure 2.

Figure 2 shows the method of bending used for the examination of the springs.

METHOD OF BENDING TEST.
(Approximately 1/3 size).
