July 27th, 1942.

ORE DRESSING AND METALLURGICAL LABORATORIES.

Investigation No. 1274.

Examination of Defective 6-Pdr.
Mark III Breech Block 457.

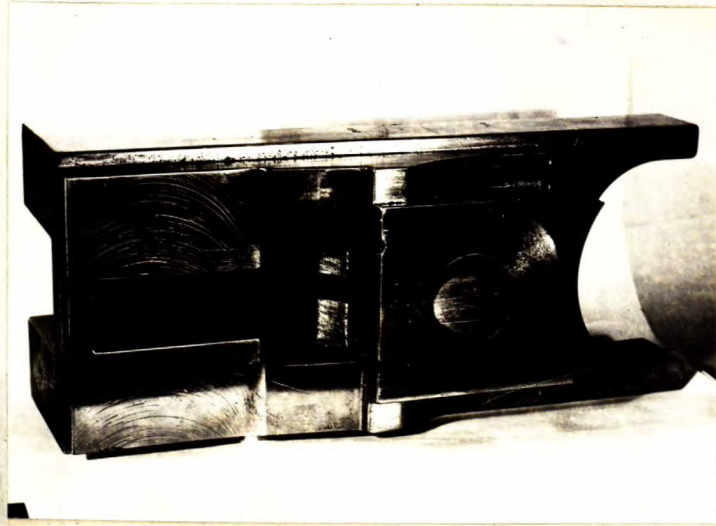
Figure 1.

I am forwarding to you by hand a breech block which has developed a defect during proof trials. In the forward face of this block is seated a bushing through which the firing pin mechanism operates. During firing this bushing has set back into the block some two or three thousandths of an inch.

Figure 1 is a view of the breech block as received, showing the bushing through which the firing pin mechanism works.

Photograph of Breech Block.
(About $\frac{1}{4}$ actual size).

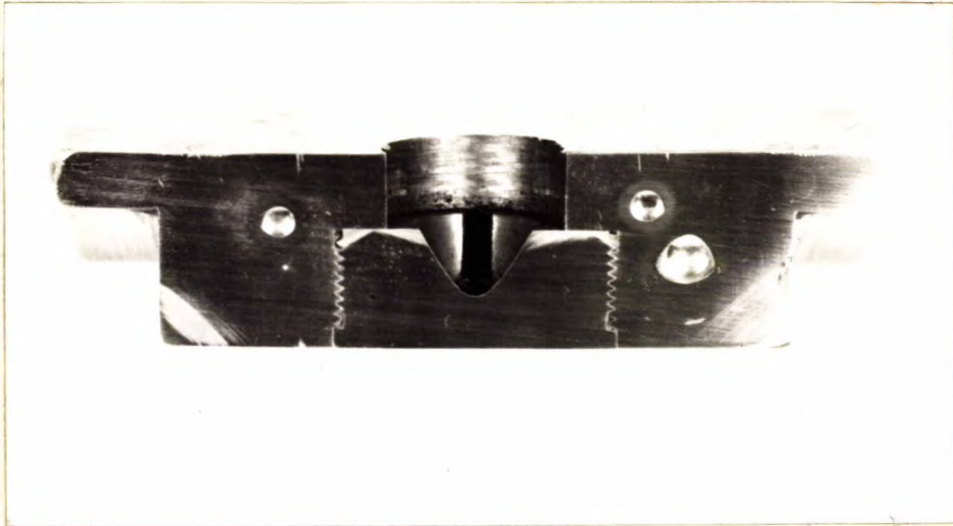
A section was cut out of the breech block where the bushing was inserted and the fit of the bushing was examined. It appeared to be a good fit. This section is shown in Figure 2.

The Brinell value was determined on the section shown in Figure 2.

Section cut to show fitting of bushing.
(Photograph at actual size).

The trouble could be eliminated by increasing the bearing area between the bushing and block, thereby distributing the compressive stresses over a larger area, if such a

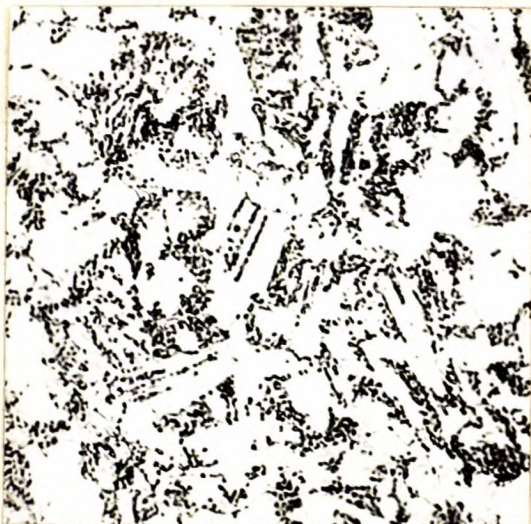
A section was taken about half an inch below the surface of the block for microscopic examination. A photomicrograph showing the structure of the steel at magnification of 1000 diameters is shown in Figure 3. Note the large amount of ferrite present.

The heat treatment as specified in the Specification S40 for "D" steel is an oil quench from a temperature not lower than 1550° F. followed by a draw at a temperature not higher than 1220° F. Apparently, from Figure 3, the block in question had not been cooled fast enough on the quench to suppress the formation of ferrite.

It will be noted that the steel in the block under examination complies with both the chemical and physical specifications as outlined in Specification S40 for "D" steel. However, the steel is quite soft and there is a large amount of ferrite present. The steel in this condition was probably not strong enough in bearing to resist the compressive forces transmitted to it through the bushing insert. This could be remedied by increasing the bearing area between the bushing and the block, if possible.

STRUCTURE OF STEEL AS RECEIVED.

Note large amount of ferrite.

The compressive strength of the steel could be improved by adopting the following heat treatment:

- (a) Heat to 1550° F.
- (b) Quench in water to below 800° F. (requires from 25 to 30 seconds).
- (c) Transfer immediately to oil and hold until temperature has reached 250° - 300° F. (requires about three and a half minutes).
- (d) Draw at a suitable temperature to produce desirable impact and tensile properties (say 1200° F.).

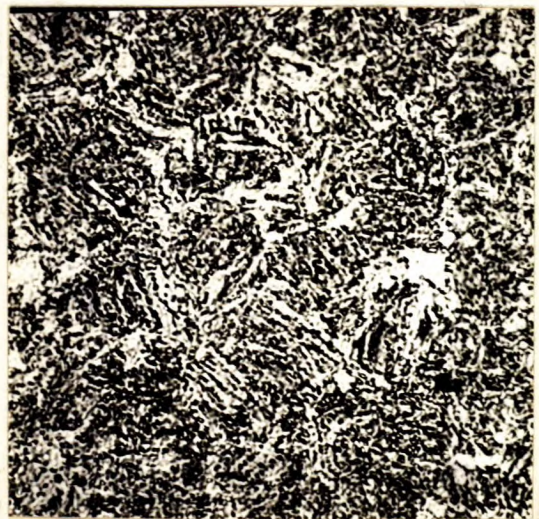
Figure 4.

Figure 4 shows the microstructure of the steel at the centre of this piece at 1000 diameters magnification. Note that there is still a little ferrite present but less than in original. It is estimated that the cooling rate at the centre of this piece at 1300° F. would be about 28 fahrenheit degrees per second.

The heat treatment tests outlined above were conducted in an effort to determine whether or not it would be possible to suppress the formation of ferrite. It will be noted, in the first test on the $1\frac{1}{4}$ " x $1\frac{1}{8}$ " piece, that the formation of ferrite was almost entirely suppressed. The cooling rate at 1300° F. in this piece was estimated to be 28 fahrenheit degrees per second. This would indicate that a cooling rate of this order would be necessary.

Structure in section $1\frac{3}{4}$ " x $1\frac{1}{2}$ "
after oil quench from 1550° F.
and draw from 1200° F.

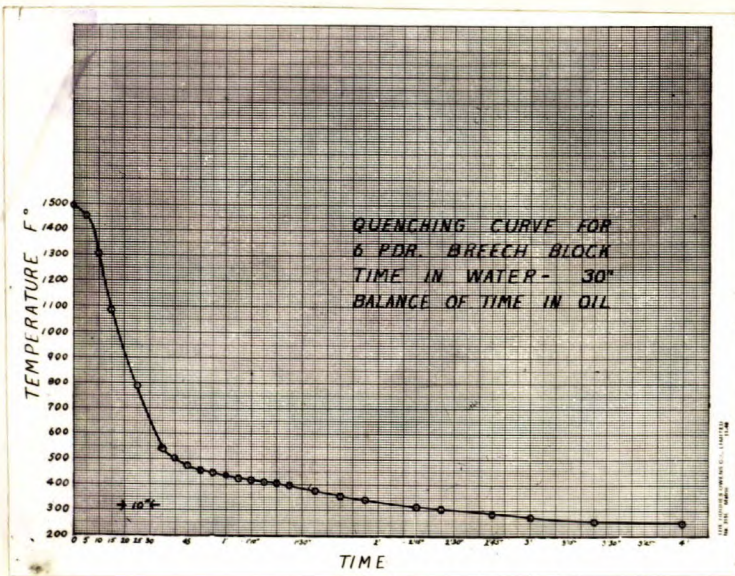
The remainder of the breech block was heat-treated next. To measure this cooling rate a thermocouple was welded on half an inch below the surface. The block was heated to 1500° F. very slowly, soaked for one hour, quenched to below 800° F. in water, and then transferred to oil. It was removed from the oil at 250° F. The resulting cooling curve is shown in Figure 5. From this curve, the cooling rate of this block at 1300° F. would be about 50 fahrenheit degrees per second, $\frac{1}{2}$ inch below the surface.

It took about 25 seconds for the block to reach 800° F. in the water quench. From the cooling curve, Figure 5, a practical quenching cycle would be 25 seconds in water, then transfer to oil and hold in the oil for about $3\frac{1}{2}$ minutes.

Cooling curve of metal, $\frac{1}{8}$ inch below surface of breech block during controlled quench in water and oil.

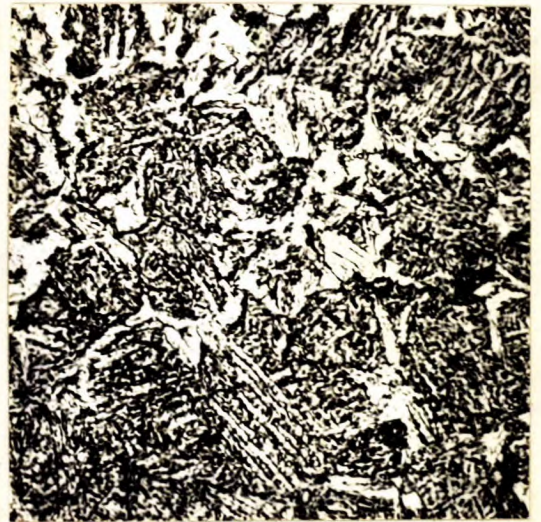
Figure 6.

Figure 6 gives the microstructure at 1000 diameters one inch below the surface. Compare with Figure 4.

a distance of one inch below the surface (Figure 6) shows that even at this point the cooling has been rapid enough to suppress most of the ferrite.

Photomicrograph, X1000. Electro polish, picral etch. Structure 1 inch below surface, resulting from controlled quench from 1500° F. and draw at 800° F. Note small amount of ferrite present. Compare with Figure 4.

Given this quenching treatment followed by a suitable drawing temperature, for example 1200° F., the compressive strength of this steel should be greatly improved over the compressive strength it possessed in the condition in which it was received. This should enable it to better support the firing pin bushing in service.

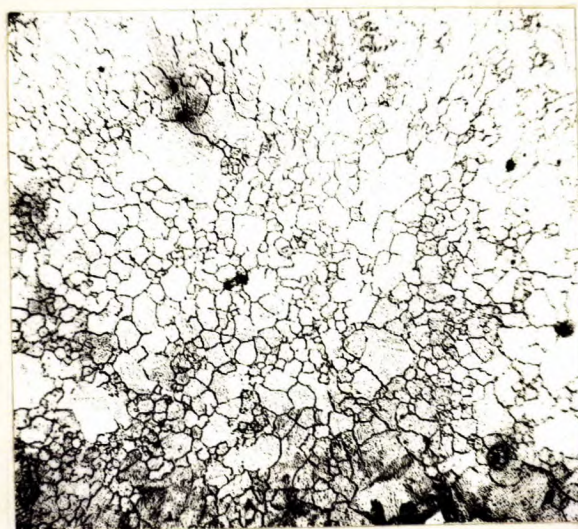
A McQuaid - Ehn test was conducted to determine the austenitic grain size at 1700° F. The result is shown in Figure 7. The grain size is mixed, 30 per cent No. 3 and 70 per cent No. 6.

MCQUAID-EHN GRAIN SIZE.

30% No. 3 and 70% No. 6.
