O T T A W A August 7th, 1942.

ORE DRESSING AND METALLURGICAL LABORATORIES.

Investigation No. 1280.

Investigation of a Broken Universal Carrier Track Link.

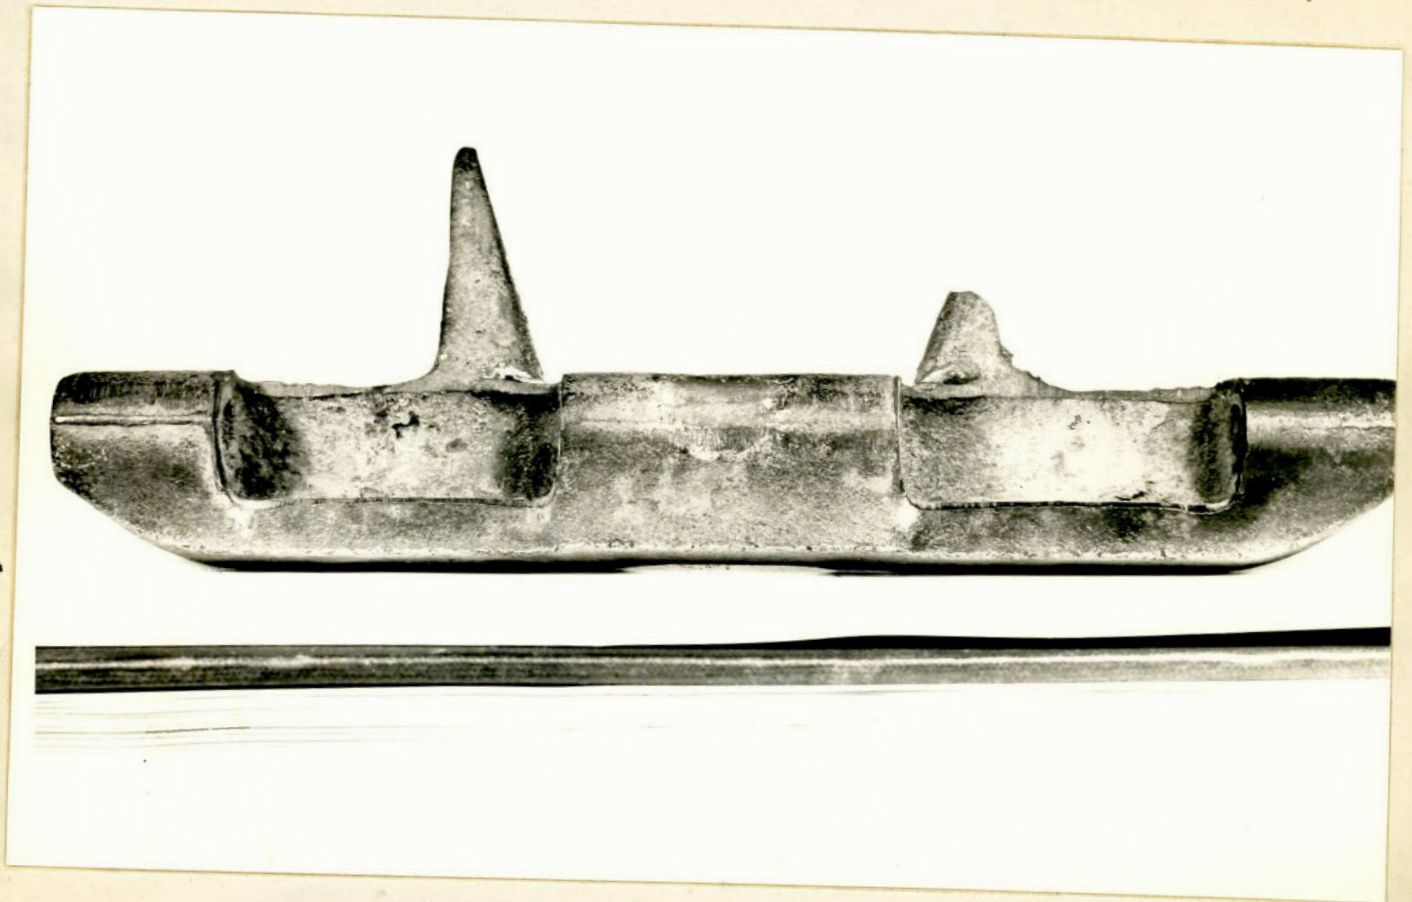
On July 31st, 1942, a track link, having a broken lug, was received through the Department of Munitions and Supply. This link came from the "Green" side of an experimental track which was first used on June 26th, 1942 and broke on July 20th, 1942. The mileage covered before the link broke was 434.

It was decided to make a thorough metallurgical examination to determine the cause of failure. Figure I shows the link as received.

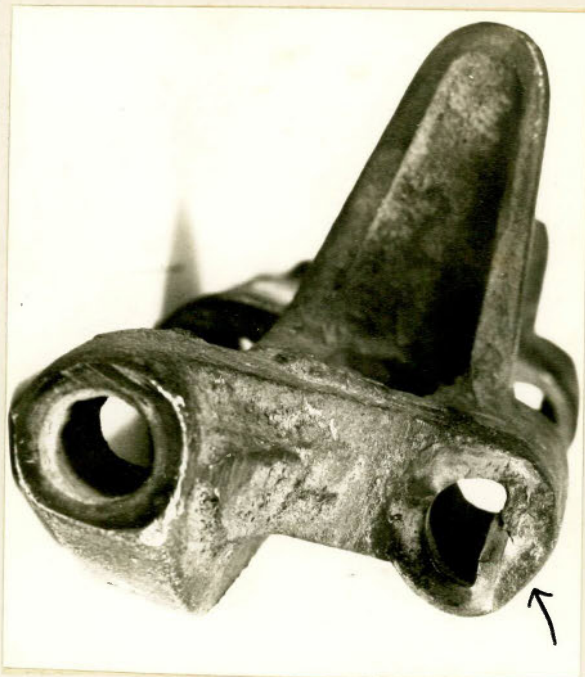
Figure II.

A link is considered to have sufficient ductility and toughness when the eye-holes will withstand the blows of a hammer until they are two-thirds of their original diameter. This link was subjected to test on two eye-holes and in both cases failure resulted. Figure II shows the cracking of the eye-hole wall.

The hammer test indicates low impact strength and this is the most probable reason for failure of the lug occurring.

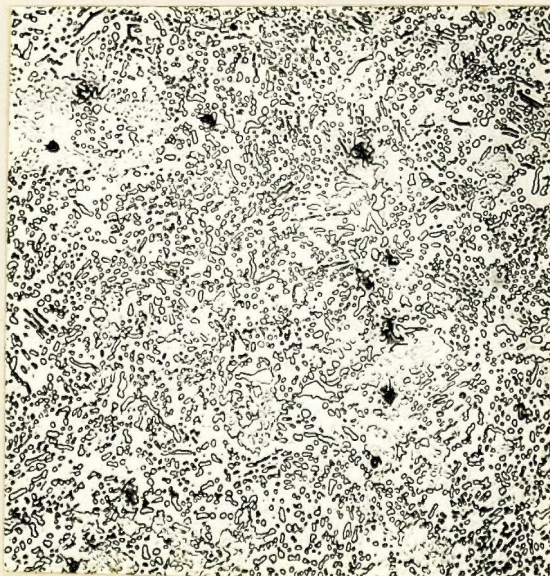
Figure III.

A microspecimen was cut from the link and examined in the unetched and nital-etched condition. An examination in the unetched state revealed that the steel contained a fair number of inclusions. Figure III taken off the etched sample at x 500 magnification shows the spheroidized carbides in a ferrite groundmass.

The polished microspecimen indicates that the steel was fairly dirty. The spheroidized structure is the most desirable state for a casting of this analysis. It must be pointed out, however, that a low impact material was obtained with this type of steel even though the most satisfactory heat treatment was given. It would appear that Ford No. 7 steel is not as satisfactory as Ford No. 4 steel for the Universal Carrier link.
