September 28th, 1942.

ORE DRESSING AND METALLURGICAL LABORATORIES.

Investigation No. 1308.

Metallurgical Examination of Aircraft
Oleo Leg Steel Forging 22666.

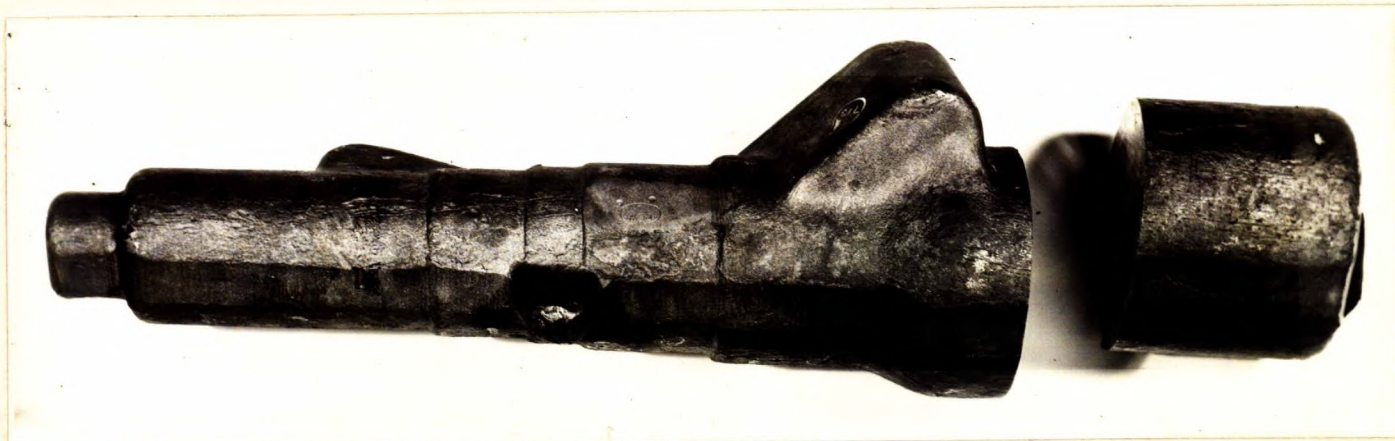
Figure 1.

A general view of the forging and a close-up of the surface are shown in Figures 1 and 2. A disc about 1 inch thick was cut from the large end of the forging at a point where surface roughness was severe. This was then immersed for 1 hour in a 50 per cent solution of nitric acid in water at 180° F.

GENERAL VIEW OF FORGING.

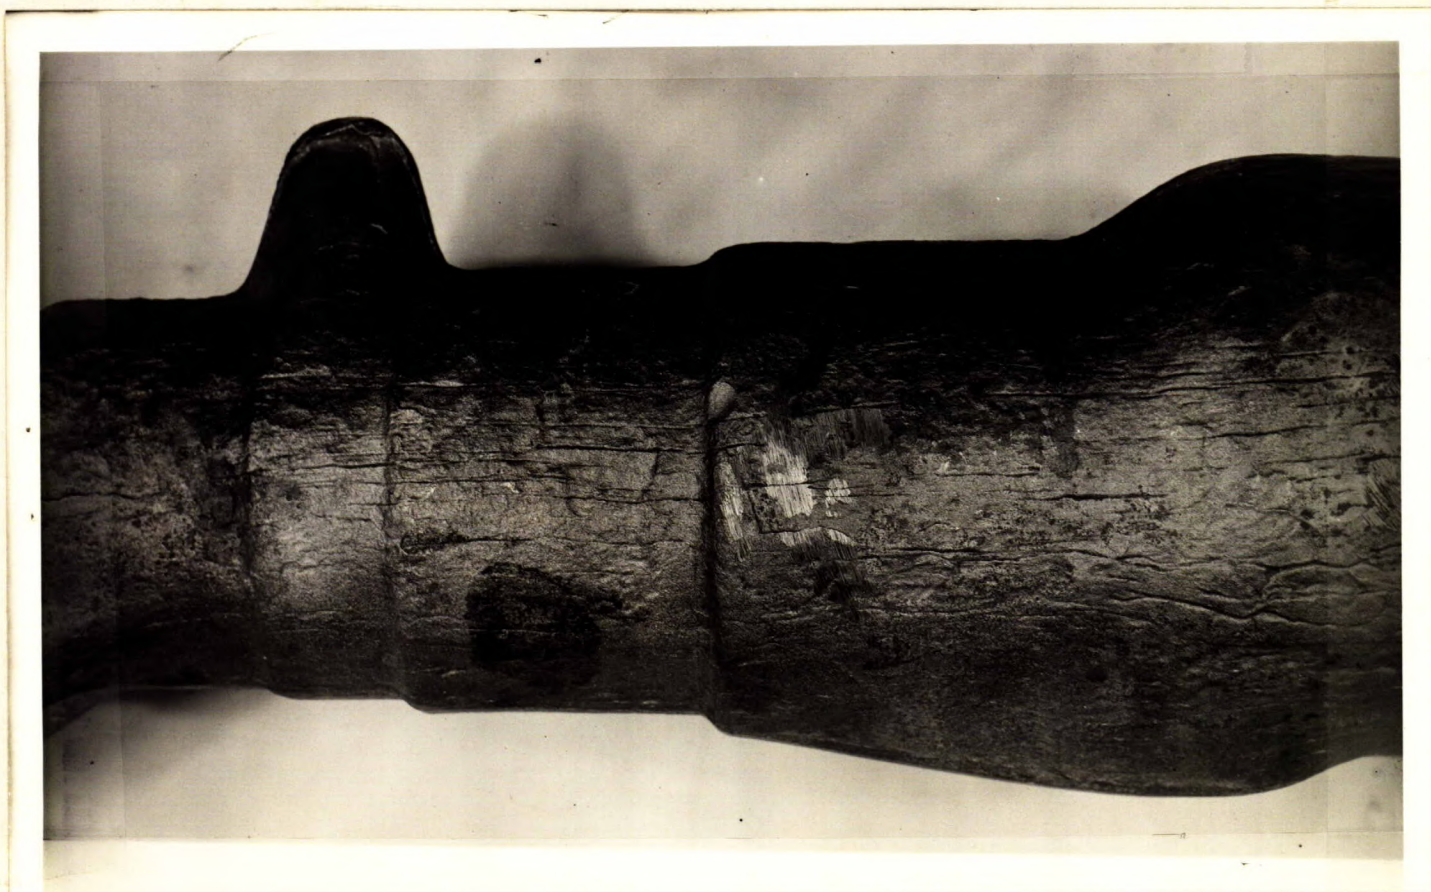
400
Figure 2.

After this treatment it was noted that some of the defects which were closed at the surface opened up again about 1/8 inch below it, while others were open their entire length. The deepest defect discovered measured about 13/32 inch. The etch revealed that none of these laps had its origin in the interior of the forging. A small defect, which appeared to be a pipe, was discovered in the centre of the etched section.

Macro- and micro-examinations definitely prove that the surface defects are laps formed as a result of folding-in of surface metal (with its covering oxide layer) in the forging operation. Such folding occurs when too few steps are used in the forging operation. The most probable cause of some laps' joining at the surface but opening up again inside is found in the fact that the oxide scale decreases toward the exterior, thus allowing the outer edges to be effectively

CLOSE-UP OF DEFECTIVE SURFACE.

From these data it is evident that the worth of the forging is decided by how much machining is to be done upon it. If it is machined below the depth of its most severe lap, then it should be entirely satisfactory; otherwise, its use is inadvisable.

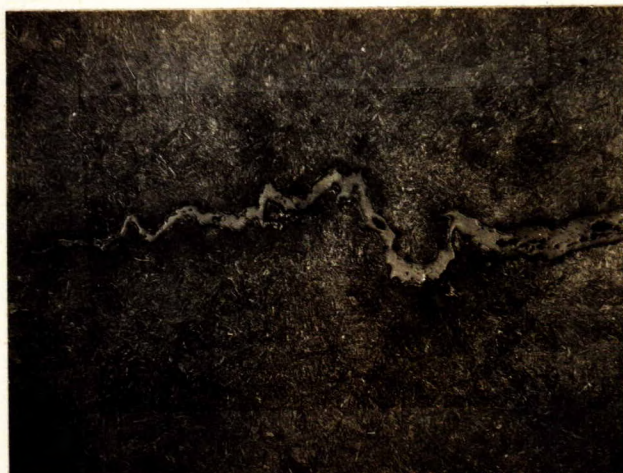
Figure 3.

A cross-section of one of the surface laps was polished and etched in a 4 per cent solution of picric acid in alcohol. The structure thus revealed showed that the steel had been quenched and tempered. The defect was found to be, at its origin, full of oxide inclusion which decreased until near the surface it was negligible. Photomicrographs of the lap are shown in Figures 3 and 4. A sulphur print taken from the surface of the forging revealed an absence of sulphur segregation.

X100, picric acid etch.

ORIGIN OF LAP.

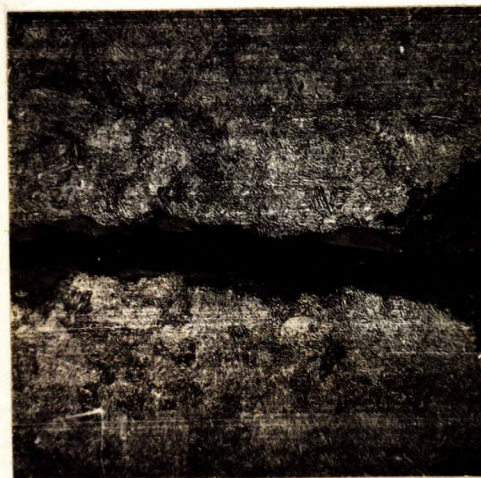
Figure 4.

joined by a process analogous to forge welding.

X100, picric acid etch.

NEARER TO SURFACE OF FORGING.
