ORE DRESSING AND METALLURGICAL LABORATORIES.

Investigation No. 1309.

Examination of
Valentine Tank Sprocket Hub No. 15611-T.

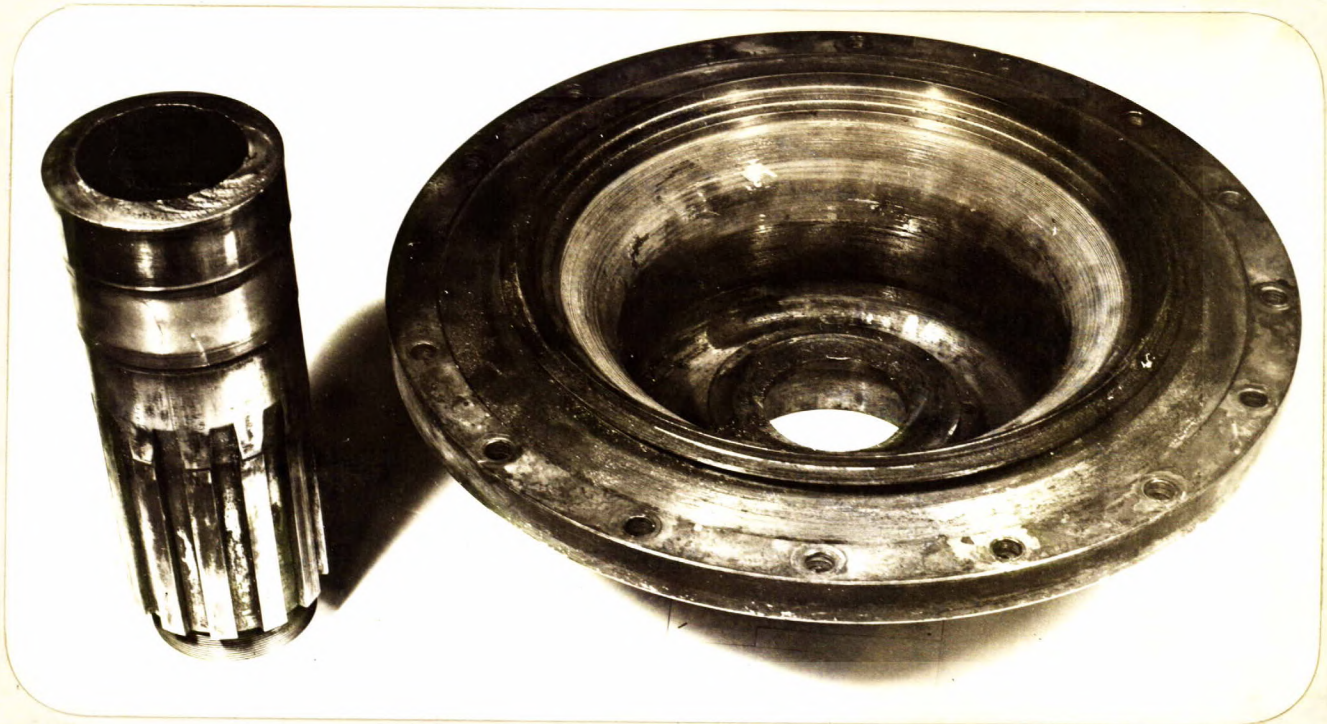
Figure 1.

The hub failed because the spline collar broke away from the disc. It was noted that the fracture, which had the appearance of a fatigue failure, occurred at a sharp corner of this highly stressed part. These points are illustrated in Figures 1, 2, and 3.

VIEW OF BROKEN HUB.
(Approximately $\frac{1}{4}$ size).

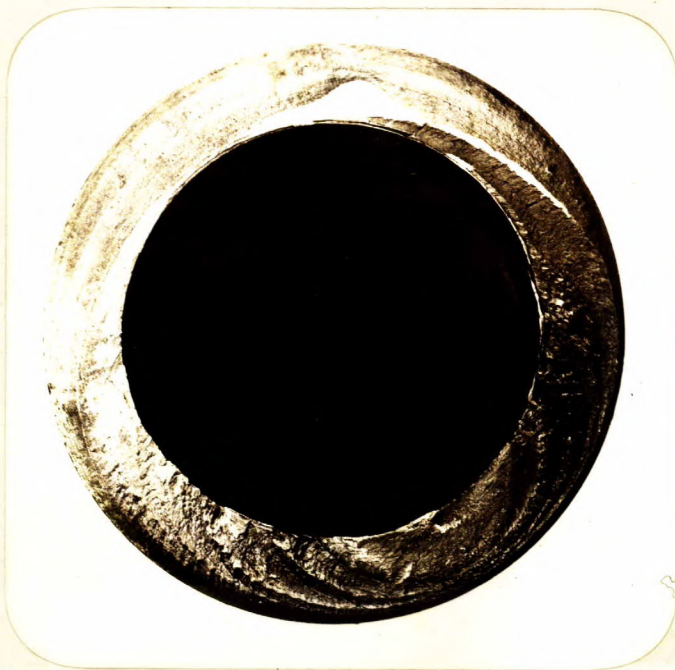
Figure 2.

From all of the foregoing it would seem that the failure of the part was brought about, first, by the concentration of stress caused by lack of filleting at the point of fracture, and secondly, by incorrect heat treatment which lowered the elastic limit of the piece below the specified limit and thus decreased its fatigue resistance.

VIEW OF FRACTURE.
(Approximately $\frac{5}{8}$ size).

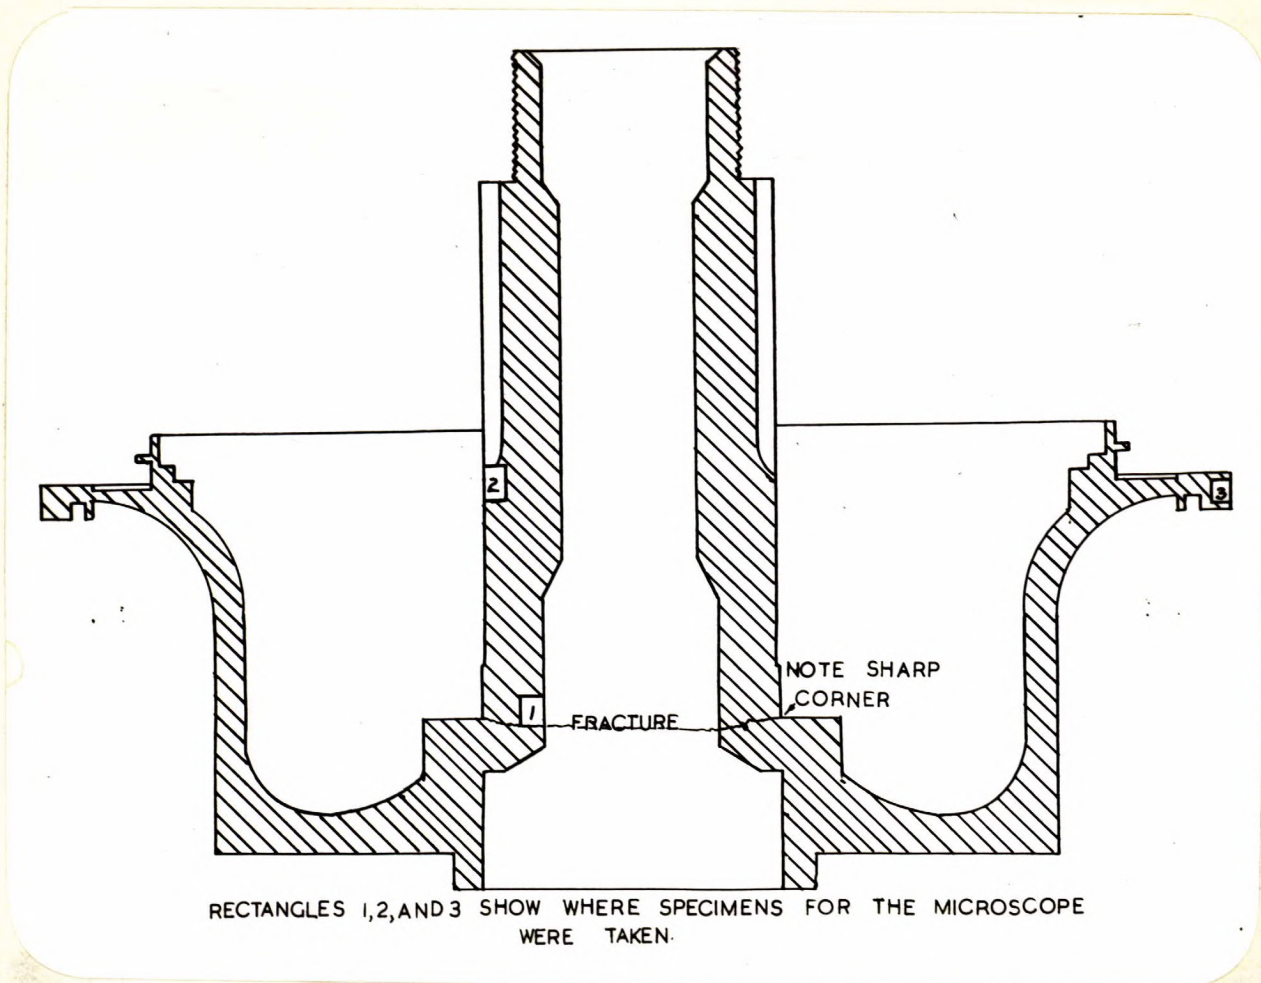
The specification called for a Brinell hardness of 260 to 310. Readings were taken at points 1, 2, and 3, as shown in Figure 3. Brinell hardness values obtained were at point 1, 212; at point 2, 205; and at point 3, 250.

It will be noted that the hub has not the required ultimate and yield strengths. The most probable explanation for the higher hardness at the outside of the flange is that when the original forging was heat-treated this part was thinner than the rest and thus cooled faster. A faster rate of cooling in heat treatment, or a heat treatment of a partially machined forging, would have conferred a more uniform structure.

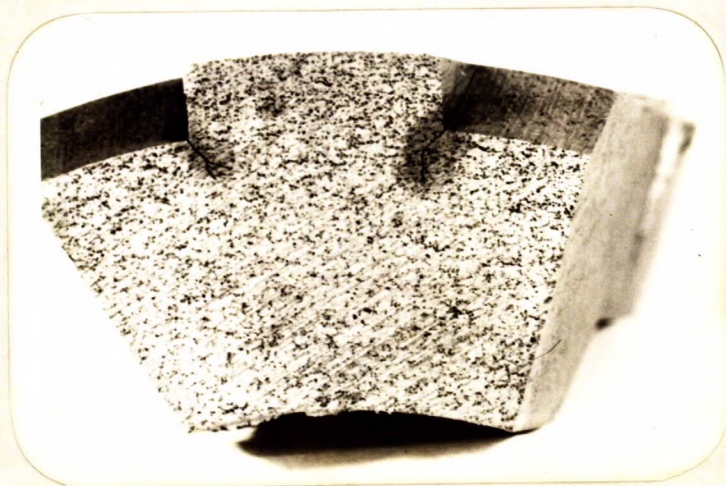
A macro etch on a section of the spline collar revealed that the bottom edges of the splines were cracked. This is shown in Figure 4.

The cracks at the base of the splines do not have any bearing upon the failure investigated but were included in this report because they may be a source of future trouble. The splines appeared to be slightly bent and cracking may have occurred in this bending.

CRACKS AT THE BASE OF THE SPLINES.

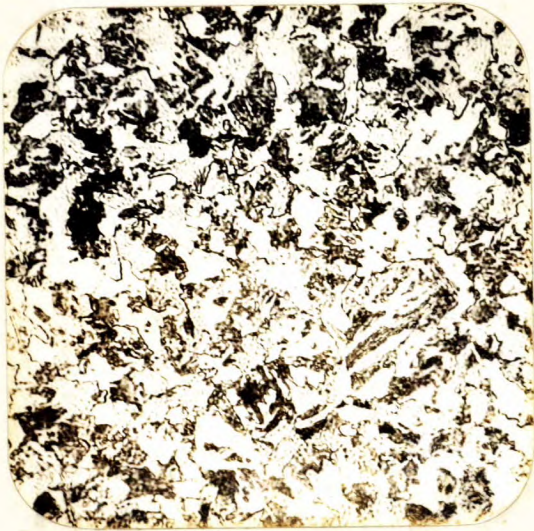
Figure 5.

MICROSTRUCTURE AT POINT 1
IN FIGURE 3.

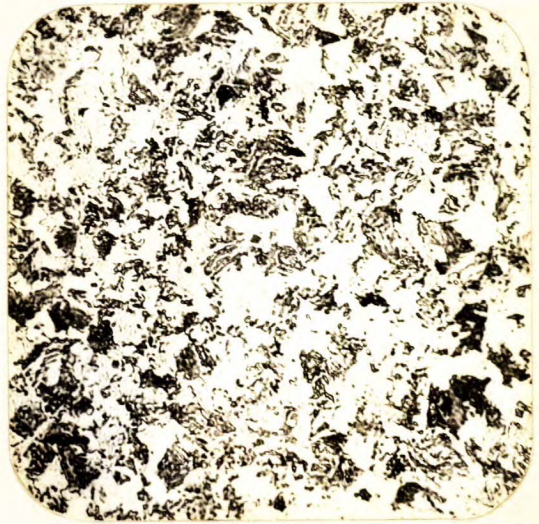
Figure 6.

MICROSTRUCTURE AT POINT 2
IN FIGURE 3.

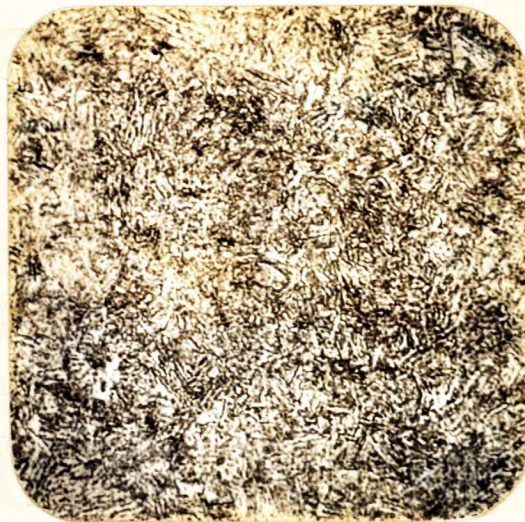
Figure 7.

Specimens 1, 2 and 3, from points 1, 2 and 3 in Figure 3, were removed and polished. After an etch of 4 per cent picric acid in alcohol was applied, a photomicrograph at 500 diameters was taken of each specimen. These are given at the end of this report. It will be noted that Specimen 3, from the outer edge of the flange, is composed of fine pearlite (sorbite), while the others, from the spline collar, are about 50 per cent pearlite and 50 per cent ferrite. An examination of the metal at the point of fracture failed to reveal any local defects.

MICROSTRUCTURE AT POINT 3 IN FIGURE 3.
