R E P O R T
of the
ORE DRESSING AND METALLURGICAL LABORATORIES.

Investigation No. 1314.

Investigation of a Cracked Valentine
Tank Track Link.

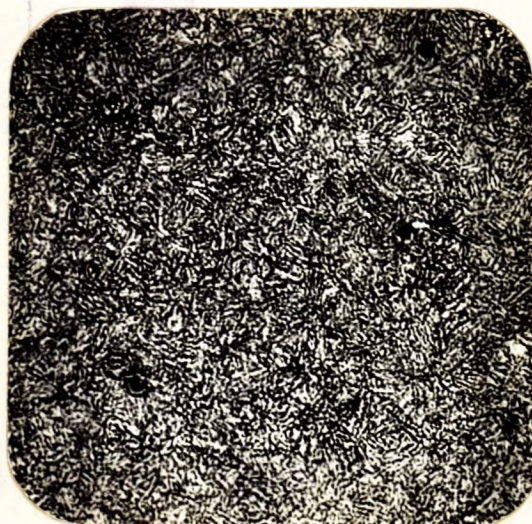
Figure 1.

A microspecimen was cut from the link and polished. It was examined in the unetched and nital-etched states. The unetched specimen showed the steel to be quite clean. Figure 1 at X500 magnification, taken of the etched specimen, indicates a uniform structure.

X500, nital etch.

STRUCTURE OF THE LINK.
