O T T A W A November 4th, 1942.

Investigation No. 1320.

Examination of a High Manganese Steel
Valentine Tank Track Link.

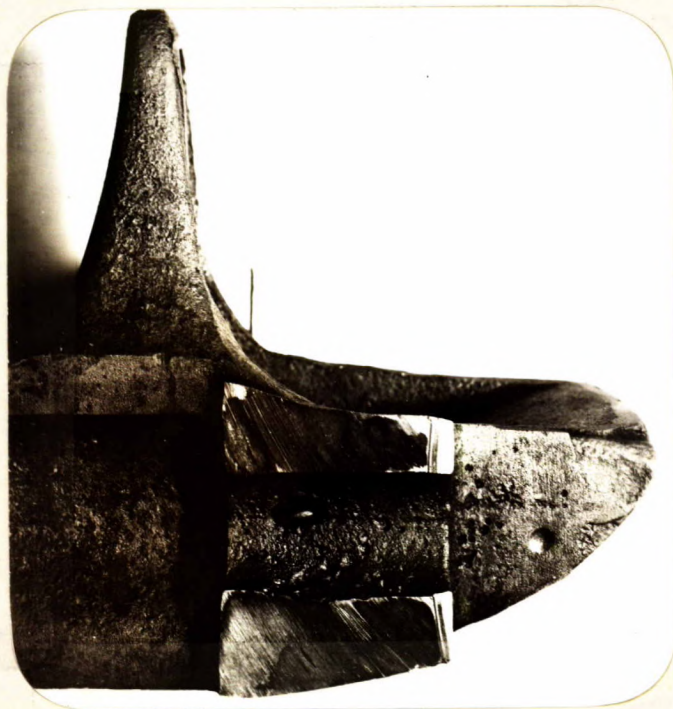
Figure 1.

Several parts of the link surface were in a pitted condition, the diameter of the pits being approximately 1/16 inch. Figure 1, showing the inner wall of the third eye-hole on the three-eye side of the link, illustrates the surface condition and also shows the presence of an exposed chill. This chill has evidently not been taken up by the metal.

INNER WALL OF EYE-HOLE.
(Approximately to size).

The pitted surface is probably due to gas. The gas may be caused by:

- (1) A poorly baked core.
- (2) A poorly vented core.
- (3) The core wash.

Instruments are now available whereby the gas volume per c.c. of core can be measured. This volume should be kept to a minimum.

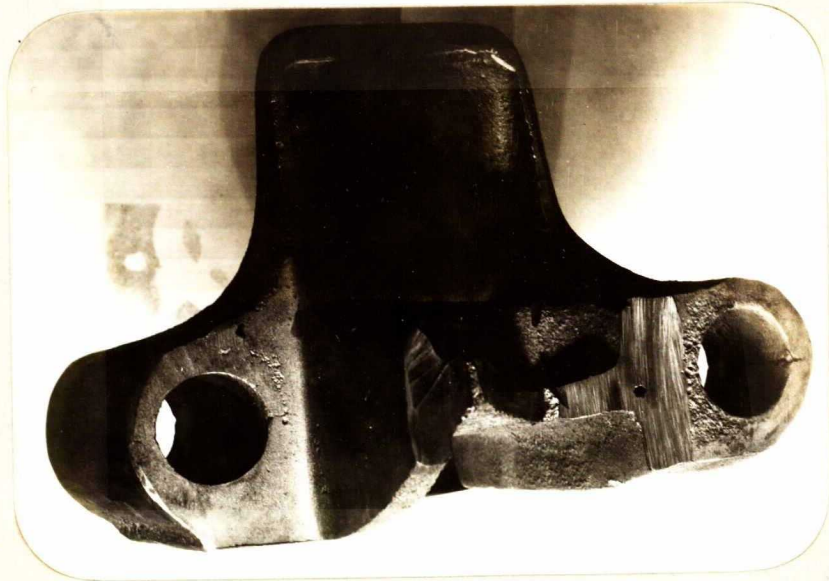
Figure 2.

An X-ray examination of the link was made by Dr. G. C. Laurence, of the National Research Council, Ottawa. Cavities were found at the connections of the eye-holes to the main section of the link on the three-eye side of the link. Figures 2 and 3 show one of these cavities. The opening shown at the right in Figure 2 is 1/8 inch in diameter. Figure 3 shows the size of this cavity after some of the

OPENING OF SHRINKAGE CAVITY.

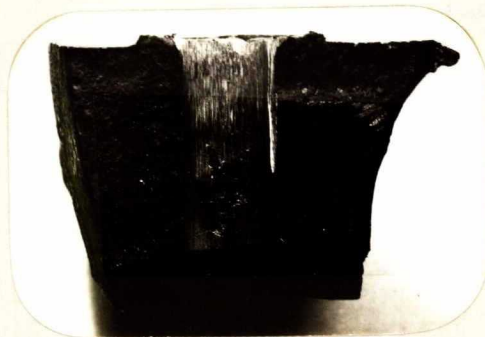
Figure 3.

enclosing metal has been ground off.

"SHRINKAGE" CAVITY.

Cavities are present but at points where they should not seriously affect the strength of the link. The cavity shown in Figure 3 is of the "shrinkage" type. Elimination of this type of cavity can be effected, however, by a change in the technique, such as,

- (1) Gating so as to supply hot liquid metal under pressure to the section while it is solidifying;
or,
- (2) Using metal chills in the mould so as to move the shrinkage to a point where Method (1) may be applied more easily.

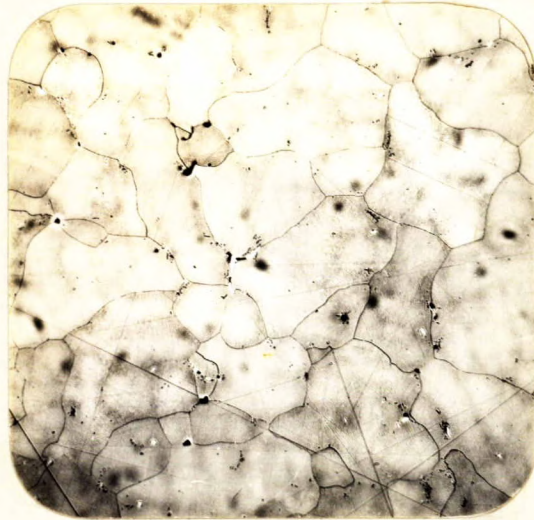
Figure 4.

Several specimens were cut from the link, polished, etched in nital, and examined under the microscope. Figure 4, taken at X100 magnification, illustrates the structure of the link.

X100, nital etch.
STRUCTURE OF LINK.

The austenitic grain size shown in Figure 4 indicates that the steel was poured close to the lower limit of the temperature range for high manganese steel. The absence of free carbides shows that the casting has been properly heat treated.
