Investigation No. 1333.

Examination of Austenitic Manganese Steel
Test Bars and Track Links from
the Beach Foundry Limited,
Ottawa, Ontario.

O T T A W A December 4th, 1942.

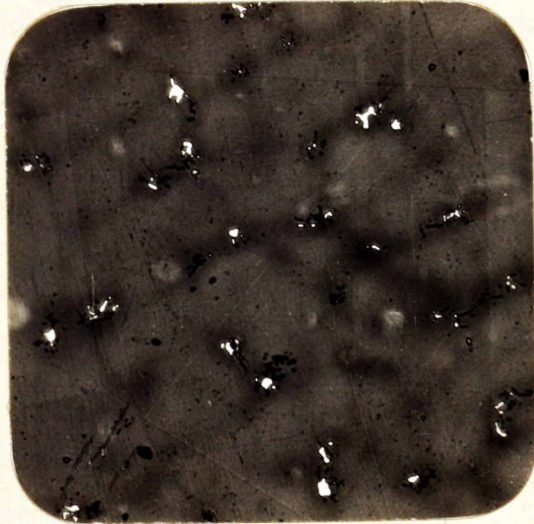
Figure 1.

Micro-examination of the three test bars revealed that each of them had globular particles of free carbide. The arrangement of these carbides conforms to a dendritic pattern. In Test Bar 4, some of the carbide constituent has been rejected to the grain boundaries. Photomicrographs, at 250 diameters, of Test Bars 1, 4 and 7 are given in Figures 1, 2 and 5, respectively.

The nature of the carbide particles present in the heat-treated test bars indicates that these specimens were quenched from too low a temperature, the carbide never being completely in solution. This condition could also have resulted from insufficient soaking time but this possibility is considered less likely. The carbide at the boundaries of the austenite grains in Test Bar 4 shows that some delay occurred in the quenching of this sample.

X250, nital etch.

TEST BAR 1.

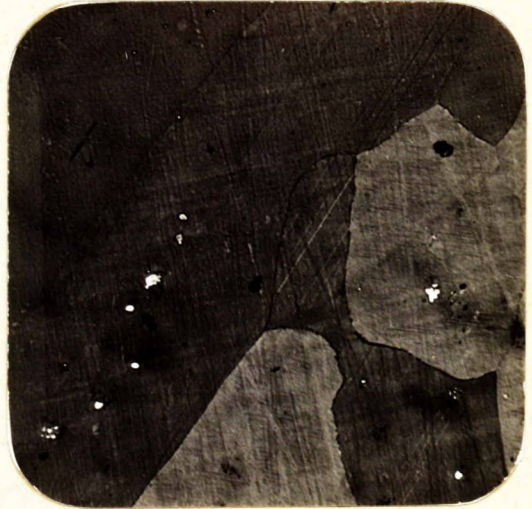
Figure 2.

X250, nital etch.

TEST BAR 4.

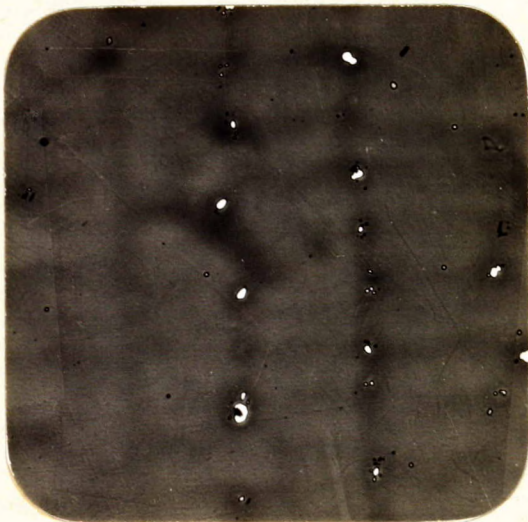
Figure 3.

X250, nital etch.

TEST BAR 7.

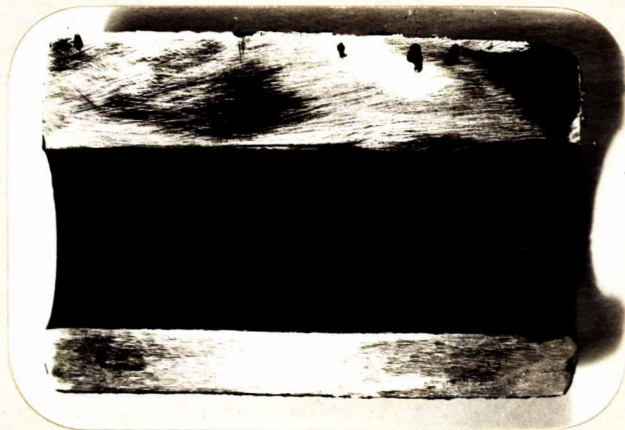
Figure 6.

The defects shown in Figure 6 were present in a large eyehole in Link No. 1. These cavities have symmetrical outlines and smooth lined surfaces. The cavities illustrated in Figure 7, from a large eyehole of Link No. 2, have irregular outlines and rough surfaces.

The two cavities in the upper right hand corner of Figure 5 were caused by gas from the chill situated at this point. The others in this picture are shrinks. The location and nature of the defects shown in Figure 6 indicate that these were probably caused by gas. The defects in Link No. 2 (Figure 7) seem to be shrinkage cavities.

DEFECTS IN LINK NO. 1.
(Approximately to size).

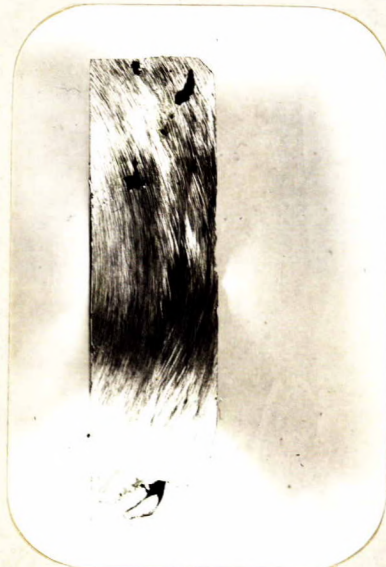
Figure 7.

DEFECTS IN LINK NO. 2.
(Approximately to size).
