December 7th, 1942.

ORE DRESSING AND METALLURGICAL LABORATORIES.

Investigation No. 1334.

An Examination of Some Universal Carrier
Bogey Wheel Springs.

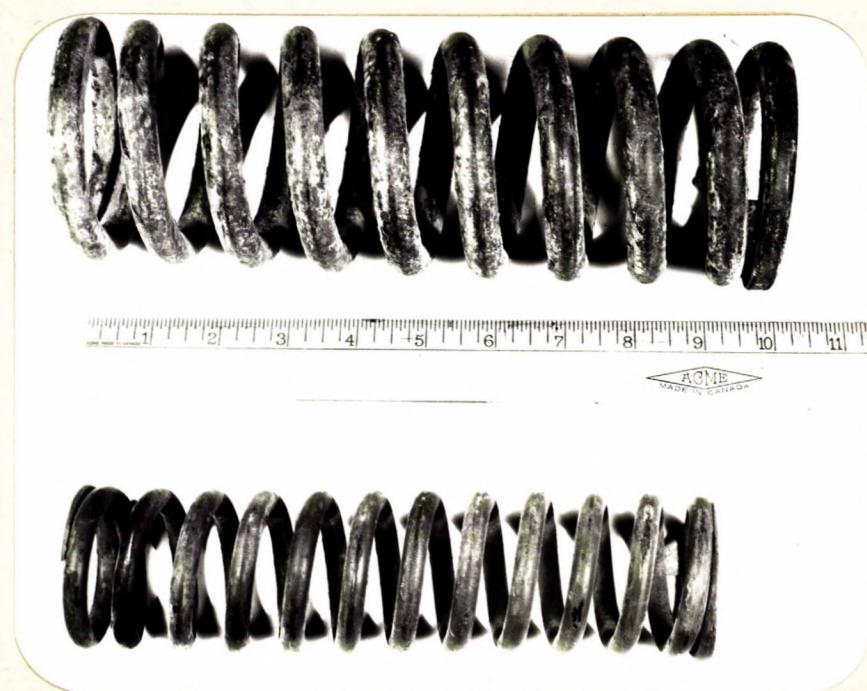
Figure 1.

TWO OF THE SPRINGS RECEIVED.

(The small spring is used inside the larger).

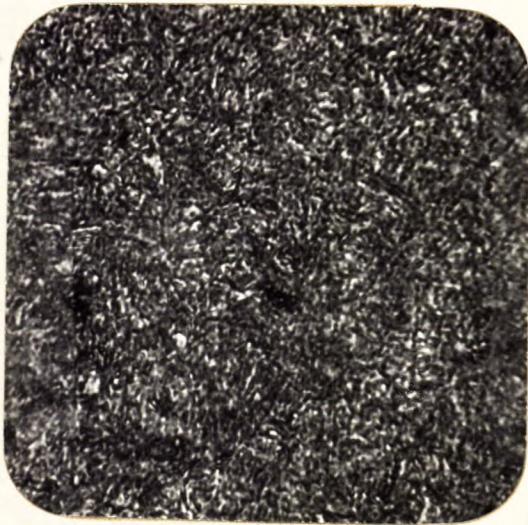
Figure 2.

Small Spring.

Rockwell 'C' hardness, 44.

NEW SPRINGS.

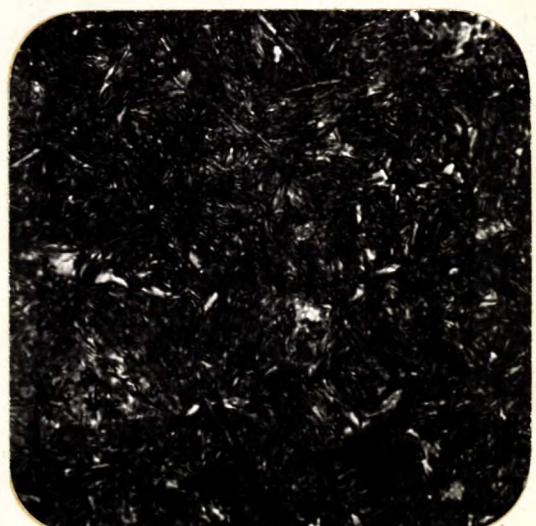
Figure 3.

Large Spring.

Rockwell 'C' hardness, 49.

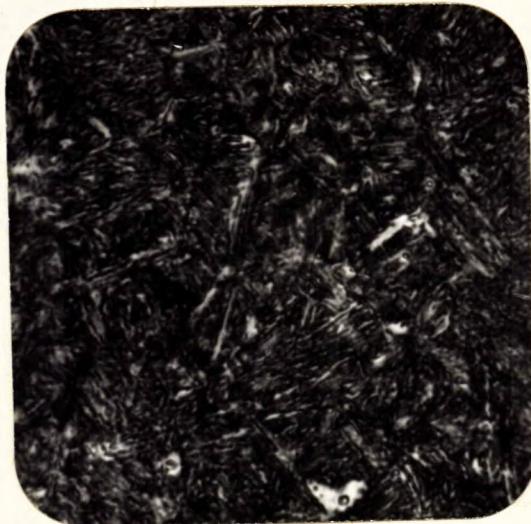
Figure 4.

Small.

Rockwell 'C', 43.

7,000-MILE SPRINGS.

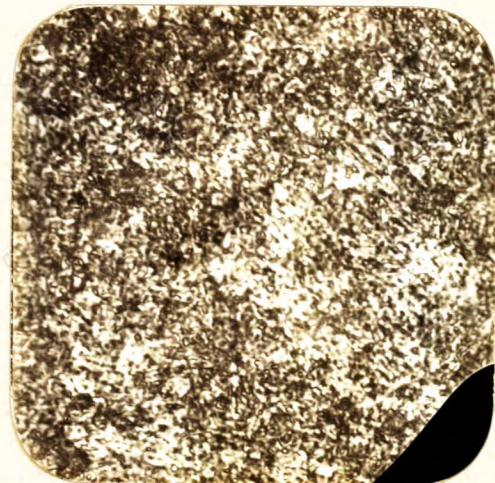
Figure 5.

Large.

Rockwell 'C', 47.

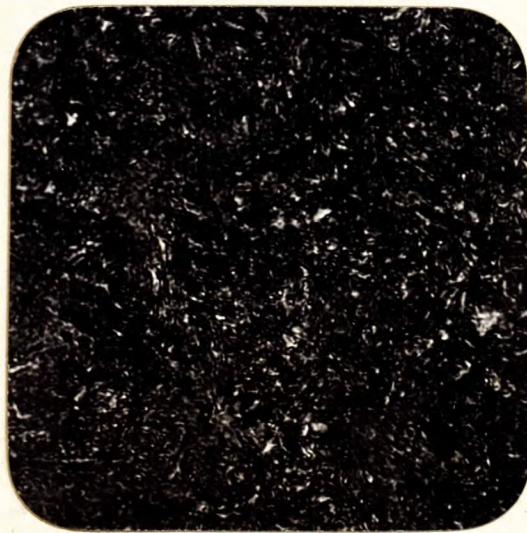
Figure 6.

Small.

Rockwell 'C', 44.

BRINE-EXPOSED SPRINGS.

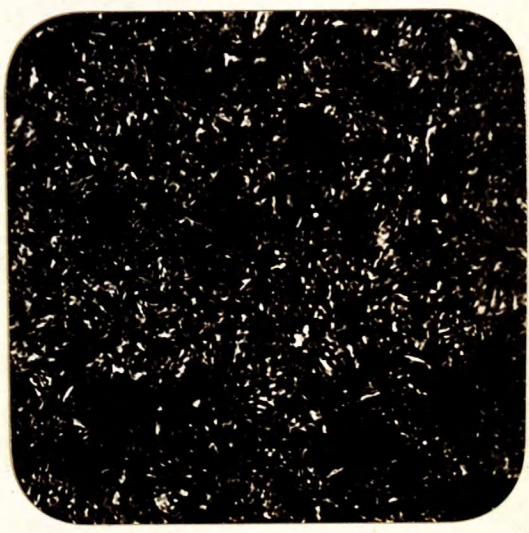
Figure 7.

Large.

Rockwell 'C', 47.

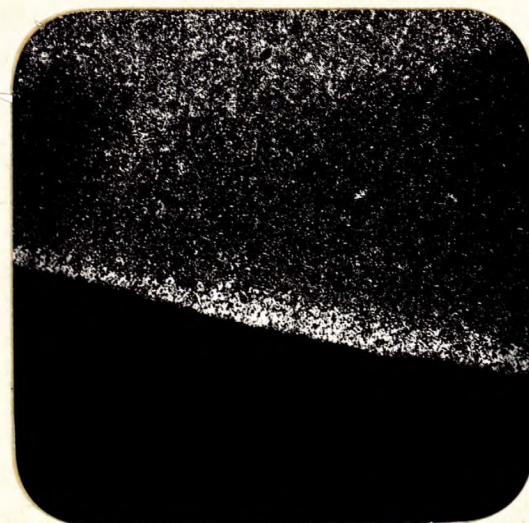
Figure 8.

Small.

EDGE OF NEW SPRINGS.

Slight decarburization is evident on most of the springs. Apparently the surface was ground but not deeply enough to remove all of the decarburization.

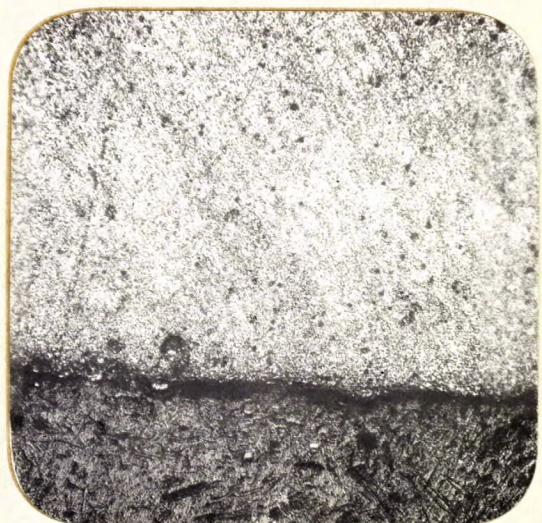
Figure 9.

Large.

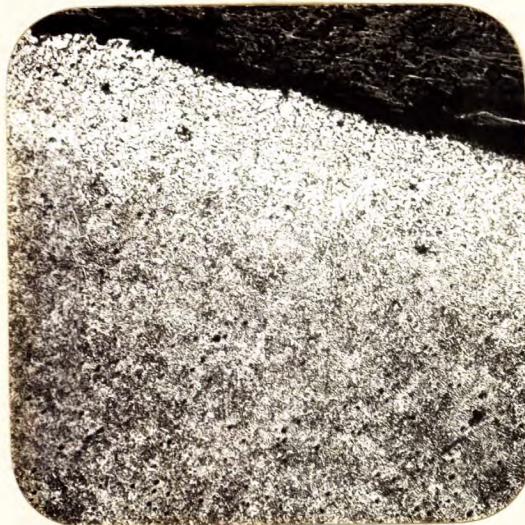
Figure 10.

Small.

EDGE OF 7,000-MILE SPRINGS.

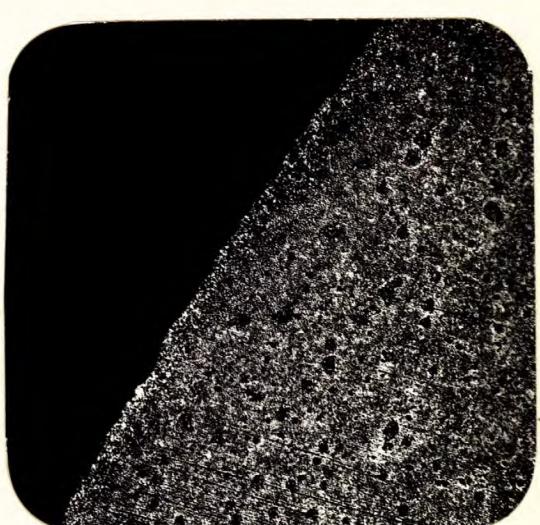
Figure 11.

Large.

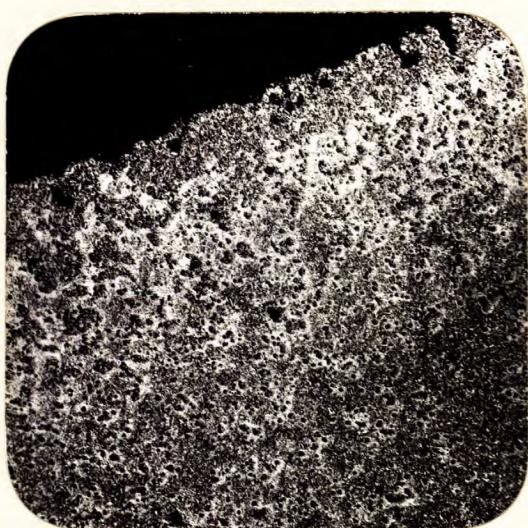
Figure 12.

Small.

EDGE OF BRINE-EXPOSED SPRINGS.
