December 23rd, 1942.

ORE DRESSING AND METALLURGICAL LABORATORIES.

Investigation No. 1337.

Examination of a Lancaster Spar
Aluminium-Alloy Extrusion.

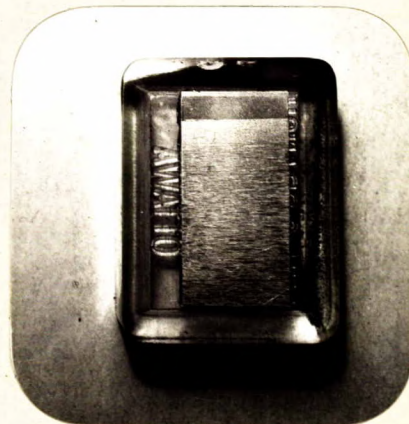
Figure 2.

Figure 2 shows the macrostructure of a cross-section cut through the "bright" spot (perpendicular to the surface shown in Figure 1) and etched with Keller's reagent. This

surface shows that the "bright" areas run parallel to the direction of extrusion.

No hair cracks were found.

SECTION LONGITUDINAL
TO THE EXTRUSION,
(etched with Keller's reagent).

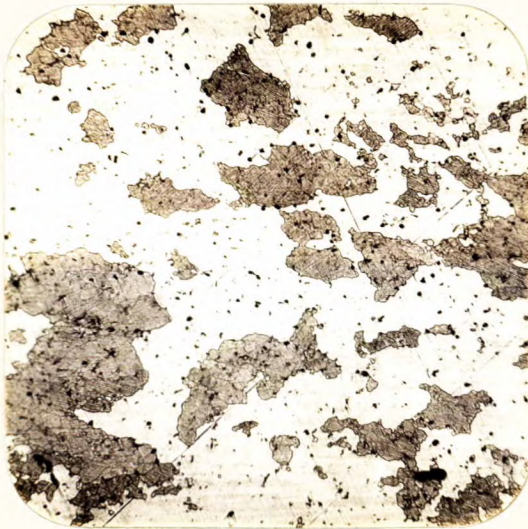
Figure 3.

Figure 3 shows the typical microstructure of the inside part of the extrusion. Figure 4 shows the microstructure of the "bright" area. Both microphotographs are representative of the section perpendicular to the direction of extrusion.

AVERAGE STRUCTURE.

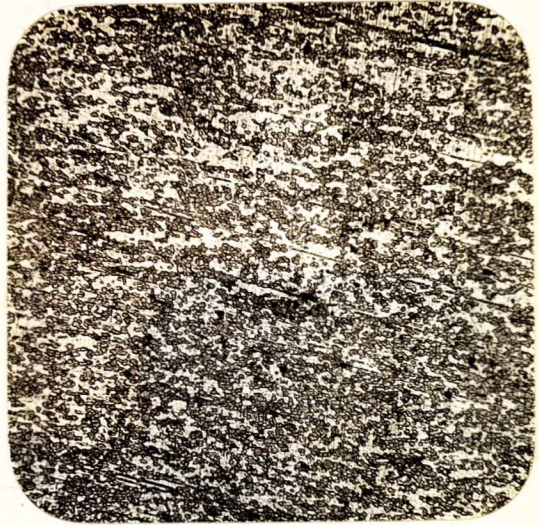
Figure 4.

No cracks on the "bright" area were detected.

"BRIGHT" SPOT.

Average (inside)	-	150 V.H.N.
"Bright" areas in the corners	-	160 V.H.N.

The hardness tests indicate that these areas are slightly harder than the rest of the material.

These differences in grain size, which are due to pressure and temperature effects in the process, are especially marked in the last part of the extrusion. Various workers have investigated these phenomena but none has been able to eliminate the heterogeneity. It was demonstrated, however, that the different structures produce no marked variations in mechanical properties of the extrusion.
