ORE DRESSING AND METALLURGICAL LABORATORIES.

Investigation No. 1345.

Examination of a Fractured Piston.

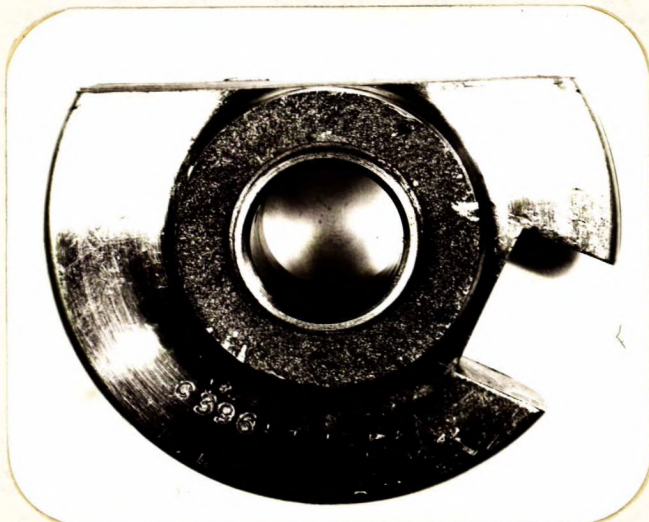
Figure 1.

PHOTOGRAPH OF
PISTON FRACTURE.

Figure 1 shows the coarse nature of the fracture.

The composition of the steel was found to correspond to that of an SAE 1040 steel, and not to SAE 1020 steel as supposed. The coarseness of the fracture of the steel indicates that the part was not heat-treated subsequent to forging or was heated to an excessively high temperature in a post-forging operation. This was confirmed in the metallographic examination of the steel. Steel with this coarse structure would have lower physical properties than a similar steel which had been properly heat-treated to refine the grain. The reasonably coarse pearlitic structure shown in Figure 3 is that of a steel which has been cooled slowly through the critical stage.

The steel in this failed piston did not have the composition (SAE 1020) mentioned in the request letter. Steel of the composition used, however, would certainly have proved most satisfactory had it been heat-treated after the forging operation.

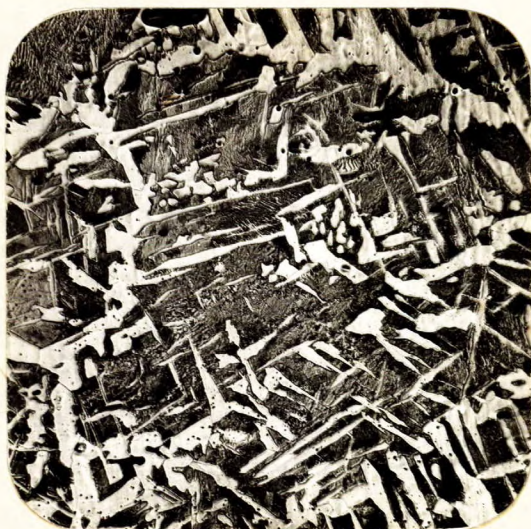
Figure 2.

Specimens cut from the piston were polished and then examined under the microscope. The steel in the unetched condition was found to be fairly clean and free from any burning defects. The picral-etched specimen showed the structure illustrated in Figures 2 and 3, photomicrographs at X100 and X1000 magnification respectively. The grain size of the steel is large and the structure consists of ferrite (the white constituent) and fairly coarse pearlite (the dark etching material).

X100, electro-polished,
etched in 4 per cent
picral.

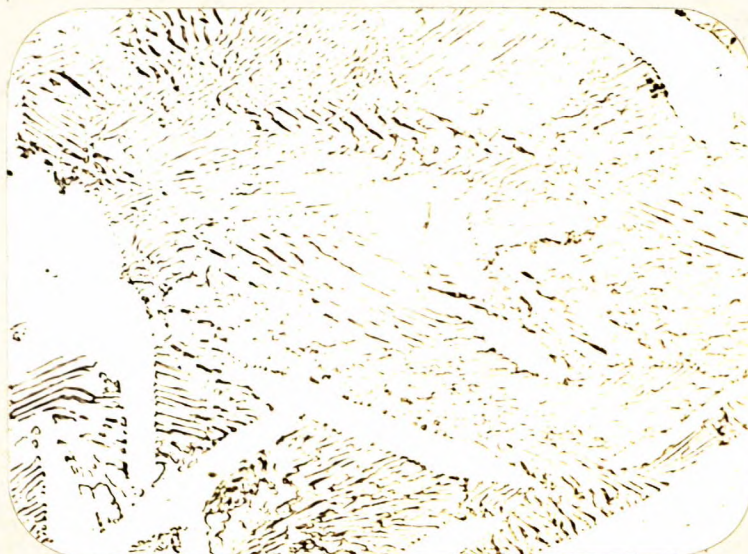
Figure 3.

X1000,
electro-polished,
etched in 4 per
cent picral.
