January 22nd, 1943.

ORE DRESSING AND METALLURGICAL LABORATORIES.

Investigation No. 1347.

Examination of Broken Crankshaft from
a Ranger Aircraft Engine.

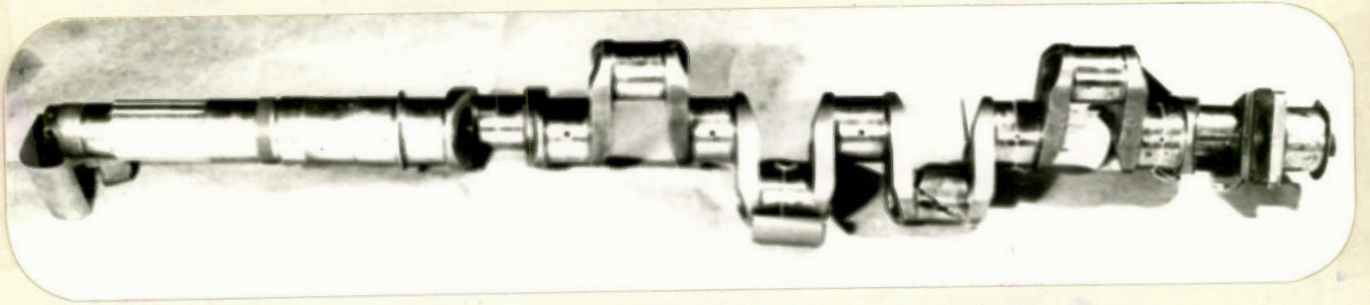
Figure 1.

A general view of the crankshaft and a close-up of the fractured surface are given respectively in Figures 1 and 2. It was noted that the fracture had the appearance of a fatigue failure, the nucleus of which seemed to be in the fillet in the under side of the crank pin (Point A in Figure 2).

CRANKSHAFT AS RECEIVED.
(Approximately 1/6 size).

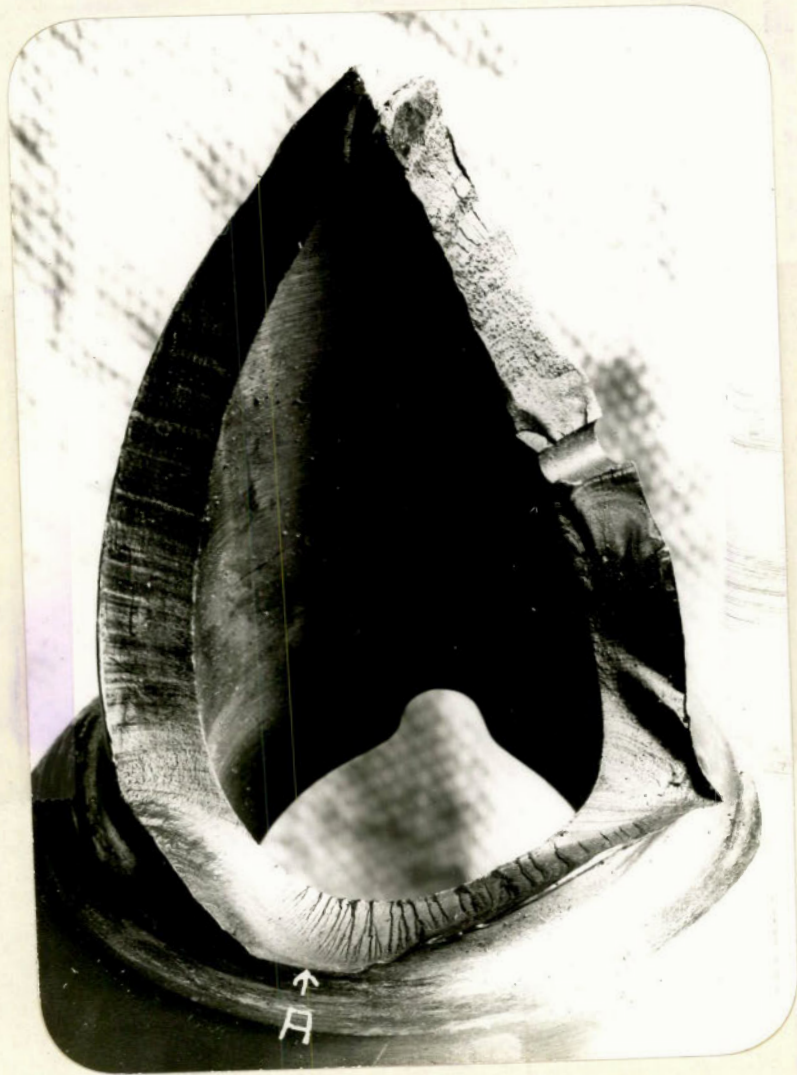
Figure 2.

The discontinuity of the grain at the point where fracture is believed to have started is considered the most serious defect in the crankshaft.

SURFACE OF FRACTURE.
(Approximately $1\frac{1}{2}$ times actual size).

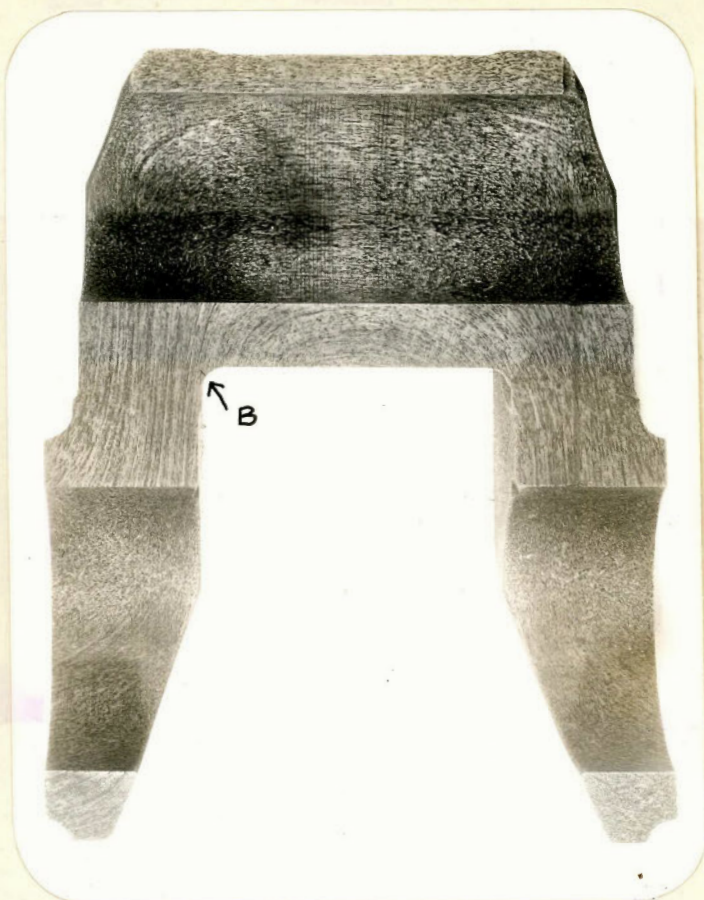
Two of the crank pins, similar to the one in which failure occurred, were removed, halved, and immersed for one hour in a 50 per cent solution of hydrochloric acid in water at 170° F. After this treatment, a crack (Point B, Figure 3) was revealed which seemed to be developing in one of the unbroken crank pins in the same way as the fracture which caused failure. The flow lines of the material do not conform to the outline of the crank pin at this point. These points are illustrated in Figure 3. A further 3/8-inch cut was taken from one of the etched surfaces and the piece was re-etched. The flow lines still left the forging near and at the fillet.

SURFACE, MACRO-ETCHED.
(Approximately $\frac{3}{4}$ size).
Note crack at B.

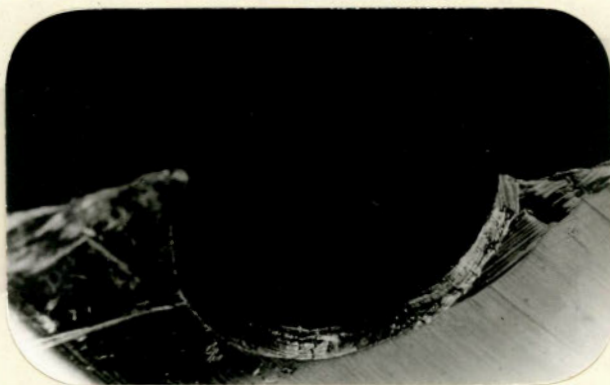
Figure 4.

The chamfer on the oil hole in the broken crank pin

was not well rounded (Figure 4). Some tool marks were found in the oil clearance slot or keyway through which the fracture which caused failure went.

to be satisfactory. The physical property results are the normal expectancy. The roughness at the oil hole and oil clearance slot are not thought to be starting points for this fracture but might have led to fracture if other defects had not been present.

CHAMFER ON THE OIL HOLE.
(Approximately X6 magnification).

1. With the exception of the carbon content, the steel met Specification AMS 6382A requirements.
2. Physical properties of the crankshaft steel are in accordance with expectations.
3. Fracture indicates the failure to have been caused by alternating stresses, with the fatigue crack starting at a crank pin fillet.
4. Forging practice which failed to hold flow lines to the crank pin constituted the major cause of failure. Elongated inclusions present in the zone of failure may have been a contributing cause.
5. To improve the factor of safety of the crankshaft, the oil hole chamfer should be more rounded.

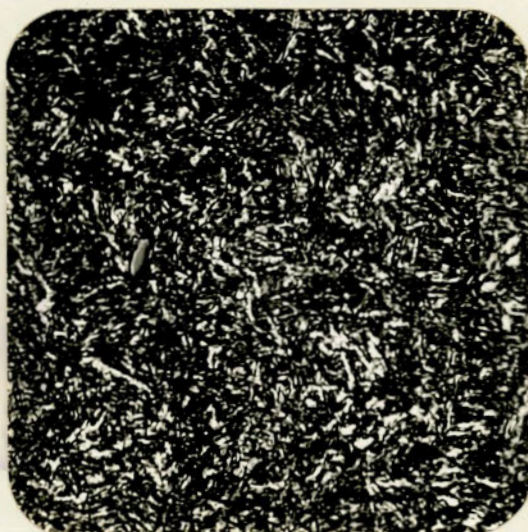
Figure 6.

Microscopic examination of the crankshaft steel revealed that it contained a more than usual amount of elongated inclusions near the point where failure is believed to have started. Figure 5 is a photomicrograph of this area at 100 diameters. Figure 6 depicts, at a magnification of 1000, the microstructure of the piece after it had been etched in 2 per cent nital.

X1000, etched in 2 per
cent nital.
