O T T A W A February 8th, 1943.

R E P O R T
of the
ORE DRESSING AND METALLURGICAL LABORATORIES.

Investigation No. 1353.

Examination of a Broken Crankshaft
from a Packard Marine Engine.

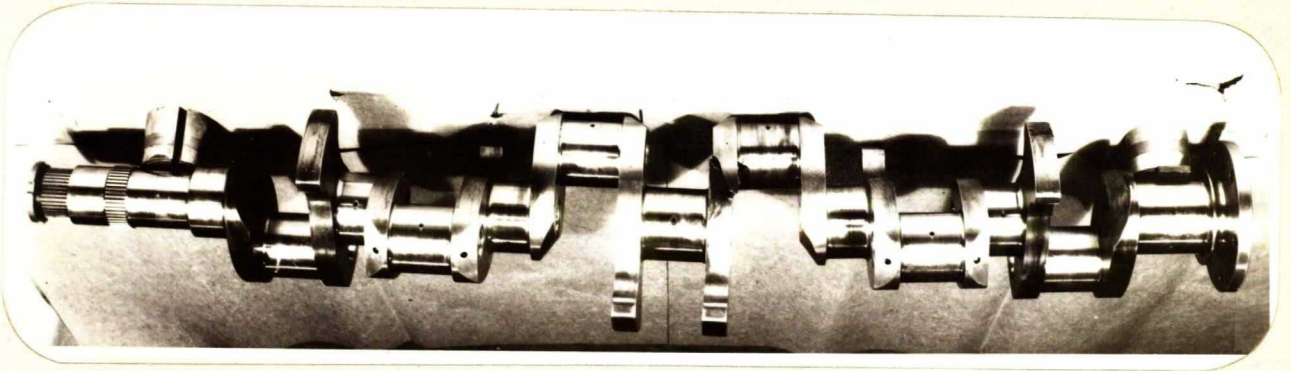
Figure 1.

The sides of the crank pins in that part of the shaft in which end play would occur after fracture were deeply burnt. The bearing on the crank pin through which failure went was deeply scored. Some of the other bearings were scored much less deeply.

CRANKSHAFT AS RECEIVED.
(Approximately $\frac{1}{9}$ size).

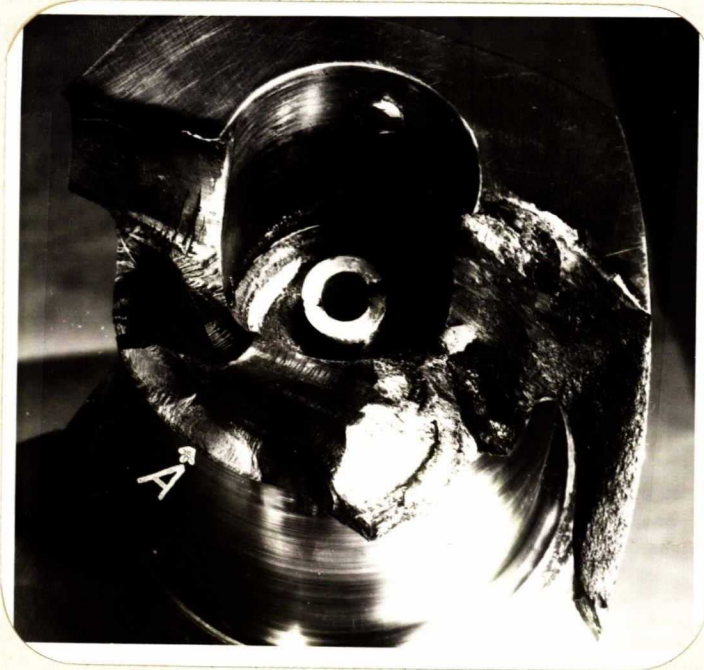
Figure 2.

A general view of the crankshaft and a close-up of the fractured surface are given in Figures 1 and 2. The fracture has the appearance of a fatigue failure of the duplex type, with its nucleus at the start of a fillet in the under side of the crank pin (Point A, Figure 2).

The examination shows flow-line discontinuity as the only discovered metallurgical defect. It is felt that the burning and scoring of the shaft occurred after the fatigue failure. If this had not been the case, high temperatures, such as must have been present to harden the metal, would have led to the fatigue failure by severely stressing the metal at the surface.

While it is difficult to be dogmatic, in the absence of complete evidence, it is felt that failure in this case may well have been due to mechanical causes with flow-line discontinuity a contributing cause. It is felt that this examination is only one of many where metallurgical and mechanical investigations should parallel each other.

Scientific shot-blasting of portions or all of this crankshaft may possibly lead to a decrease in the number of failures being encountered, as this shot-blasting would certainly raise the fatigue strength at critical zones.

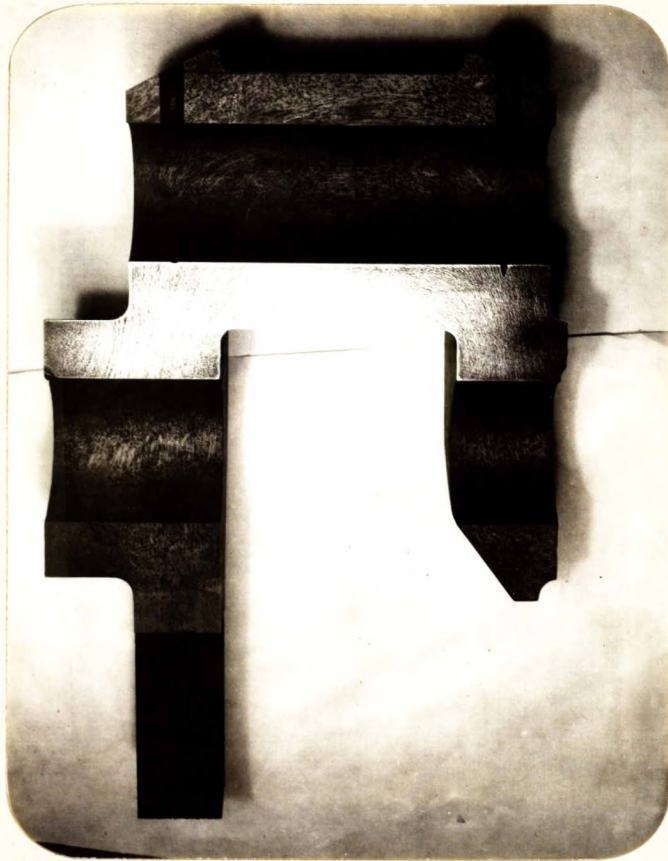
Figure 3.

VIEW OF ETCHED CRANK PIN
SHOWING ATTACHED WEIGHT.

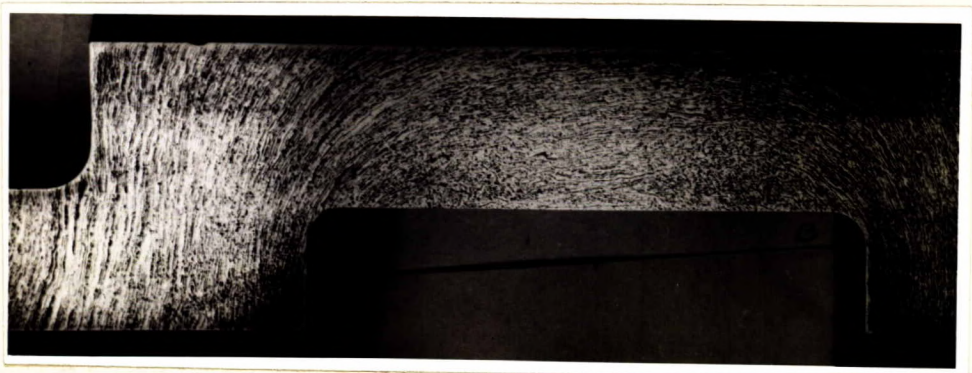
Figure 4.

One of the crank pins was sectioned about one-half inch off centre, polished, and immersed for one hour in a 50 per cent aqueous solution of hydrochloric acid at 170° F. Some of the flow lines of the piece leave the forging near the fillet in the under side of the crank pin (Point B, Figure 4). Figure 5 is a photograph of a macro-etched specimen taken from the broken crank pin at what is believed to be the nucleus of the failure. The flow lines leave the forging at the exterior edge of the fracture (Point C).

The discontinuity of some of the flow lines at the fillet in which fracture is believed to have originated would lower the fatigue limit at this spot. The actual reduction in fatigue limit, however, is thought to vary with different

FLOW LINES NEAR FILLETS
IN UNDER SIDE OF CRANK PIN.

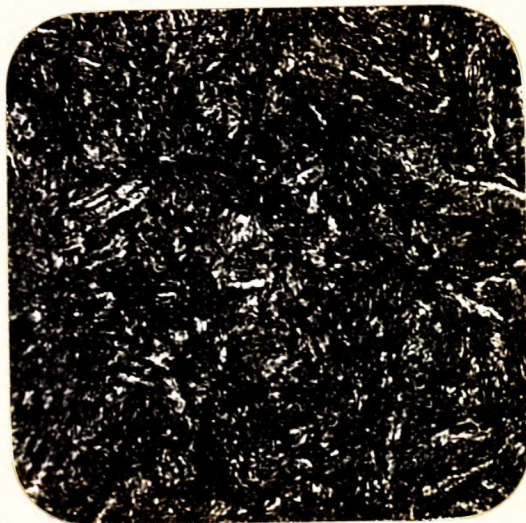
Figure 7.

Figure 6 is a photomicrograph, at 100 diameters, of the inclusions in the steel near one of the crankshaft fillets. This is the worst area discovered and is not considered representative of the material. Figure 7 depicts, at a magnification of 1000, the structure of the steel in the crankshaft after it had been etched in 2 per cent nital.

The material in this crankshaft seems to be a steel of normal quality, accorded an acceptable heat treatment with resultant satisfactory physical properties.

X1000, nital etch.
STRUCTURE OF STEEL
IN CRANKSHAFT.
