O T T A W A February 12th, 1943.

ORE DRESSING AND METALLURGICAL LABORATORIES.

Investigation No. 1355.

Examination of a Defective Muzzle Brake.

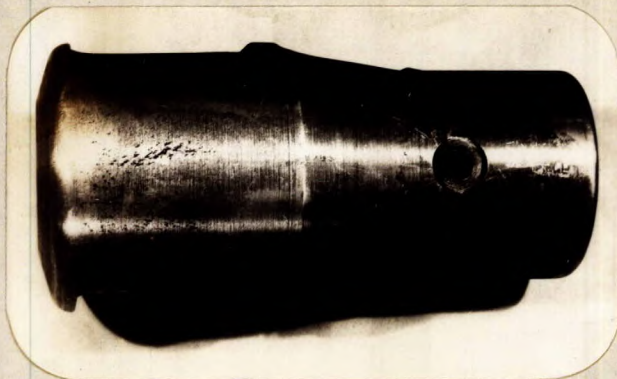
The exterior of the brake was "magnafluxed" in an attempt to reveal surface imperfections. The only discovered discontinuity of this surface is shown in Figure 1. This defect is in line with the parting line of the core.

This shows defect discovered on the exterior surface (outlined with magnalux powder).

Careful inspection should prevent further parts with defects of this type from entering service. This Division is not familiar with the requirements of muzzle brakes but since this one withstood 200 rounds and was still unbroken, it is quite possible that defects of the type discussed herein are not critical.

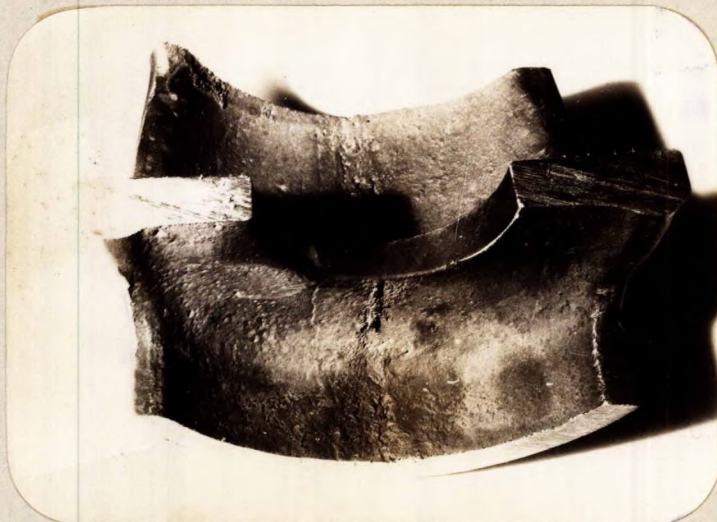
Figure 2.

The interior surface of the muzzle brake had, along the parting line of the core, several cracks in the metal (Figure 2). The interior surface, opposite the discontinuity discovered by magnafluxing, was cracked. A cross-section of this crack was removed and polished. This is pictured (with the exterior surface denoted by point A), at about 7 diameters, in Figure 3.

1. Excessive turbulence of the metal at this point, caused by gases emanating from the core or, more probably, the core paste.
2. A core that had too high a hot strength, causing the metal to tear at this point on contraction.

Partial section of muzzle brake, showing defects along the parting line of the core.

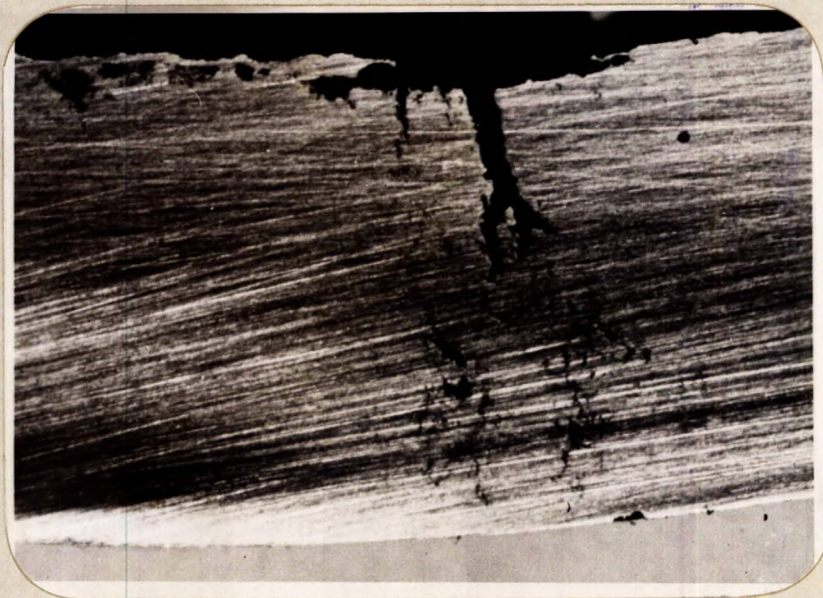
Figure 3.

Cross-section of defect shown in Figure 1.

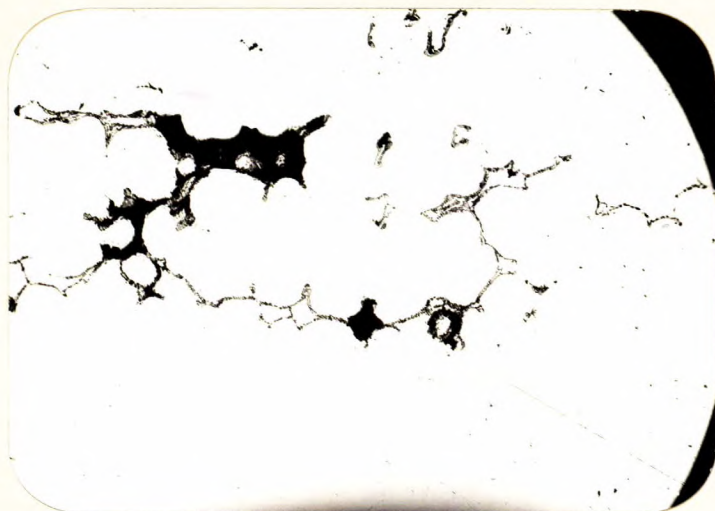
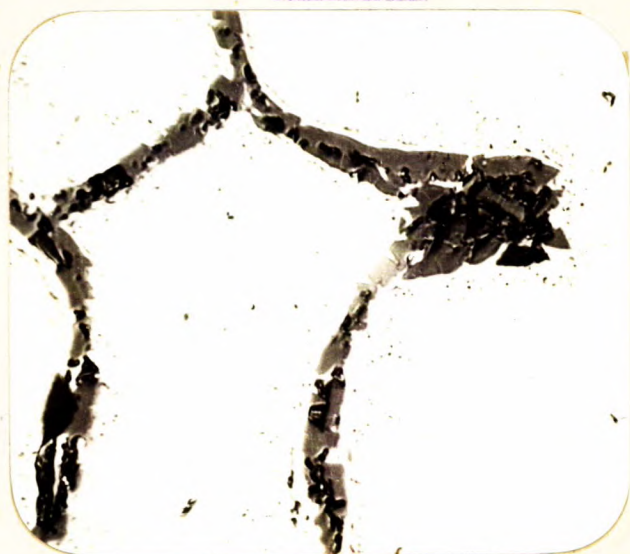
Part of the defect, with the inclusions present (probably oxide), is depicted, at 100 and 1000 diameters respectively, in Figures 4 and 5.

The decarburization and the oxide inclusions in the defective portion of the muzzle brake show that the defects were formed when the muzzle brake was cast and were not incurred in subsequent service. The fact that the interior surface of this brake was not decarburized nearly as much as was the defective area is taken to mean that all of the decarburization present did not occur on heat treatment. These defects, which are of the shrinkage type, were probably caused by one or a combination of the following:

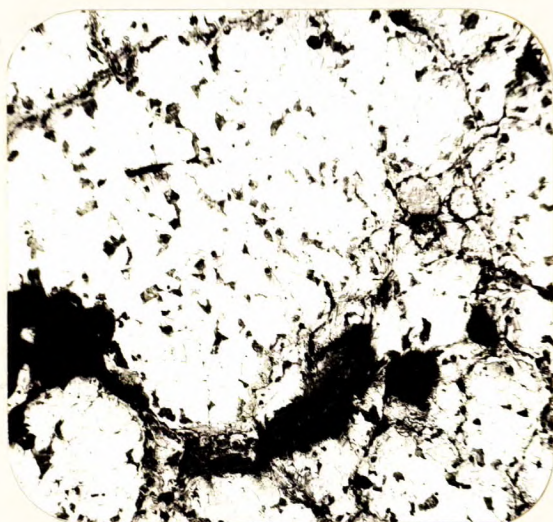
Figure 6.

After etching the part in 2 per cent nital, it was found that the area around the defect was decarburized. Figure 6, taken near the crack, and Figure 7, from the parent metal, show that there is a difference in carbon content.

Photomicrograph showing structure
at defective area.
Carbide is small dark constituent in
white matrix (ferrite).

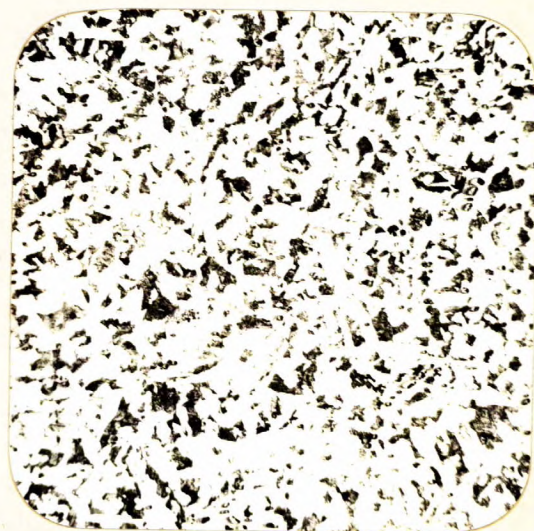
Figure 7.

Normalized structure of
parent metal.
Carbide is dark
constituent.
