ORE DRESSING AND METALLURGICAL LABORATORIES.

Investigation No. 1359.

Examination of a Broken New Canadian
Dry Pin Track Link.

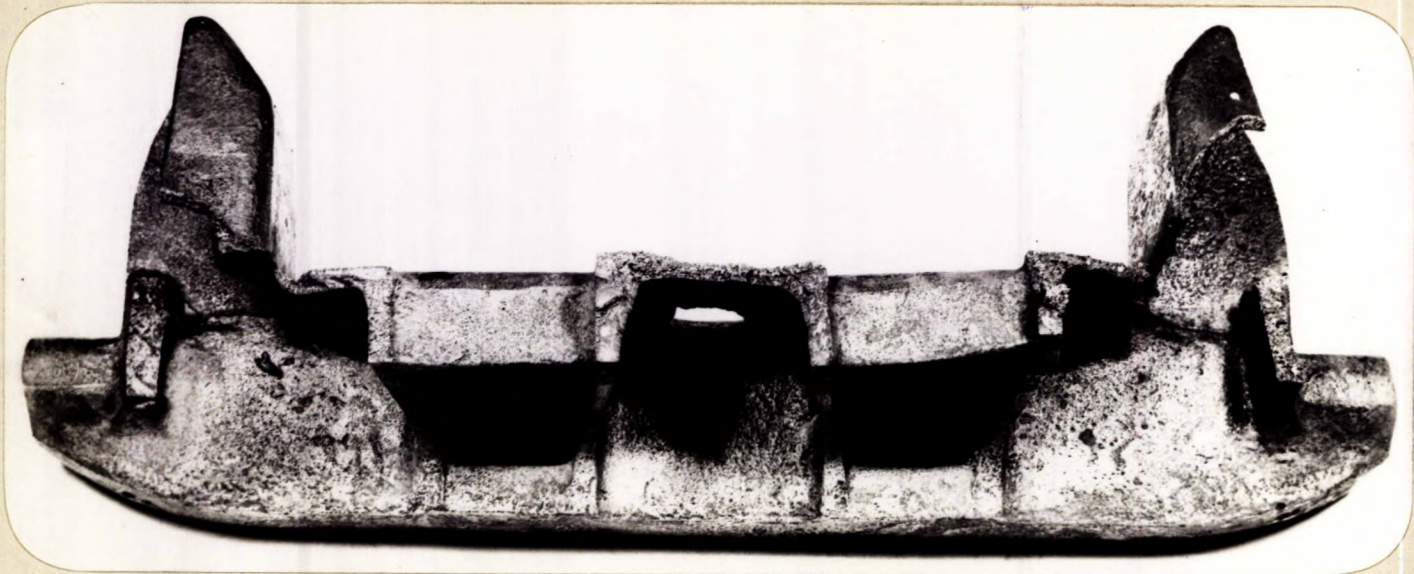
Figure 1.

Figures 1 and 2 illustrate the condition of the failed link. Figure 1 shows that the three-eye side of the link has been ripped off. Figure 2 is taken of the ground contact face of the link. It is interesting to note that one of the ribs has been forced apart during the failure.

FAILED SHOE.
(Approximately $\frac{1}{2}$ size).

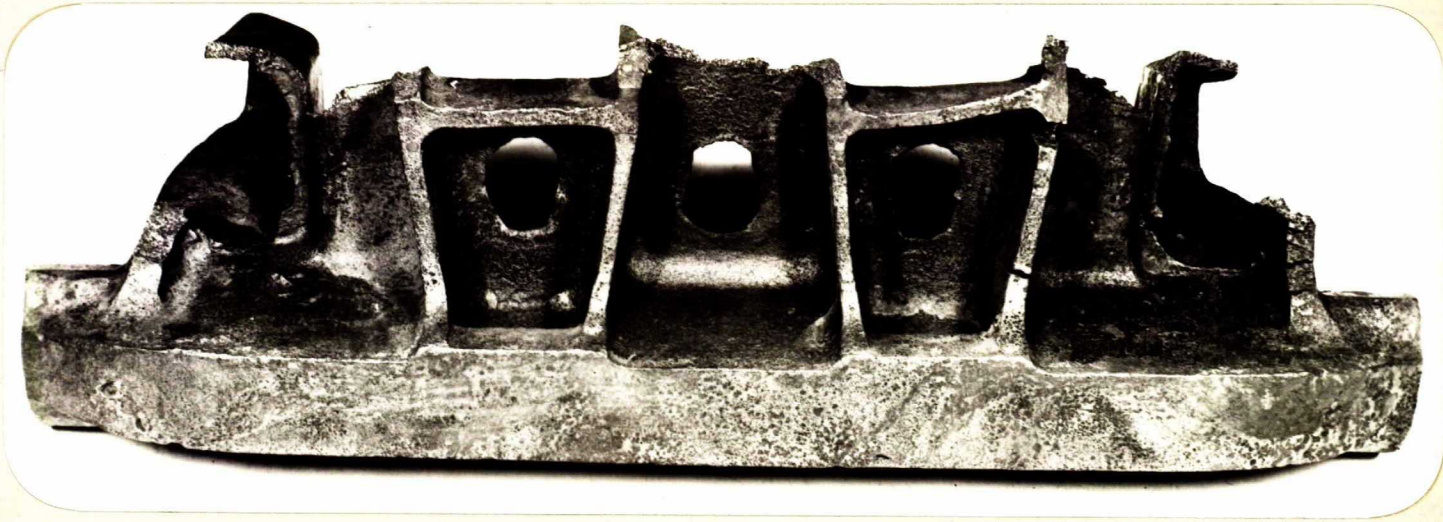
Figure 2.

GROUND CONTACT FACE OF FAILED SHOE.

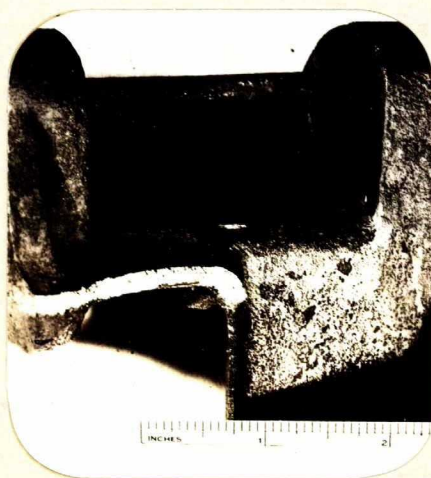
Figure 3.

Figure 3 illustrates the thinness of section at the base of one of the grinding lugs, where it is quite likely that the failure may have first started. The diameter of this section should be $3/8$ inch. It is only $1/16$ inch.

DIAMETER OF SECTION $\frac{1}{16}$ INCH INSTEAD OF $\frac{3}{8}$ INCH.

The thin section at the base of the lug was most likely caused by a shifting of the core.

4. The thin section at the base of the lug has been caused by a shift in the core. This would happen only on rare occasions when proper pattern equipment is used.

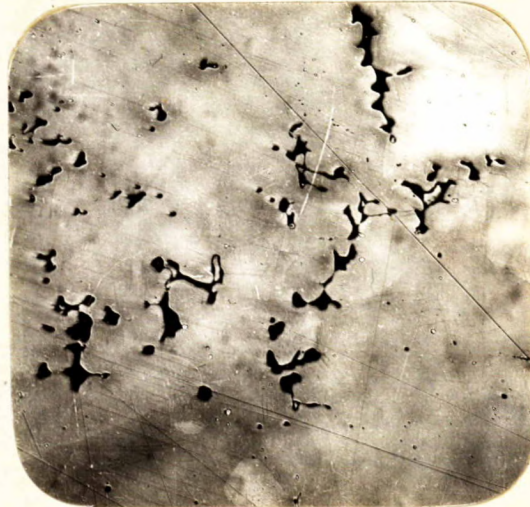
Figure 4.

Specimens of the link were cut and polished. The unetched specimens showed that the steel was reasonably clean. Figure 4, taken at X100 magnification of a nital-etched specimen, illustrates the structure of the link. Microshrinkage cavities and a coarse grain size are evident.

STRUCTURE OF LINK

Note large grain size and
microshrinkage cavities.

The large grain size indicated in the photomicrograph results in a lowering of the tensile strength by about 20 per cent (15,000 to 20,000 p.s.i.). This coarse grain size is produced by a high pouring temperature. The microshrinkages would also lower the strength of the casting somewhat.

2. A large grain size is evident. This is caused by high pouring temperature. Tensile strength would be about 20 per cent lower.

In order to eliminate cavities, the casting technique would have to be altered.

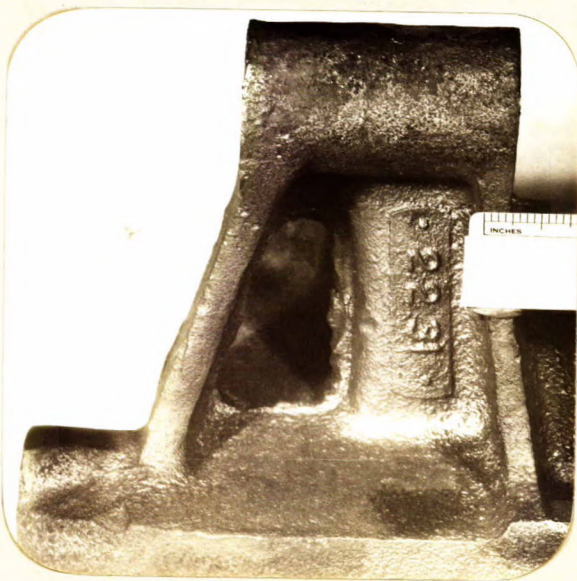
Figure 5.

LINK WHICH IS ON FIELD
TEST AT PRESENT.

allow for a reasonable margin of safety. In this connection, the foundry has already submitted a casting with ribs of wider diameter. Figure 5 illustrates the diameter of the rib as at present on field test. It is about $7/32$ inch. Figure 6 shows the new rib. This is $12/32$ inch in diameter. It is felt by the firm that this will greatly improve the strength of the link at one of its weakest sections.

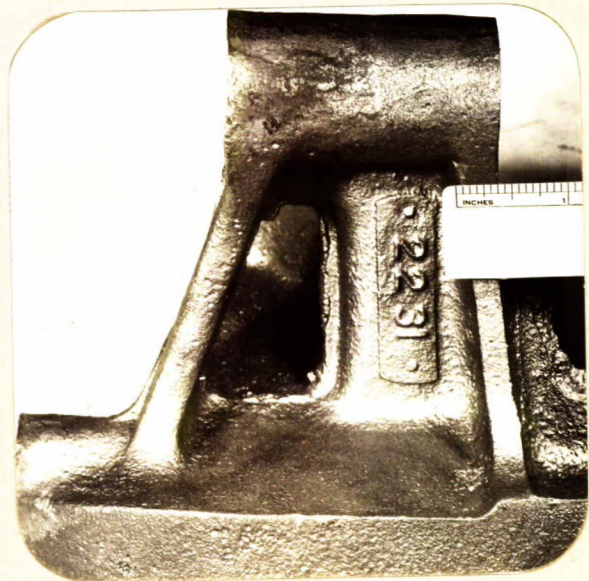
Figure 6.

PROPOSED LINK.
