Investigation No. 1372.

Examination of Broken Steel Tie Rods.

On March 5th, 1943, Mr. G. A. Lindsay, Engineer-in-charge, General Engineering Branch, Department of Transport, Ottawa, Ontario, submitted two samples of broken tie rods for examination. It was stated that two self-supporting antennae towers had collapsed as a result of the failure of these tie rods. It was desired to check the composition, physical properties, and structure of the steel used.

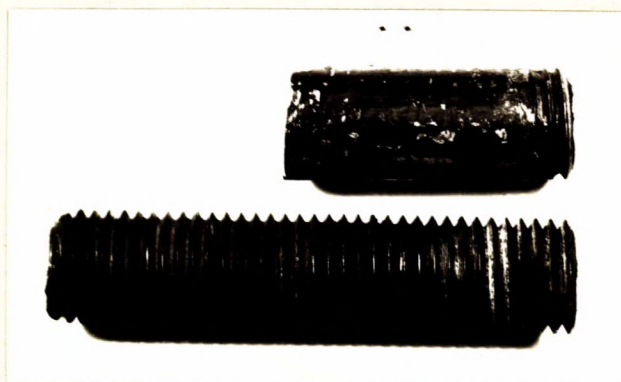
Figures 1 and 2 are two photographs showing fractures in the threaded and unthreaded sections of the bars respectively. It will be observed, in Figure 2, that a piece of the metal split off the bar on the inside of the bend. Figure 3 shows the coarsely crystalline nature of the fracture of the broken tie rod shown in Figure 1. The fracture of the bars was of the non-duplex type.

The material used in making these tie rods was found to have the composition of SAE 1080 steel. The non-duplex nature of the fractures indicates that they had been produced by impact stresses, the fracture being practically identical to that of the izod test bar. The steel had the required ultimate strength, namely 120,000 p.s.i. However, it did not have the specified yield strength of 85,000 p.s.i. The low elastic properties of the steel examined does not leave much margin of safety since the stress in the bolts under design load was stated to be about 58,000 p.s.i.

It is concluded, from the results of these physical tests on the "as received" and heat-treated" bars, that this high-carbon steel should not have been used in the construction of these towers, as the impact properties are too low.

It is recommended that a steel of SAE 1045 composition be used. This steel, when normalized at 1650° F. hardened at 1,475 to 1,525° F. in water and drawn at 900° F. should have approximately the following physical properties:

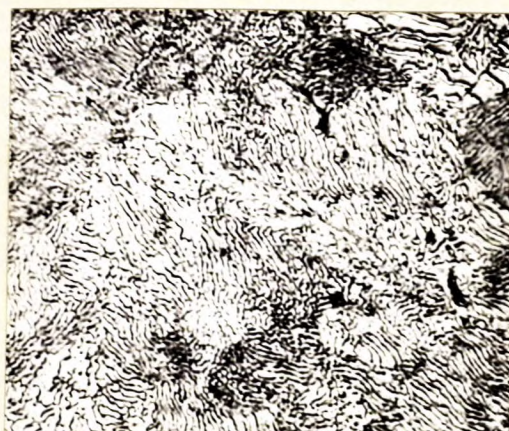
Figure 4.

A section of one of the steel bars was given a metallographic examination and examined under the microscope in the unetched condition. The steel was found to be fairly clean. After etching in a solution of 2 per cent nitric acid in alcohol, the steel was re-examined. Figure 4 is a photomicrograph, at X1000 magnification, showing the structure to be similar to that of an annealed SAE 1080 steel. The structure consists of fairly coarse pearlite (the dark etching constituent), and ferrite (the white constituent).

The coarse pearlitic structure of the steel indicates that it was given an anneal heat treatment, i.e., it was cooled slowly through the critical range.
