ORE DRESSING AND
METALLURGICAL LABORATORIES

Investigation No. 1375.

Examination of a Failed Bend Test
Specimen of Mild Steel.

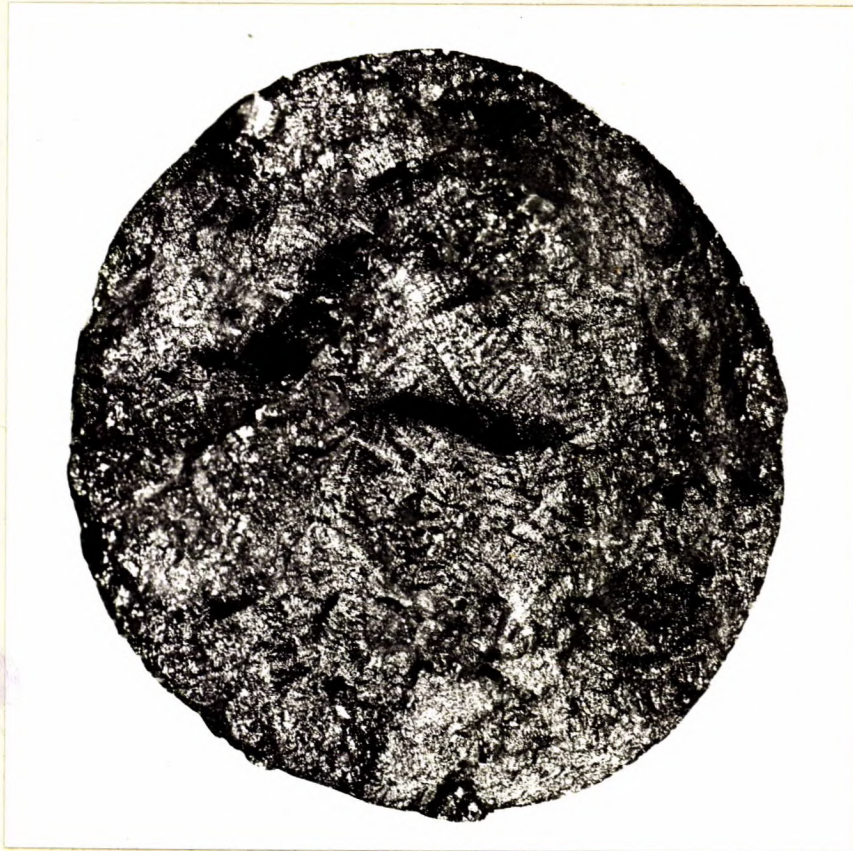
The steel was observed to have a coarse dendritic fracture and also to contain several small particles of sand embedded in the steel. The coarse nature of the fracture is illustrated in Figure 1. Figure 2 shows the large shrinkage cavities encountered in the test specimen, approximately half an inch below the fracture.

PHOTO SHOWING DENDRITES IN STEEL.
(Approximately 4 times actual size).

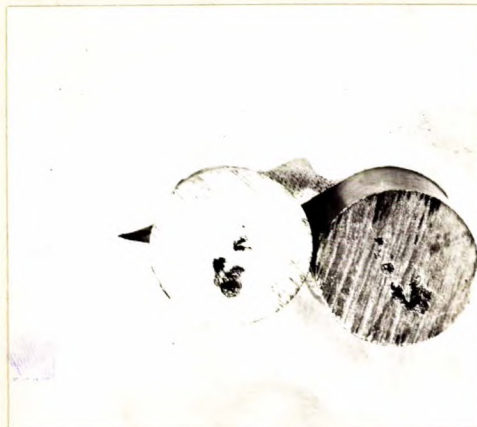
Figure 2.

PHOTO SHOWING SHRINKAGE CAVITIES.
(Approximately 7/8 actual size).

The presence of shrinkage cavities in the steel is due to poor feeding of the casting during the solidification period. The presence, in the steel, of small particles of sand may have contributed to the development of shrinkage cavities in this test specimen by chilling the metal and

It is concluded, from the examination of this bend test specimen, that failure was due to the presence of shrinkage cavities in the steel.

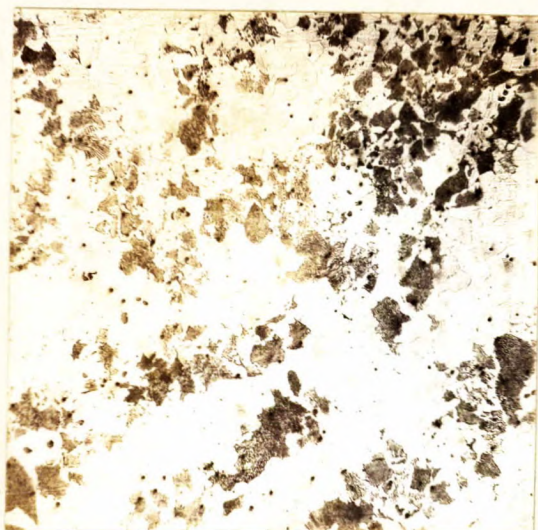
Figure 3.

A section of the steel bar was given a metallographic polish and examined under the microscope in the unetched condition. The steel was found to be fairly clean. However, several areas of shrinkage cavities were noted. The steel was etched in a solution of 5 per cent picric acid in alcohol and re-examined. Figures 3 and 4 are photomicrographs, at X100 and X1000 magnifications respectively, showing the structure of the steel in the 'as received' condition. Figure 5 is a photomicrograph, at X100, showing the structure of the steel after receiving a normalizing heat treatment. In Figures 3, 4 and 5, the structure consists of pearlite (the dark etching material) and ferrite (the light constituent).

X100, etched in
5 per cent picral.

STRUCTURE OF STEEL IN THE ANNEALED CONDITION.

The results of chemical analysis did not check with those supplied for this heat of steel. The composition, however, would appear to be normal for steel made by the acid electric steel process. The absence of any large number of non-metallic inclusions in the steel would indicate that the steel had been properly made. The presence of dendrites in the steel shows that the cast structure was not broken up during the heat treatment. An improved distribution of the carbides in the steel can be obtained by a normalizing-and-draw heat treatment. (Compare Figures 3 and 5).

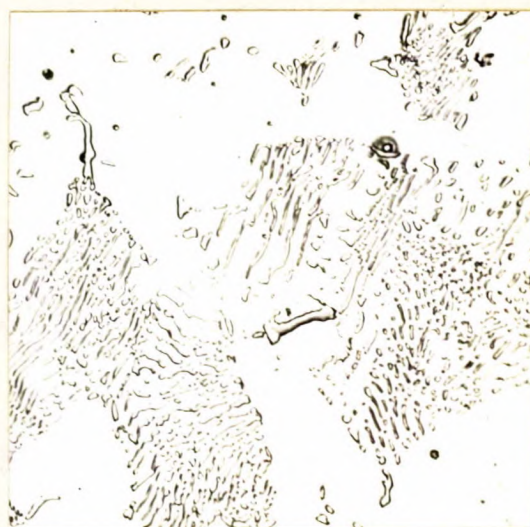
Figure 4.

X1000, etched in
5 per cent picral.

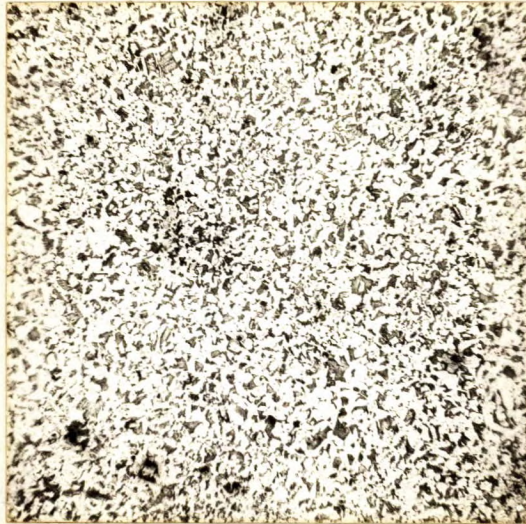
Figure 5.

X100, etched in
5 per cent picral.

NORMALIZED AND DRAWN.
