ORE DRESSING AND METALLURGICAL LABORATORIES.

Investigation No. 1377.

Examination of Broken Front Axle Egg Cup for a Rzeppa Universal Joint,

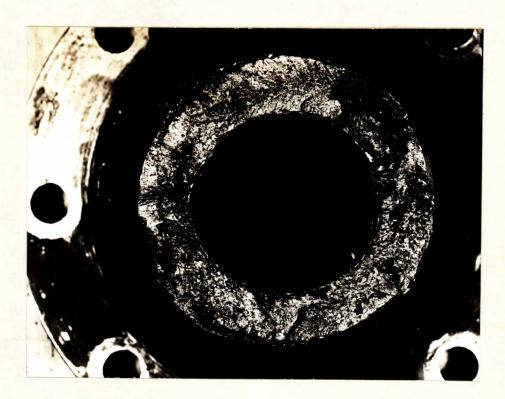
# Figure 1.

The fracture of the casting, shown in Figure 1, is of the non-duplex type.

The steel was found to have a composition similar to that of an SAE 1040 steel. The non-duplex nature of the fracture would indicate that failure was caused by impact stresses which the steel could not resist because of its relatively low impact strength.

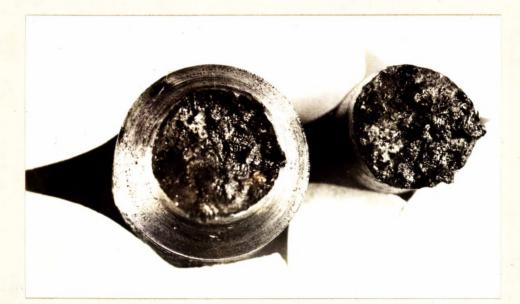
Tensile and izod test bars were machined from the casting. The steel had an izod impact value of 16 foot-pounds. The tensile bar broke adjacent to a shrinkage cavity outside the gauge length. The coarse dendritic structure of the fracture of the tensile test bar is shown in Figure 2.

The steel was found to contain shrinkage cavities adjacent to the fracture. The structure of the steel with its relatively small amount of ferrite and its tendency to spheroidization in the pearlite indicated that the casting had probably received a normalizing-and-draw heat treatment. A quench from below the upper critical followed by a hightemperature draw would produce the same structure. It is thought unlikely, however, that the casting had been quenched. Inasmuch as the composition and structure of the steel was fairly satisfactory it is concluded from the examination of this casting that failure was due to the presence of shrinkage cavities in the metal.

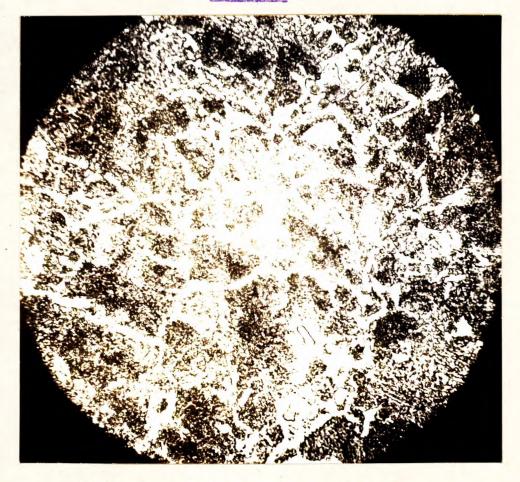
Figure 4.

A polished specimen of the steel was stehed in 2 per cent nital solution. Figures 1 and 2, photomicrographs at 100 and 1000 magnifications respectively, show the structure as revealed by the etch. In Figure 3 the white areas are ferrite (the iron content) and the dark areas are pearlite (the iron-iron carbide constituent). The grain size, while fine, is somewhat mixed. Figure 4 shows that the pearlite is beginning to spheroidize.

X1000, etched in 2 per cent nital.
