ORE DRESSING AND METALLURGICAL LABORATORIES.

Examination of a Cylinder Barrel
from a Cheetah Aircraft Engine.

CANADA
DEPARTMENT
OF
MINES AND RESOURCES
MINES AND GEOLOGY BRANCH

Investigation No. 1580.

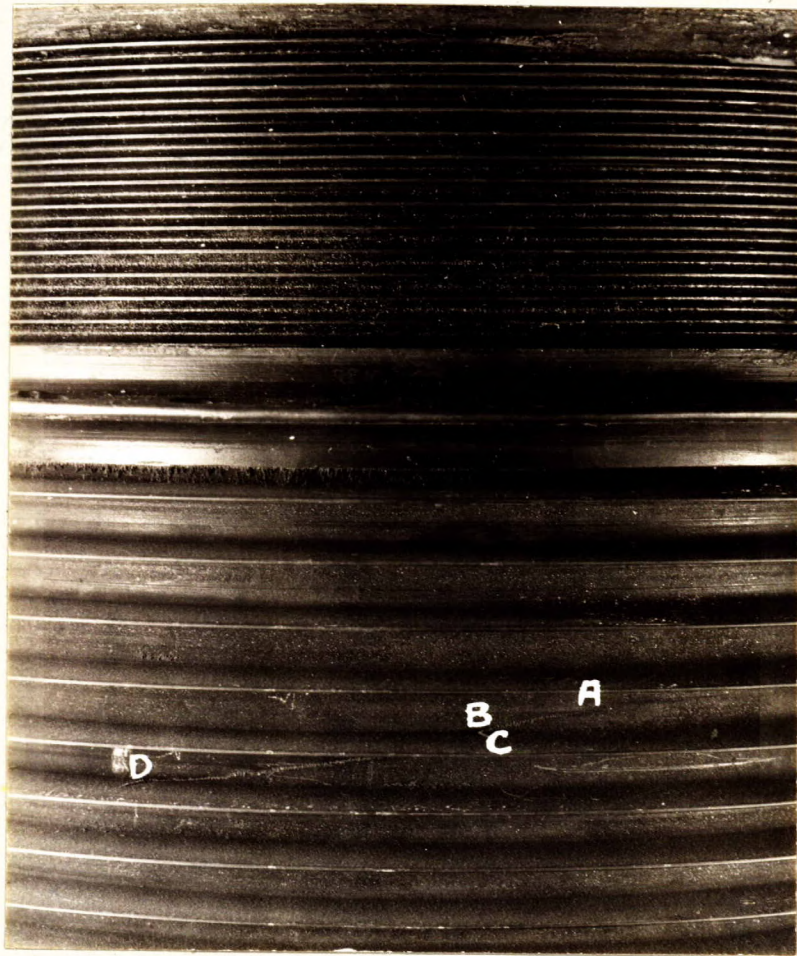
Figure 1.

Magneflux examination of the barrel revealed that the crack, about $3\frac{1}{2}$ inches long, traversed the fifth and sixth fin from the finned end of this part. This crack, which went through the barrel wall, did not, however, progress as far as the outer edge of either of these fins. This crack (indicated by letters) is shown in Figures 1 and 2.

CRACK OUTLINED BY MAGNAFLUX POWDER.
(Approximately to size).

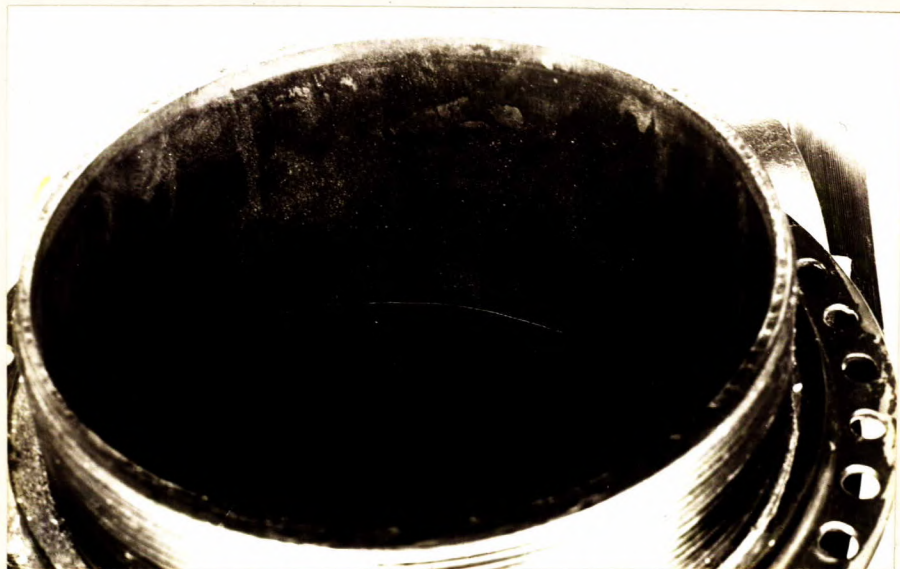
Figure 2.

CRACK OUTLINED BY MAGNAFLUX POWDER.
(Approximately 2/3 size).

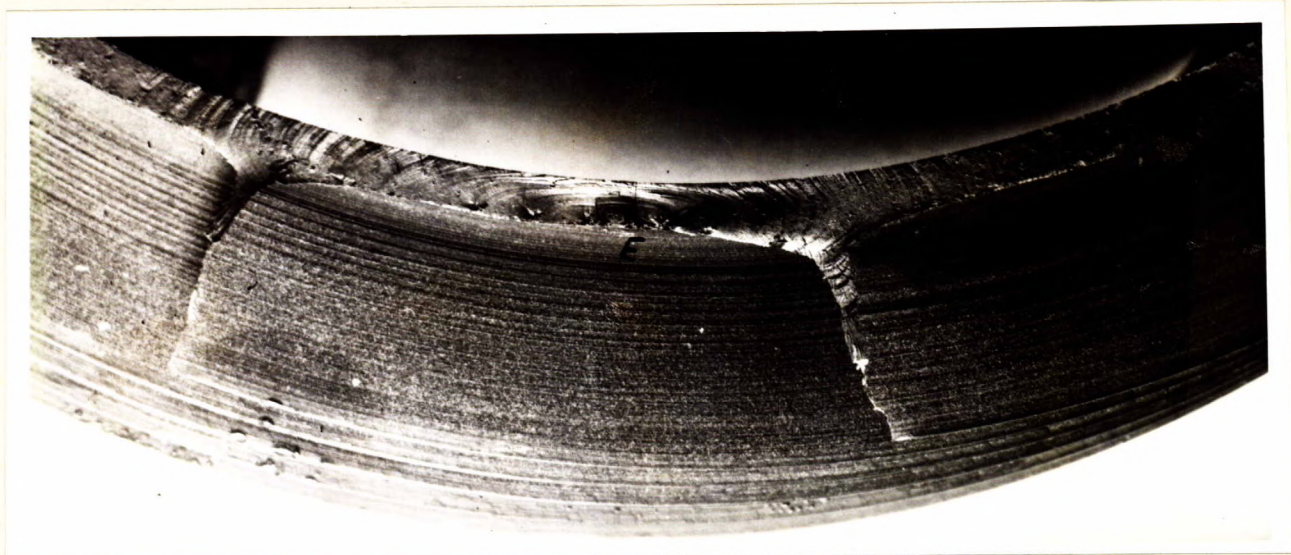
Figure 3.

A section containing the crack was then removed and broken. The crack was seen to be of the fatigue type with its nucleus (point E, Figure 3) between the fifth and sixth fins. That the outer edge of the nucleus was rough may be seen from Figures 3 and 4.

Note nucleus at E.
(Approximately twice actual size).

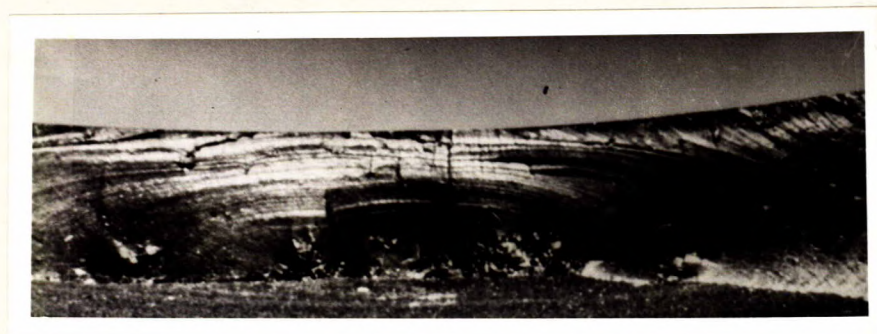
Figure 4.

Note roughness at nucleus of failure.
(Approximately 8 times actual size).

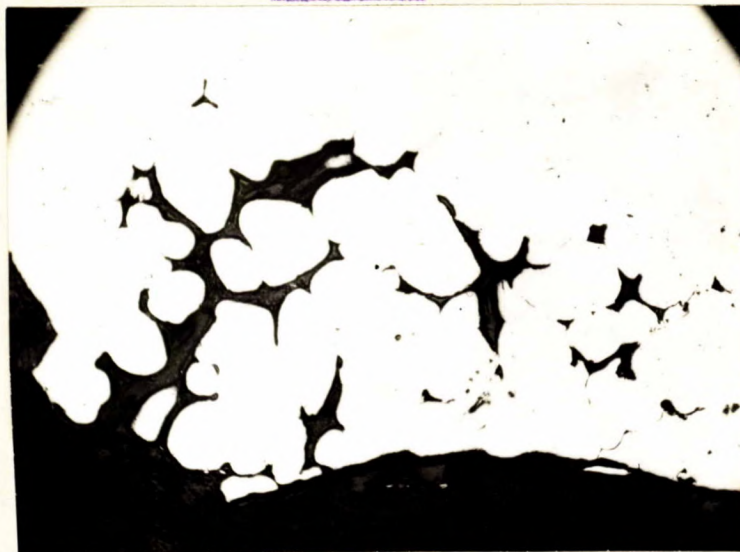
It was found that the rough nucleus of the failure was actually a shrinkage-type defect. This is pictured, at

100 diameters, in Figure 5. Figure 6 is a photomicrograph of another shrinkage defect found in this same region.

Macro and micro examinations definitely show that the crack, of a fatigue type, originated at a shrinkage-type defect (caused by faulty casting technique) on the machined surface between two fins.

X100, unetched.

Horizontal surface is fillet between fifth and sixth fins. Sloping surface (lower left of picture) is the fractured surface. Note shrinkage-type defects at start of fracture.

It is understood that this part has been machined from a centrifugally cast sleeve that is radiographed before the machining operation. Such inspection practice is, of course, desirable because it eliminates the machining of bad castings. It might well not, however, show up defects which in relation to the thickness of the casting are quite minor. However, these defects, if present in the finished machined sleeve, would then, in relation to the total thickness of the finished article, be quite large. An X-ray of the machined sleeve, therefore, would be expected to reveal defects of the type responsible for this failure. It is quite possible that a magnafluxing of the finished article would also have uncovered the defect. It is not unlikely, however, that such a small defect would pass magnaflux examination, especially if an inexperienced operator were examining a number of sleeves. As the X-ray method gives a permanent record, when it is used there is much less chance that defects will escape detection.

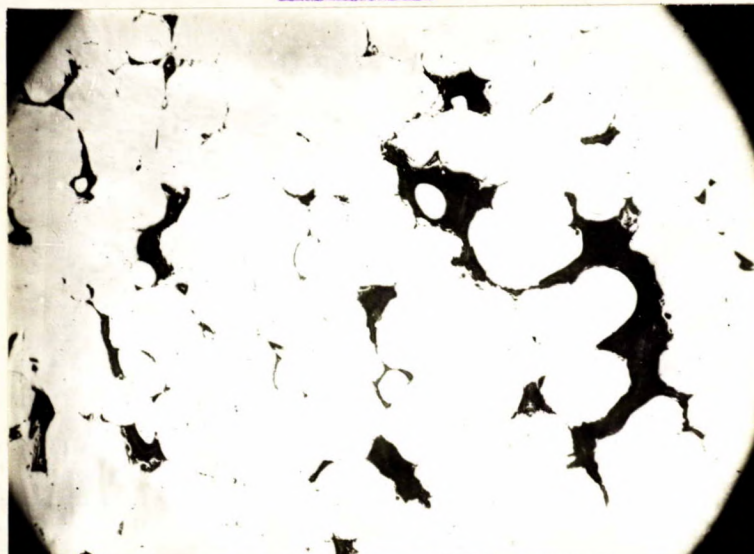
Figure 6.

X100, unetched.

Shrinkage-type defects present in the region of the fracture.

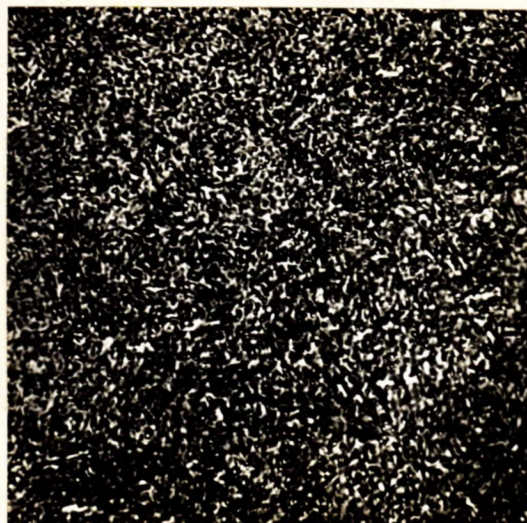
After an etch of 2 per cent nitric acid in alcohol was applied to this specimen, it was seen that the part was composed of fine pearlite (commonly termed sorbite). This structure is shown, at a magnification of X1000, in Figure 7.

The heat treatment accorded this cylinder barrel seems to be satisfactory. In view of its hardness and structure it was probably quenched from around 1500° F. and drawn at about 1100° F.

X1000, nital etch.
MICROSTRUCTURE OF THE STEEL.
