April 9th, 1943.

ORE DRESSING AND METALLURGICAL LABORATORIES.

Investigation No. 1386.

Investigation of Four SAE 9255 Homogeneous  
Universal Carrier Track Pins.

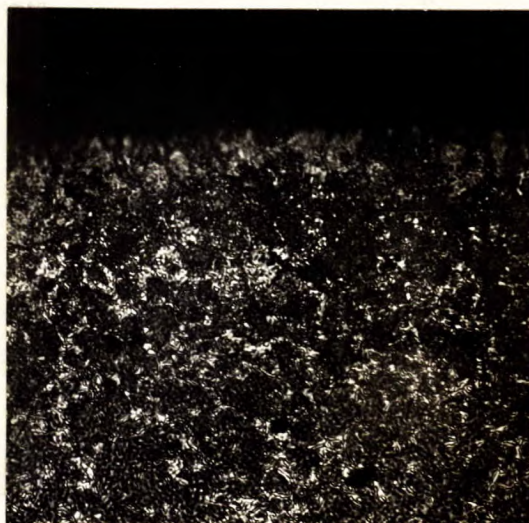
Figure 1.

Microspecimens were cut from one of the failed and one of the passed pins and were then examined under the microscope. Figure 1 (at X500 magnification) was taken at the surface. This shows that recarburization of the decarburized zone was completely effected to a depth of about 0.0015 inch. Figure 2 (X1000 magnification) illustrates ferrite around the grain boundaries. This is a photomicrograph of the zone immediately below the totally recarburized surface layer. This zone extents to a depth of approximately 0.010 inch from the surface. Figure 3 (X1000) illustrates the structure of the case. These pictures were all taken from one specimen.

X500, nital etch.  
SURFACE STRUCTURE.

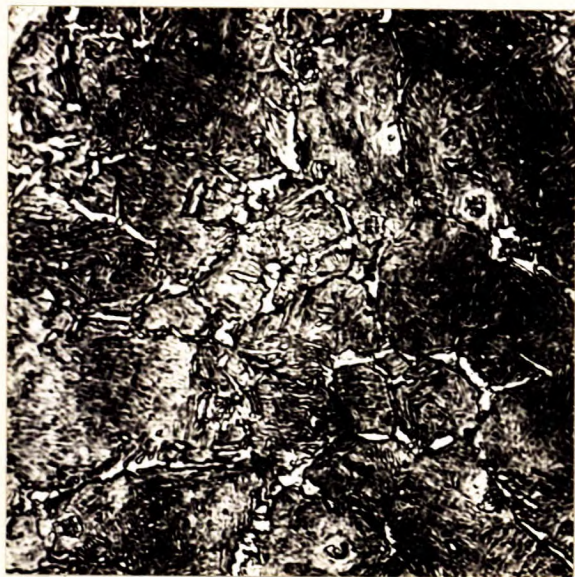
Figure 2.

X1000.  
ZONE BELOW SURFACE  
NOT FULLY RECARBURIZED.

Two of the four pins failed the impact tests. High hardness results were obtained, which explain the tendency towards brittleness. The surface hardnesses were lower than the core hardnesses in all the pins. The microscopic examination indicates the probable reason for this feature. A lower carbon material appears to be present immediately under the surface skin. This is indicated by the presence of ferrite around the grain boundaries. Although this zone might not have any deleterious effect upon the service properties of the pin, it might be advisable to increase the carburizing time slightly, which would eliminate the remaining ferrite. The producers should draw the pins at a higher temperature, in order to meet the specified hardness range of  $43 \pm 3$  Rockwell "C".

1. The pins should be drawn at a higher temperature.
2. A slightly longer carburizing time could be used, to eliminate the remaining ferrite near the surface.

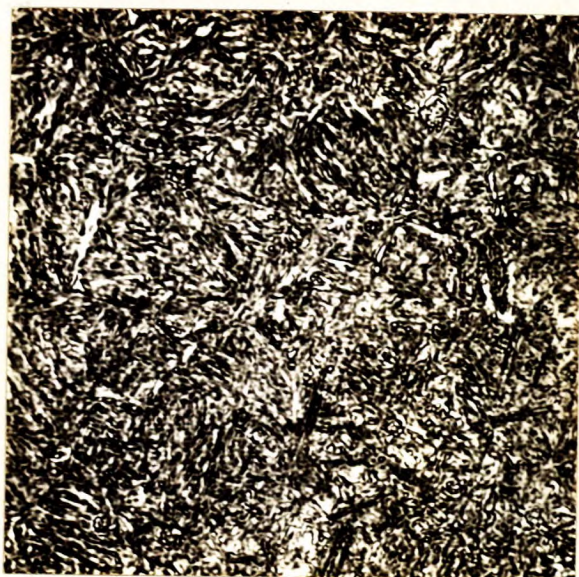
Figure 3.

X1000.  
CORE STRUCTURE.
