April 26th, 1943.

ORE DRESSING AND METALLURGICAL LABORATORIES.

Investigation No. 1393.

Examination of Failed Differential Gears  
from a Snowmobile.

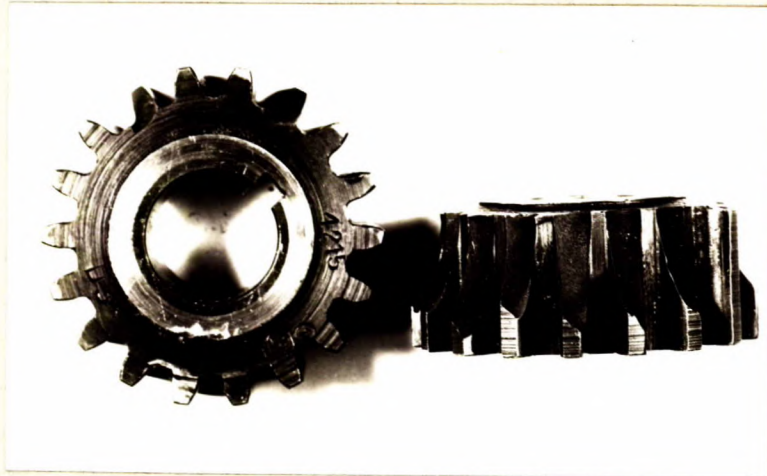
Figure 1.

Figure 1 shows the gears as received. They are about  $2\frac{1}{4}$  inches in diameter and about  $\frac{7}{8}$  inch thick.

A considerable number of teeth are broken away.

SPUR GEARS AS RECEIVED.

#1 is vertical;  
#2 is horizontal.

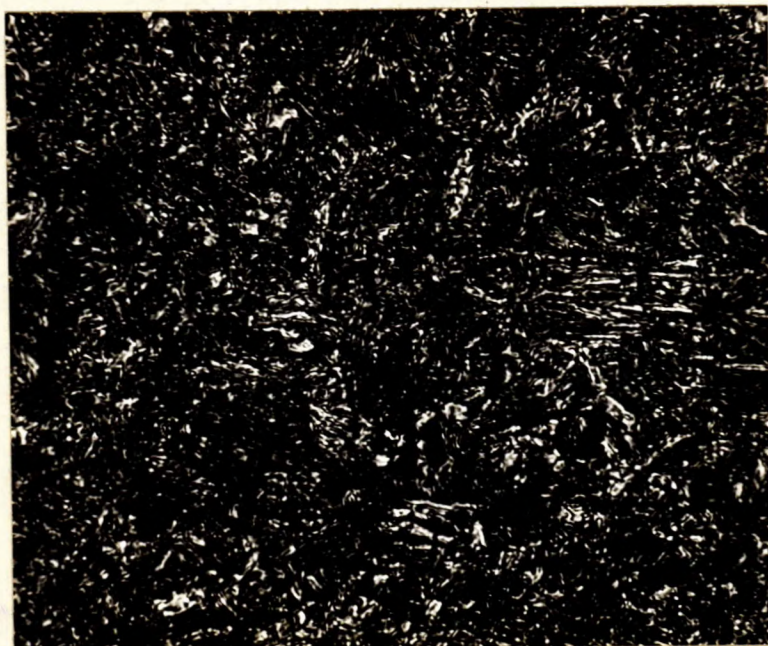
Figure 2.

Figure 2 shows the structure typical of both gears. This structure is usually produced by quenching and drawing and is called "sorbitic". There are traces of free ferrite (white patches), indicating that quenching was not quite rapid enough. Free ferrite lowers fatigue and impact strength.

X1000, nital etch.  
SORBITIC STRUCTURE OF SPUR GEARS.

These gears are typical of normal industrial practice. They are homogeneously hardened.

No metallurgical reason for failure was found. A slight increase in life would be expected if more drastic quenching could be applied without warping the gears.

The life of a gear may be reduced by the presence of free ferrite, decarburization, inclusions, or carbides. These lower the fatigue strength of the metal. The gears examined had traces of free ferrite, which could have been avoided by a more drastic quench.
