Investigation No. 1406.

Examination of Armour Plate Which
Cracked in Straightening.

Bureau of Mines
Division of Metallic
Minerals
Ore Dressing
and Metallurgical
Laboratories

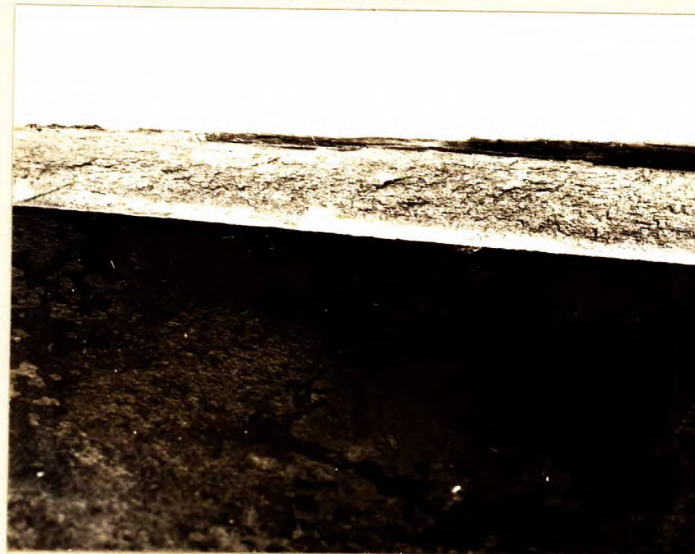
Figure 1.

The plate broke with a duplex fracture. This fracture, all across one side of the plate (top, Figure 1), had a slaty, laminated appearance and was partially oxidized while most of the rest of the fracture apparently occurred at a single moment of time. The slaty defect seemingly did not extend more than 1.5 mm. to 2 mm. into the plate.

From all of the foregoing it appears that, in all probability, the failure of this plate during straightening was caused by the notch effect of the slaty, laminated discontinuity.

View of fracture, showing slaty defect at top of picture.

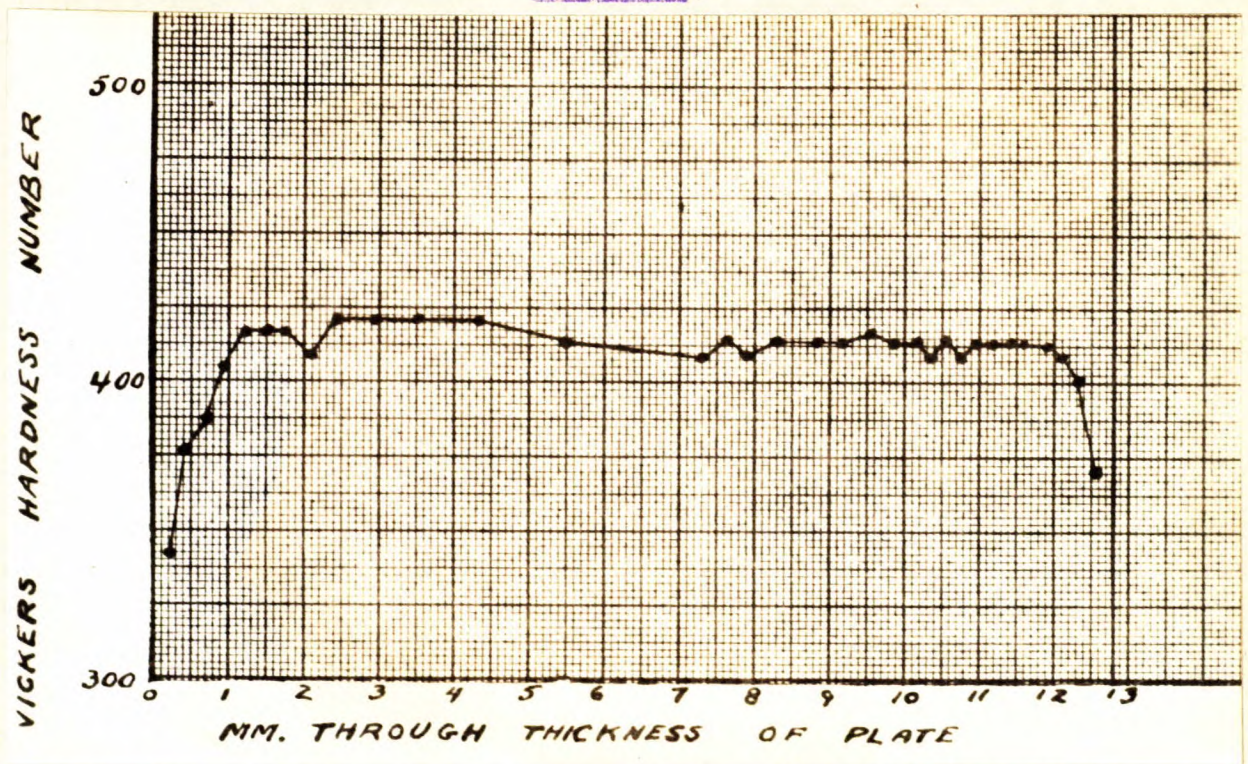
Figure 2.

Hardness readings were taken (using the Vickers method with a 10-kilogram load) through the thickness of the plate. Figure 2 depicts graphically the values obtained. These tests indicate that there is approximately 0.9 mm. decarburization on the slaty side of the plate and about 1.3 mm. decarburization on the other (decarburized material being considered as any which has lost a portion of its original carbon).

Side of plate that had slaty defect on it is at right of diagram.

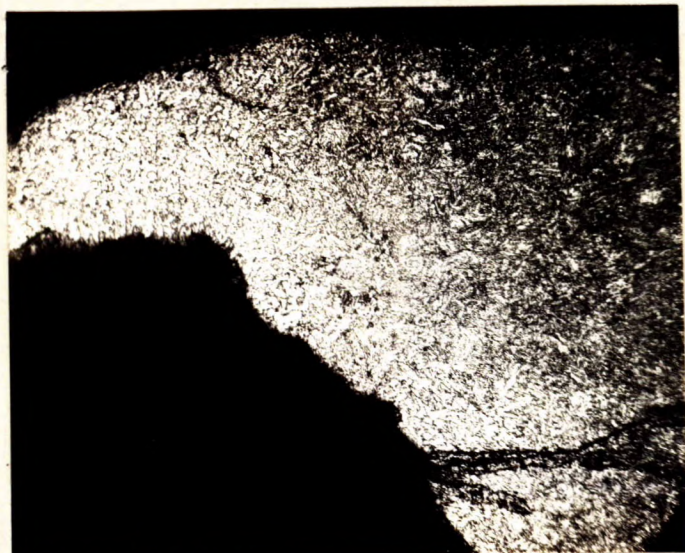
Hardness tests on the slaty part of the fracture shown at 100 diameters in Figure 3 gave readings of 178 and 222 Vickers.

After an etch of 2 per cent nitric acid in alcohol was applied, the slaty part of the fracture was found to be much more severely decarburized than the outside edge of the plate. This is shown in Figure 3.

Surface at top of picture is outside edge of plate. Irregular sloping surface is part of slaty section of fracture.

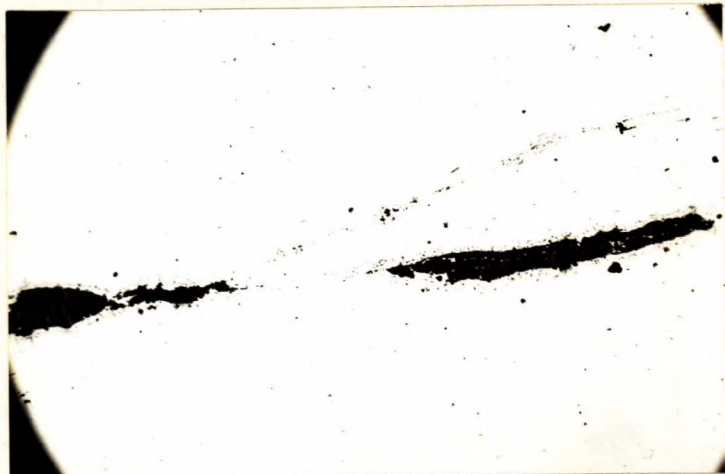
The slaty part of the fracture had very large inclusions, with numerous small inclusions acting as connectors between the larger ones. These points are illustrated in Figure 4. Examination of these large inclusions at high magnifications (Figure 5) shows that they are of the duplex type and that they contain little globules of metal. These large inclusions, however, were found only at and in the vicinity of the slaty part of the fracture.
