Investigation No. 1420.

Examination of a Failed Aluminium Alloy Rivet Joint.

Bureau of Mines
Division of Metallic
Minerals
Ore Dressing
and Metallurgical
Laboratories

CANADA
DEPARTMENT
OF
MINES AND RESOURCES
Mines and Geology Branch

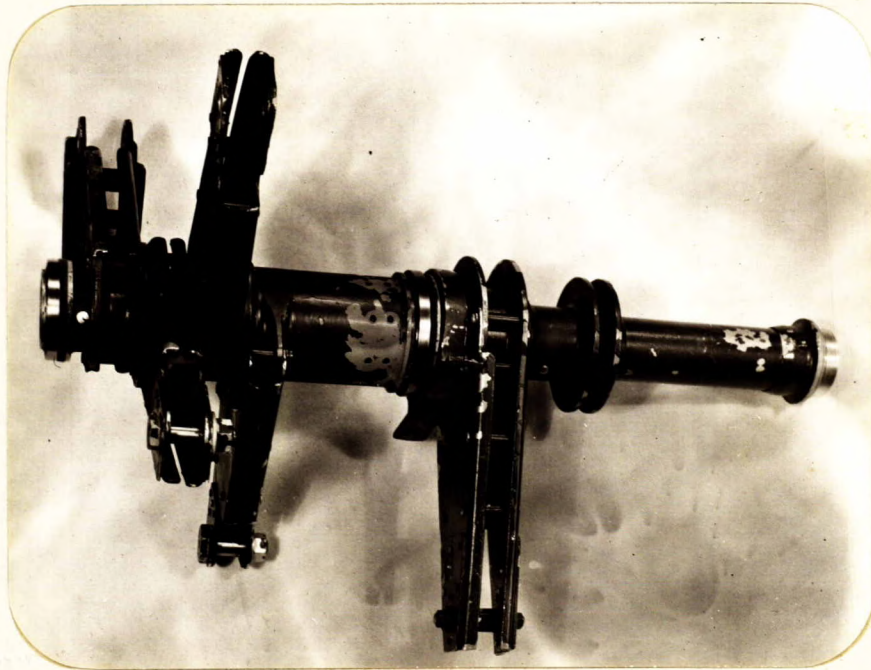
Figure 1.

Figure 1 shows the elevator control assembly "as received".

SAMPLE AS RECEIVED.
(Approximately $\frac{1}{4}$ size.)

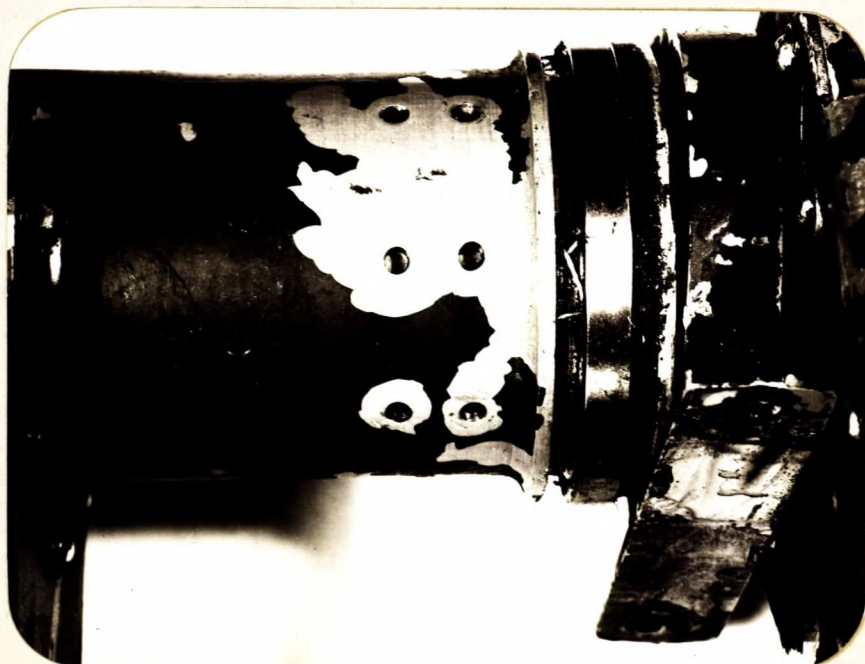
Figure 2.

Figure 2 shows the failed joint at approximately actual size. The rivet holes in the tubing are visibly deformed.

FAILED JOINT.
(Approximately actual size.)

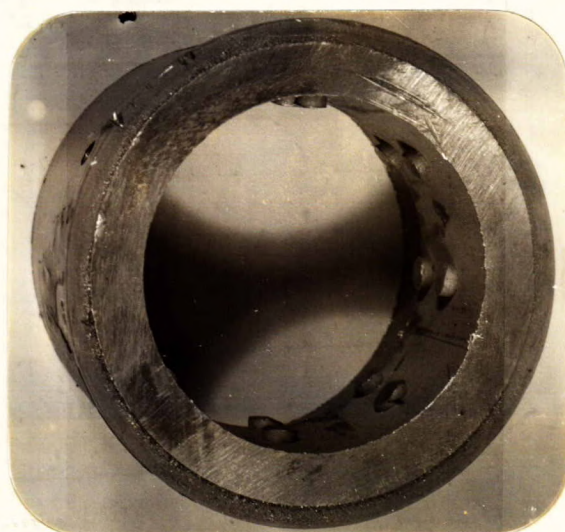
Figure 3.

A broken piece of one of the failed rivets was submitted, and the inner ends of the broken rivets remained in the joint (see Figure 3).

INNER ENDS OF BROKEN RIVETS
REMAINING IN THE JOINT.

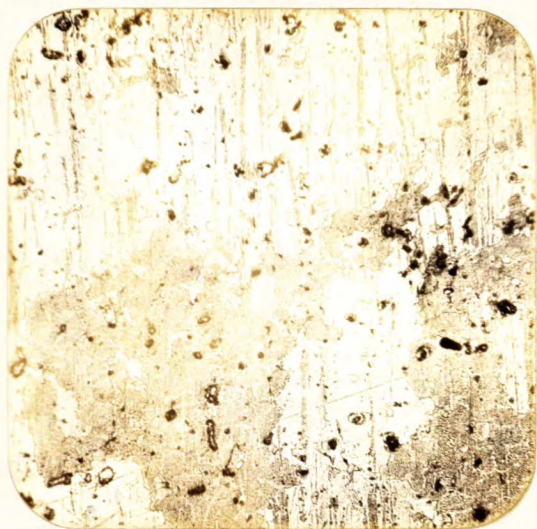
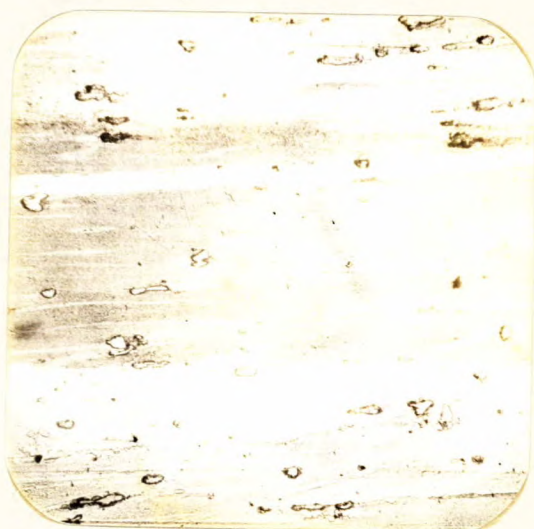
Figures 4 and 5 show the microstructure of the examined tubing. The structure is normal for an Aluminium Alloy 17ST which was subjected to considerable plastic deformation and later fully heat-treated.

X100, etched[⊙].
TUBING - CROSS-SECTION.

X100, etched[⊙].
TUBING - LONGITUDINAL SECTION.

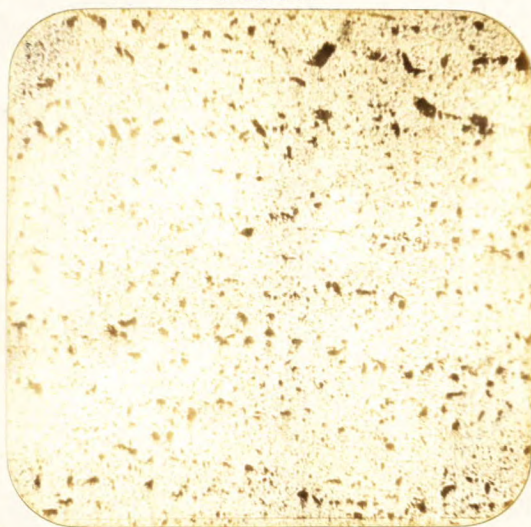
Figure 6.

Figure 6 shows the microstructure of the submitted piece of rivet. The structure reveals that the material was only annealed and cold-worked (in the joining operation). No proper solution-heat treatment was performed on it.

X100, etched[⊙].
RIVET - LONGITUDINAL SECTION.

The results of hardness tests and the microscopic examination show that the rivets were used without previous solution-heat treatment.

The rivets used for the failed joint were not solution-heat treated, apparently due to a mistake in the aircraft factory.

The much lower mechanical properties of the used material were certainly a contributing factor to the failure.
