June 1st, 1943.

ORE DRESSING AND METALLURGICAL LABORATORIES.

Investigation No. 1421.

Examination of a Failed Bolingbroke
Aircraft Fuel Tank.

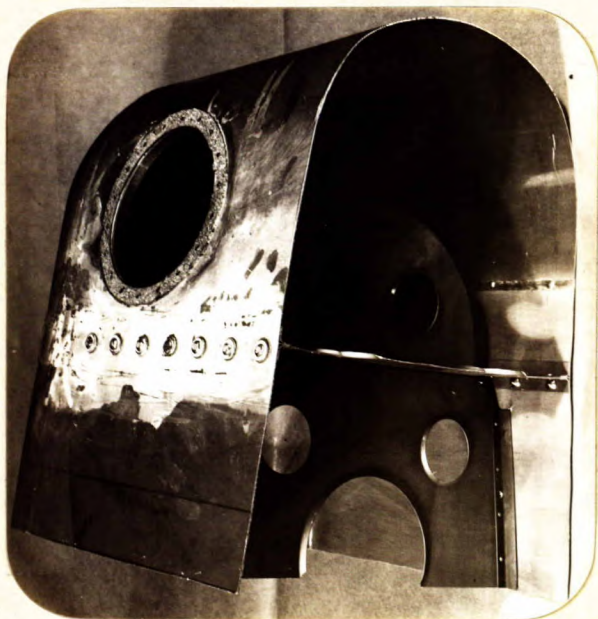
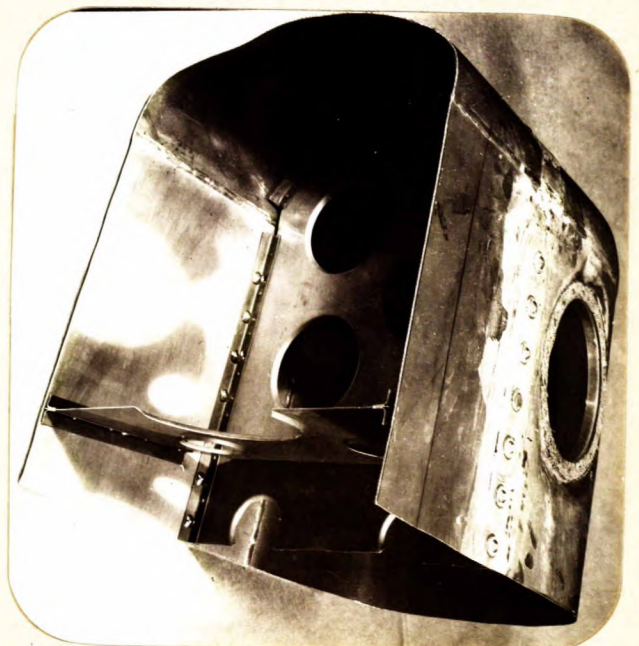
A fuel tank from a Bolingbroke aircraft which had proved defective was dismantled and a corner including the section which failed was submitted for examination. See Figure 1.

Figures 1 and 2 show the failed part of the fuel tank, as received.

FUEL TANK CORNER - AS RECEIVED.
(Approximately 1/6 size).

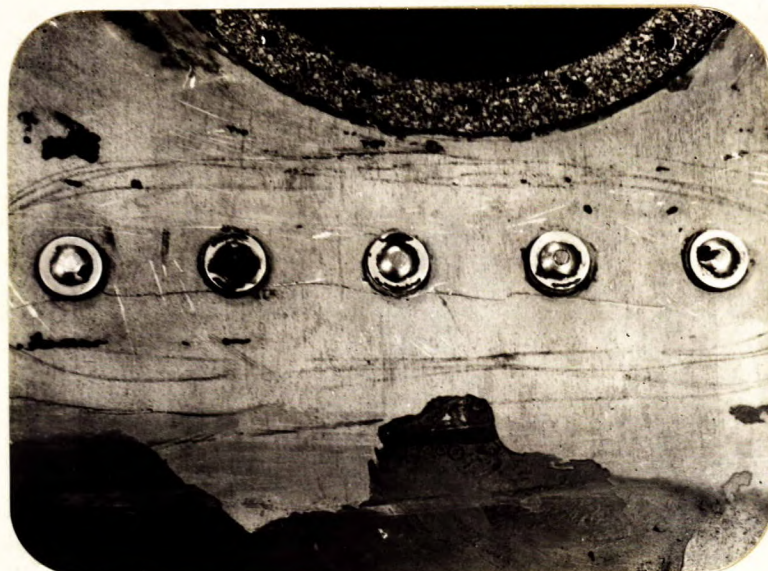
Figure 3.

The nature of the defect was the development of fine cracks along the line of bolts securing the baffles

Figure 3 shows the character of the failure, cracks along the line of bolts.

CRACKS ON FUEL TANK SKIN.
(Approximately $2/3$ size).

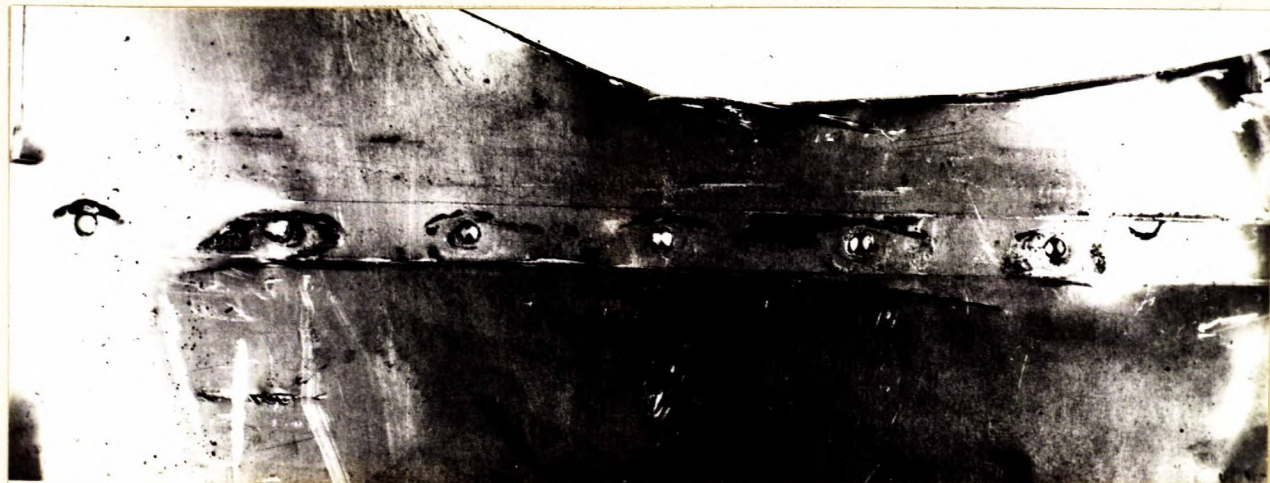
Figure 4.

Figure 4 shows the inside of the cracked tank skin after dismantling and dismantling of the baffles. During this operation the cracks originally present developed into one continuous, long crack.

INSIDE VIEW OF THE CRACKS.
(Approximately $2/3$ actual size).

As shown in Figure 4, the cracks occurred in the

sheet along the line where the inner edge of the angle supporting the baffle was attached.

It seems that the use of a weaker sheet metal was only partly responsible for the failure, which was caused, probably, by the design or manufacture of the supporting members. Clearly visible scoring of the sheet (see Figure 4) at the outer edge of the angle in the baffle mounting would indicate either that too great a pressure was used in the tightening of the bolts or that the angle was originally distorted and extra force was required during the joining operation in order to obtain a tight joint.

It is, however, probable that the failure occurred as a result of overstressing of the material during the assembling of the baffles.
