Investigation No. 1423.

Examination of Defective Boiler Tubing.

On May 26th, 1943, Engineer Rear-Admiral H. A. Sheridan, British Admiralty Technical Mission, 58 Lyon St., Ottawa, Ontario, sent in two samples, taken from defective boiler tubes, for examination.

It was stated (letter of May 26th, File No. 21-16-8-3) that these tubes had pitted after a relatively short period of service in a cylindrical boiler of H.M.S. "Anticosti". It was also stated that best quality seamless steel tubes were specified and it was desired to establish whether these samples were seamless or whether they were butt-welded. A full report on this examination was requested.

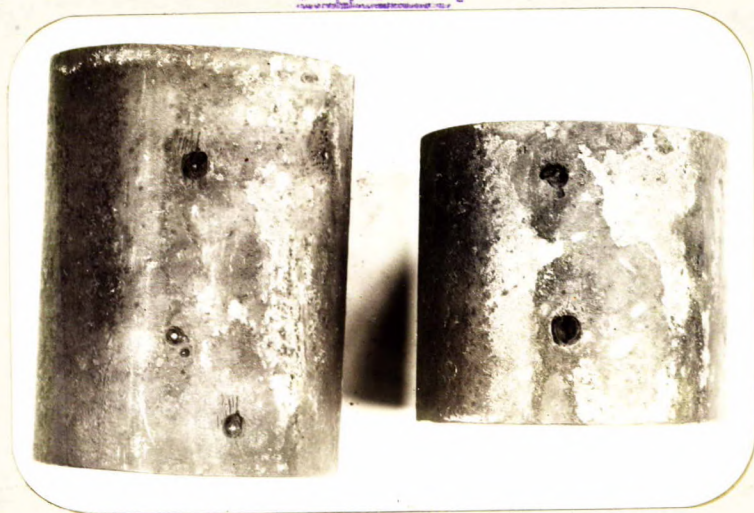
Figure 1.

The samples submitted were oxidized on both the inside and outside of one half of the tube. The oxidized areas exhibited a number of large pit-holes. Figures 1, 2 and 3 are photographs illustrating the nature of these defects. The unoxidized surface was not attacked, as may be seen by reference to Figure 3 which shows the inner surface of one side of the tube.

SCALE ON OUTER SURFACE OF TUBES.

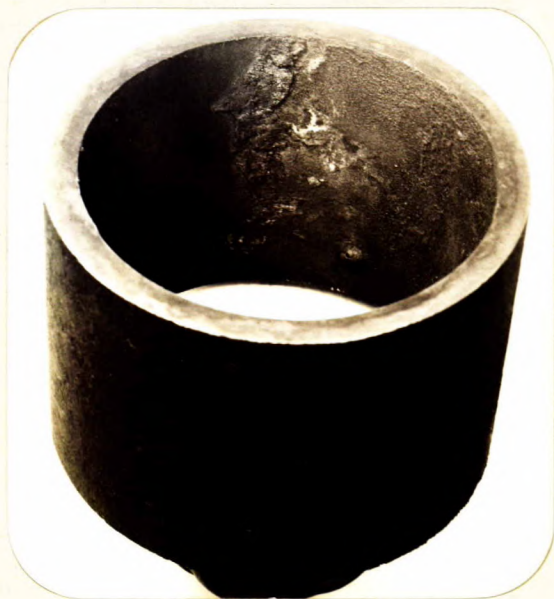
Figure 2.

SHOWING SCALE ON INNER SURFACE OF TUBE.

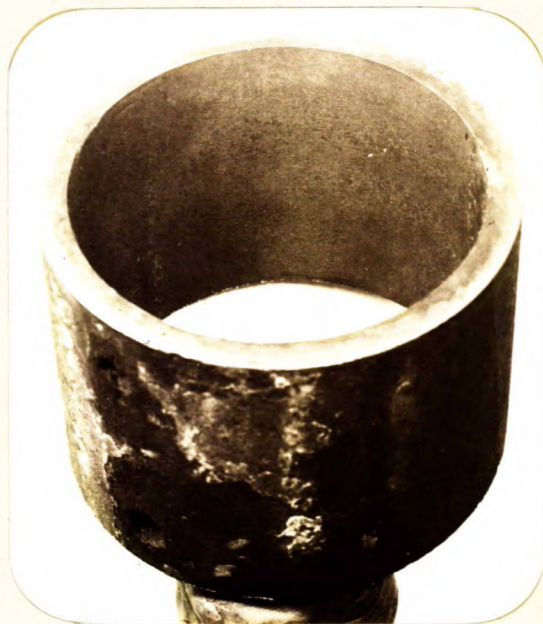
Figure 3.

SHOWING INNER SURFACE OF TUBE FREE FROM SCALE.

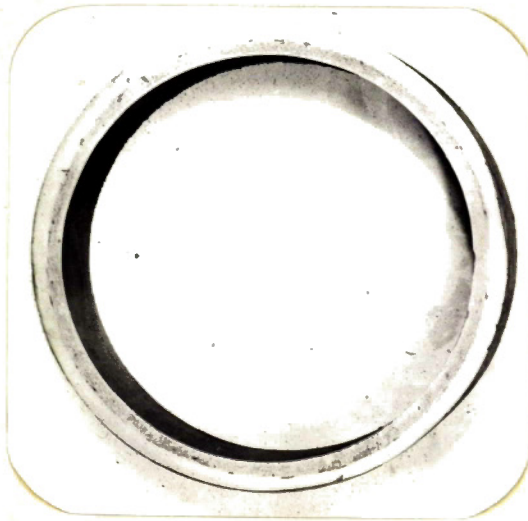
Figure 4.

A full section of the tube was polished and given an etch at 180° F. in a solution of 12 per cent H<sub>2</sub>SO<sub>4</sub>, 38 per cent HCl and 50 per cent H<sub>2</sub>O. Figure 4 is a photograph showing the duplex nature of the etched surface, the outer half of the material being quite sound with the remaining inner material apparently being of lower density.

PHOTOGRAPH SHOWING RIMMED STRUCTURE.

The macro-examination showed that the tubes were seamless and that the duplex nature of the etched surface proved them to have been made from rimming steel and not from a killed steel as specified. The low silicon content in the metal confirmed this latter conclusion. The sulphur print showed a concentration of sulphides in the central and inner portions of the tubing. This is characteristic of rimming steels. The sulphur content, however, is not considered excessive. It is thought that the scaled portion faced the bottom of the boiler, as the fact that all tubing in the boiler was attached removes the possibility that a low water level was responsible. The only alternative would appear to be an overheating of the bottom of the tubing as a result of steam insulation, which might take place in a rapid heating of a boiler.

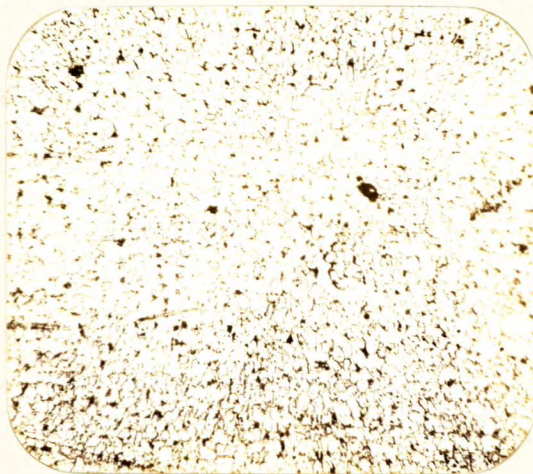
Figure 6.

Specimens cut from the tubing were mounted in bakelite, polished, and then examined in the unetched condition under the microscope. The steel contained a large number of oxide and some sulphide inclusions. The specimens were next etched in a solution of 4 per cent picric acid in alcohol and re-examined. Figure 6 is a photomicrograph, at X100 magnification, showing the fine-grained structure of the steel. Figure 7 is a photomicrograph, at X100 magnification, showing scale (the grey constituent) on the outer surface of the tube. Figure 8 is a photomicrograph, at X100 magnification, showing the

GRAIN STRUCTURE OF STEEL.

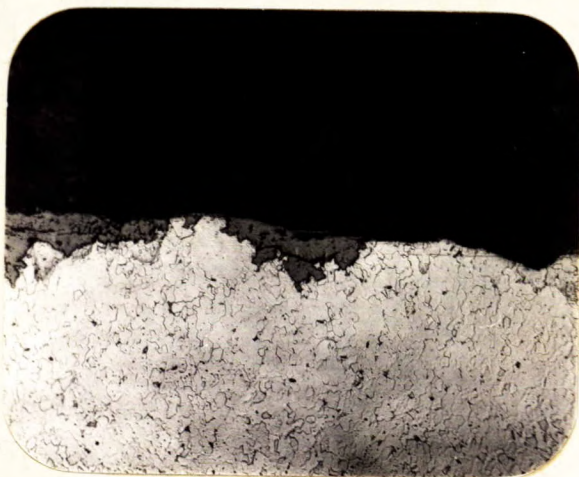
Figure 7.

SHOWING SCALE ON  
SURFACE OF TUBE.

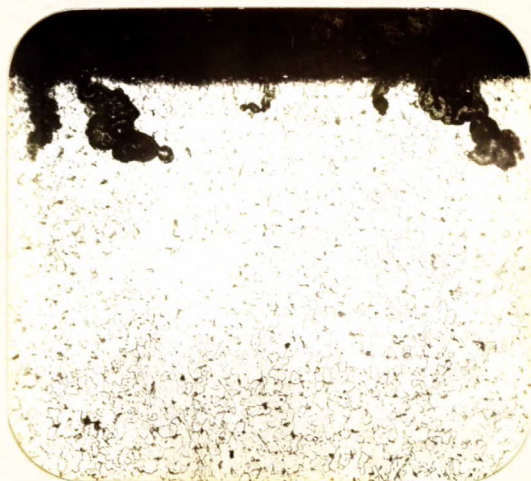
Figure 8.

start of pitting on the outer face of the tube.

START OF PITTING ON  
SURFACE OF TUBE.

The microscopic examination showed that the pitting originated at a scaled portion of the tubing.

It is concluded that the pitting of the tubing occurred as a result of highly localized corrosion in scaled areas which were present as a result of overheating in service, probably because of a too rapid heating of the boiler. The tubes are seamless but the tube steel is of the rimming type which definitely violates the specification.
