O T T A W A June 7th, 1943.

ORE DRESSING AND METALLURGICAL LABORATORIES.

Investigation No. 1424.

Examination of Samples of English, American
and Page Hersey (Canadian) Steel Tubing.

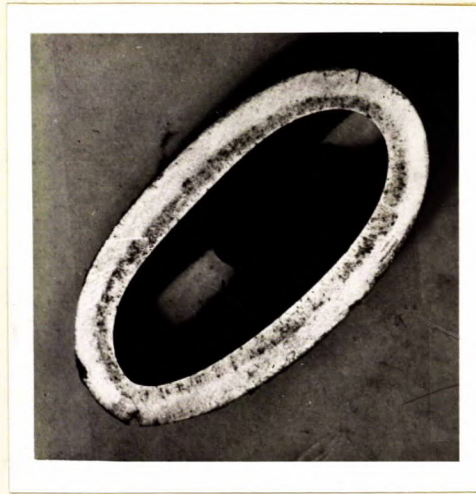
A cross-section from each of the four types of tubing submitted was etched in a hot 50 per cent aqueous solution of hydrochloric acid. The Page Hersey tube which had cracked in a flattening test was seen to be made from rimming steel. This is shown in Figure 1. The other American, British, and Page Hersey tubes were evidently made from killed steel.

Since the cracked Page Hersey tube was made from rimming steel it does not conform to Clause 1 of the specification. No relation between this fact, however, and the cracking of the tube in a flattening test is seen. The defect present extended only partly into the outer rim of comparatively sound metal in the tube. Since this tube was already broken open when received, exact determination of the nature of the defect was not possible, but it would seem to have been caused by an ingot defect, lap, or deep score, which subsequent drawing had transformed into a tight-lipped defect extending longitudinally along the tube. It is felt that this tube cracked in flattening because of the notch effect of this defect.

PHOTOGRAPH OF MACRO-ETCHED SECTION FROM PAGE HERSEY TUBE WHICH CRACKED IN FLATTENING TESTS. (Approximately twice actual size).

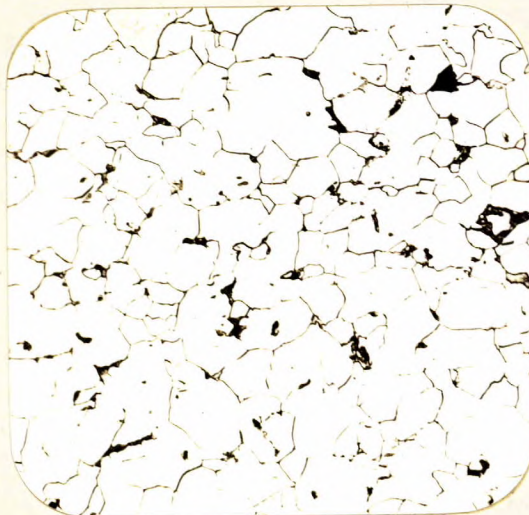
Figure 2.

English and Page Hersey tubes have their carbide constituent present as pearlite, while that of the American one is pearlite that has been partially spheroidized. The ferrite in all samples has been recrystallized. While the carbide constituent of the American tube is elongated, the pearlite in the English and Page Hersey tubes shows no preferred orientation. These points are illustrated in Figures 2 to 5 which are photomicrographs, at 250 magnifications, of etched longitudinal sections from each of the tubes.

ENGLISH TUBE.

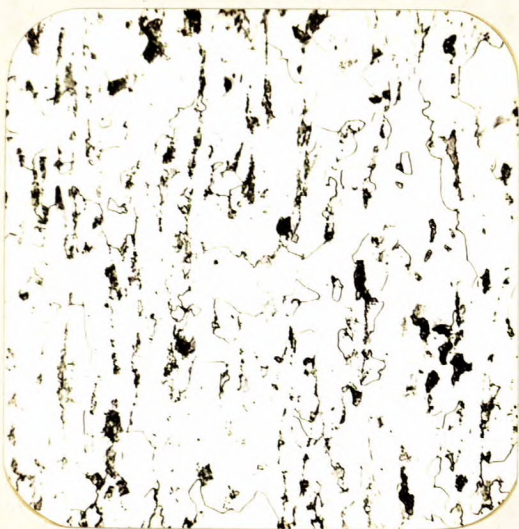
Figure 3.

Microstructure examination would seem to indicate that the 1400° F. anneal given the Page Hersey tube was as good as an anneal from above the upper critical point having the same rate of cooling, because, having been taken over the lower critical point the pearlite is equiaxed. Also, the tube was evidently cold-worked enough to make the recrystallization temperature of the ferrite be below 1400° F. The English tube was evidently given either the same heat treatment as the Page Hersey one or an anneal from a higher temperature. The American tube seems to have been given a high sub-critical draw.

AMERICAN TUBE.

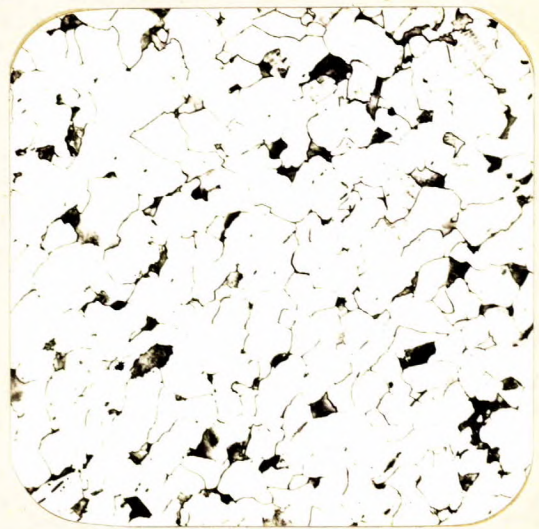
Figure 4.

PAGE HERSEY TUBE.
