June 21st, 1943.

ORE DRESSING AND METALLURGICAL LABORATORIES.

Investigation No. 1431.

Examination of Welded Oxygen Cylinders.

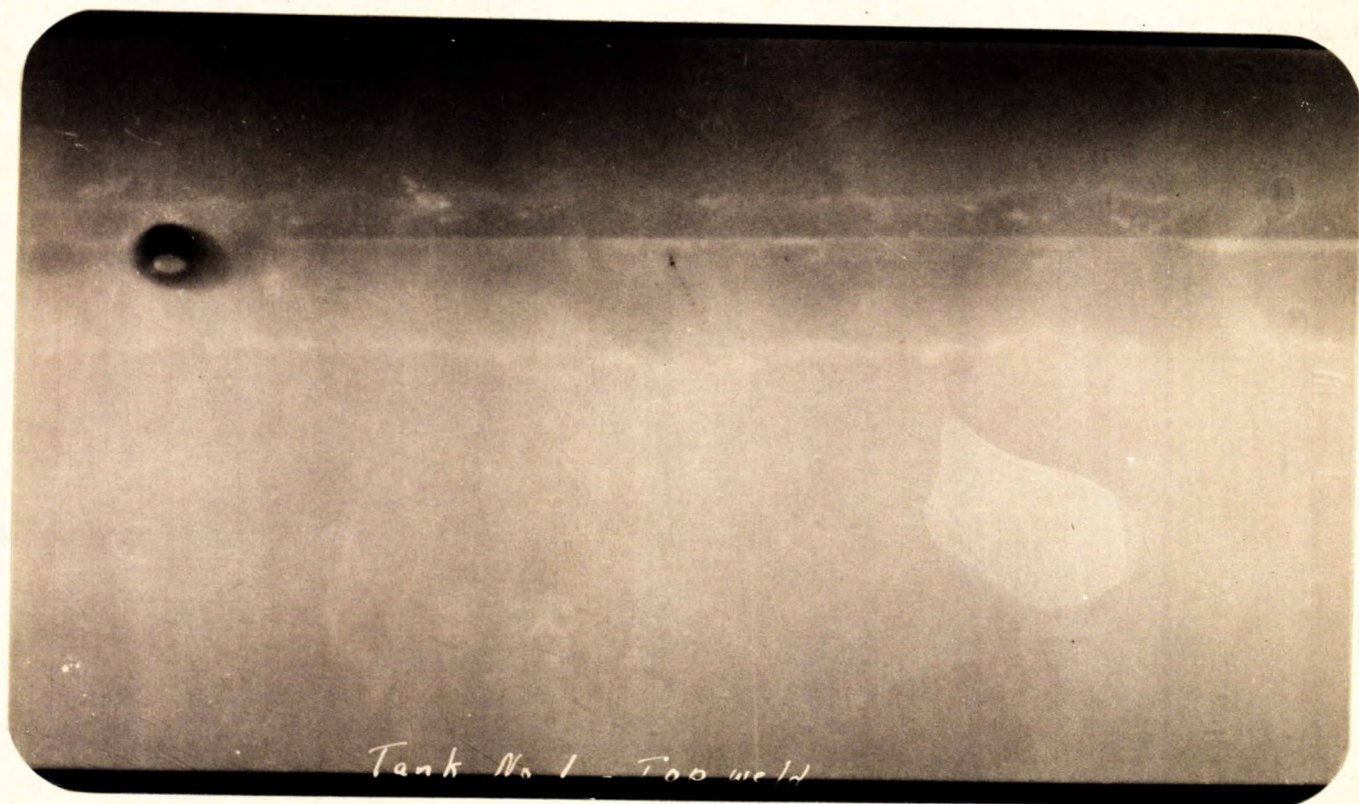
Figure 1.

The radiographs indicate serious lack of fusion in the penetration zone in every case, slightly less serious in the bottom welds of Tanks 2 and 3. Undercut is also shown in every case, less pronounced in the top weld of Tank 3.

There is considerable porosity scattered throughout the welds. Films on Tank 3, top weld, exhibit excessive porosity. Linear porosity, as in film C, Tank 1, bottom weld, occurs in several welds.

Tank No. 1 - Top weld

PRINT OF X-RAY FILM, SHOWING LACK OF FUSION
IN THE WELD OF CYLINDER NO. 1.

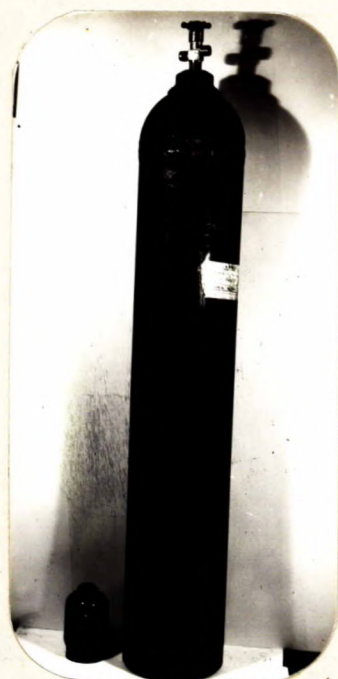
Figure 2.

Figure 2 is a photograph of one of the welded cylinders. The bottom and top sections of the cylinder were assembled by welding. The valves on the tops of the cylinders were provided with a safety arrangement and also a threaded tee gas outlet. The latter was threaded with a standard right-hand thread, 14 threads to the inch, and the outside diameter measured $29/32$ inch. This dimension was found to be approximately $1/16$ inch larger than a similar fitting on a Linde Air Products Company oxygen cylinder.

GAS CYLINDER.
(Approximately $1/16$ th size).

The oversize dimensions of the threaded outlet tees on the valves supplied with these cylinders would prohibit their use either in filling or in service, unless a special oxygen hose coupling were supplied. An alternative to this would be to obtain new valves with tees threaded to fit Canadian standard oxygen hose couplings.

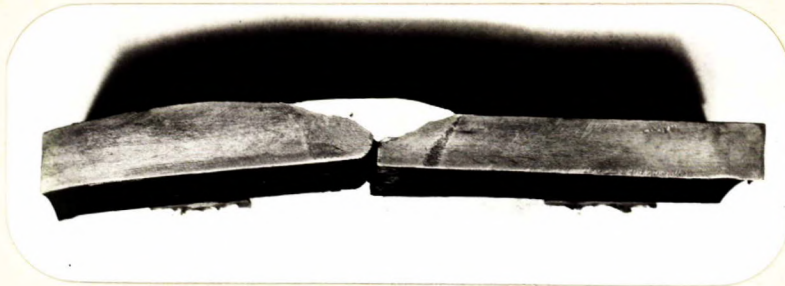
Figure 3.

A section of the weld was cut from Cylinder No. 1 and given a macro-etch in a solution of 5 per cent HCl and 1 per cent picric acid in alcohol. Figure 3 is a photograph showing the macro-etched structure of a cross-section of the weld and parent metals. The weld metal consisted of four layers, and from the nature of the weld it would appear to have been produced by gas welding. It may be seen that alignment is quite bad and penetration is only about 50 per cent.

CROSS-SECTION OF WELD AND PARENT METAL.

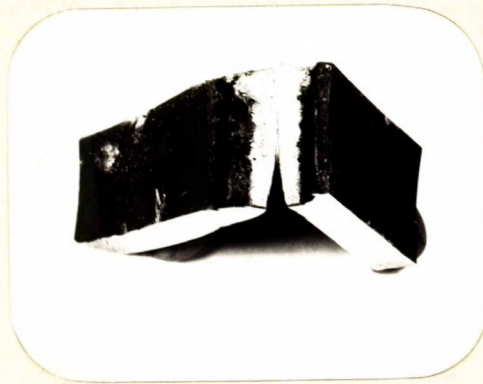
Figure 3.

A weld bend test specimen from Cylinder No. 1 broke under a load of 2,500 pounds. Figure 3 shows the fracture of this specimen. It will be observed that the weld metal covers only approximately one-half of the cross-section.

FRACTURE OF BEND TEST SPECIMEN.

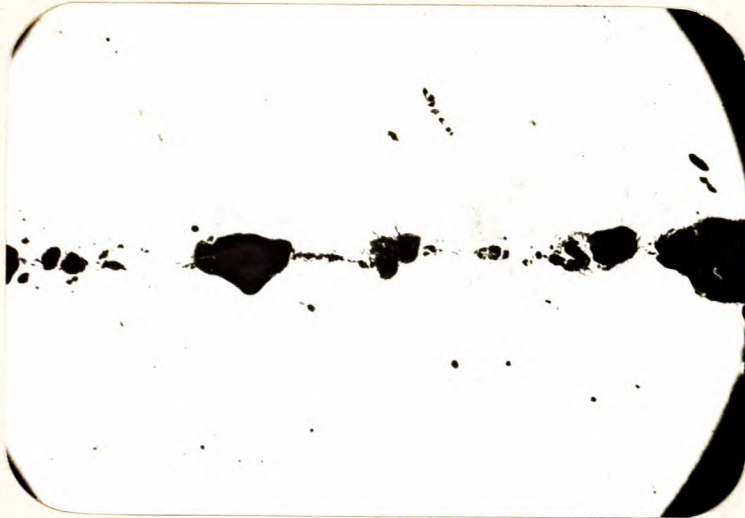
Figure 4.

A cross-sectional specimen of the weld and parent metal was prepared for microscopic examination. The steel was first examined under the microscope in the unetched condition. Figure 4 shows a porous section of the unetched metal. The steel was then etched in a solution of 2 per cent nitric acid

X100, unetched.
POROUS METAL.

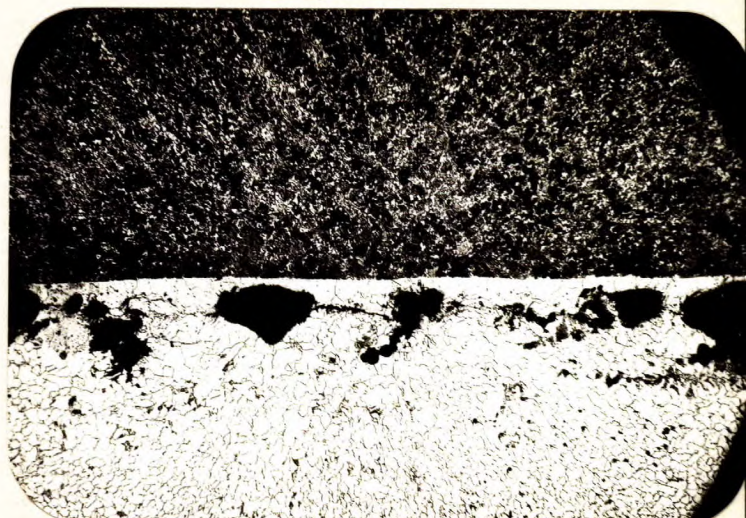
in alcohol and re-examined. It was found that the porosity shown in Figure 4 occurred in the weld metal. This is illustrated in Figure 5. Figure 6 shows the structure of a sound portion of the weld metal.

X100, etched in 2 per cent nital.
SAME AS FIGURE 4, SHOWING
POROUS WELD METAL.

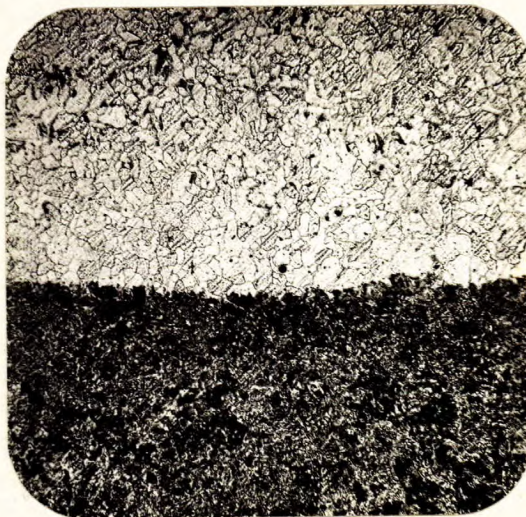
Figure 6.

X100, etched in 2 per cent nital.
SOUND WELD METAL.

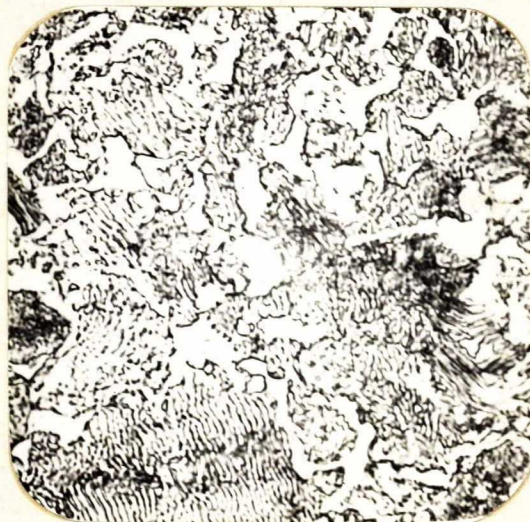
Figure 9.

Figures 7 and 8, photomicrographs at X100 magnification, show the fine-grained structure of the weld and parent metals respectively, after an etch in 2 per cent nital. These structures consist of ferrite (the white etching constituent) and pearlite (the dark etching material). The coarse nature of the pearlite is illustrated in Figure 9, a photomicrograph at X1000 magnification.

X1000, etched in 2 per cent nital.

PARENT METAL.

A hardness survey showed that there were no brittle zones adjacent to the weld metal. The low hardness values obtained indicated that the steel was in the annealed condition. This latter fact was confirmed by a microscopic examination (see Figure 9).
