Investigation No. 1432.

Magnaflux and Radiographic Examination of  
Cylinders for Cheetah Aircraft Engines.

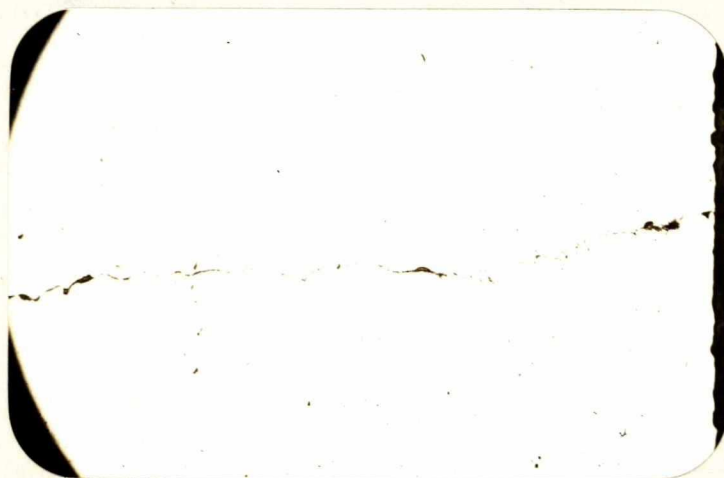
Figure 1.

One of the cylinders which had been shown to be definitely defective by magnafluxing passed the radiographic examination because the defect, being in the unfinned portion of the barrel, was evidently overexposed so much as to make interpretation impossible. A one-quarter-inch strip containing part of the defect, which seemed to be about one-half inch long, was removed from the barrel. It broke open with a very light blow from a hammer. The defect extended inward from the outer surface to a depth of approximately 0.047 inch at the point measured. Photomicrographs obtained from a specimen removed from the defective portion and polished on a face perpendicular to the main axis of the barrel are given in Figures 1 and 2. This defect, which does not seem to be of the shrinkage type, probably originated during the centrifugal casting.

X100, unetched.  
CROSS-SECTION OF THE DEFECT.

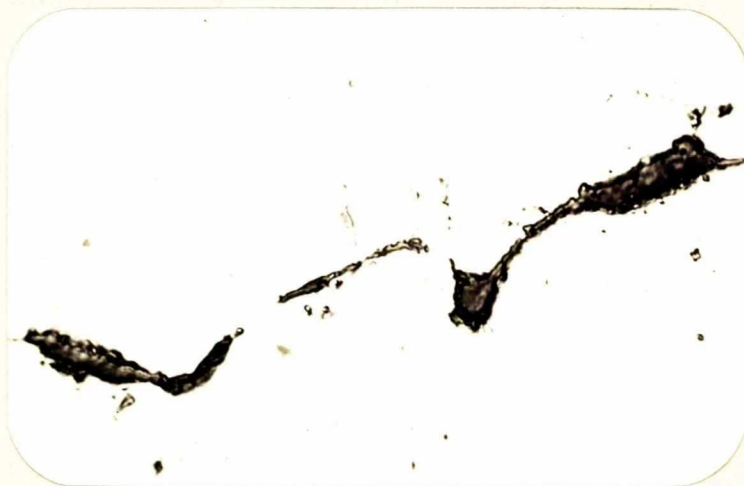
Figure 2.

X1000, unetched.  
Note inclusions in the defect.
