R E P O R T
of the
ORE DRESSING AND METALLURGICAL LABORATORIES.

Investigation No. 1434.

Examination of a Pitted Hoover Airscrew Blade.

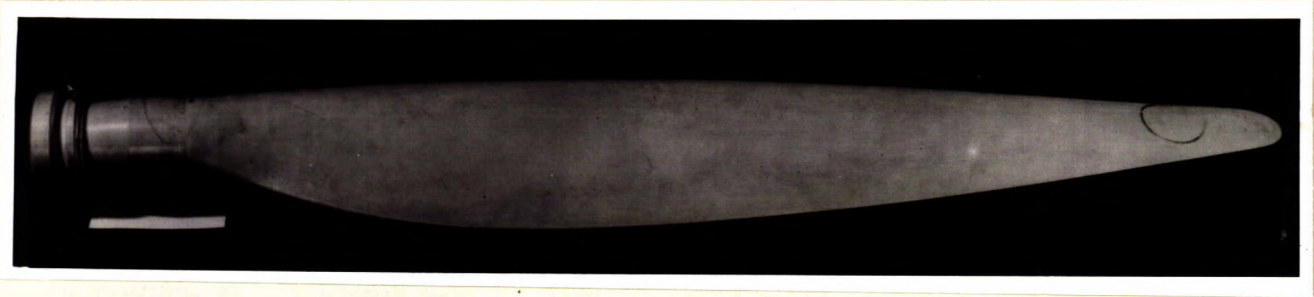
Figure 1.

Figure 1 shows the airscrew blade as submitted. The areas of surface pits are marked, one on the tip and one on the shank of the blade.

AIRSCREW BLADE AS SUBMITTED.

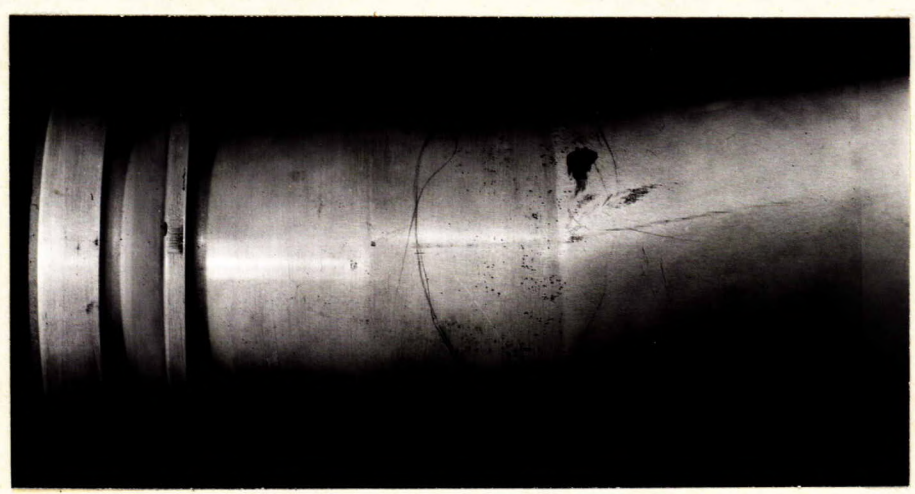
Figure 2.

Figure 2 shows the appearance of the pitted area on the shank of the blade.

SURFACE PITS ON SHANK PART OF THE BLADE.

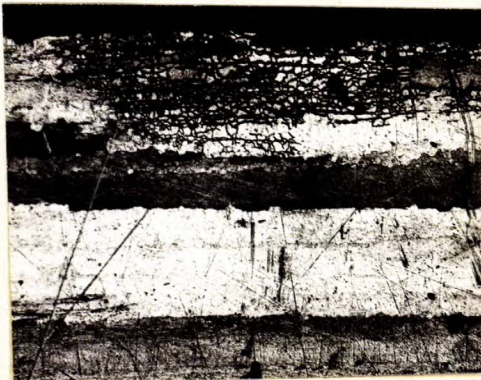
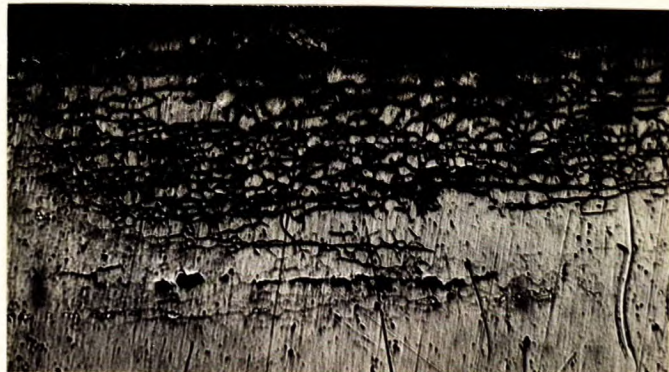
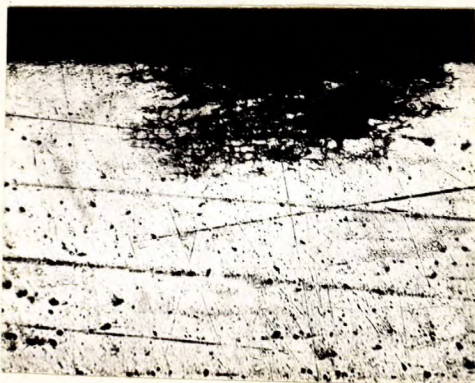
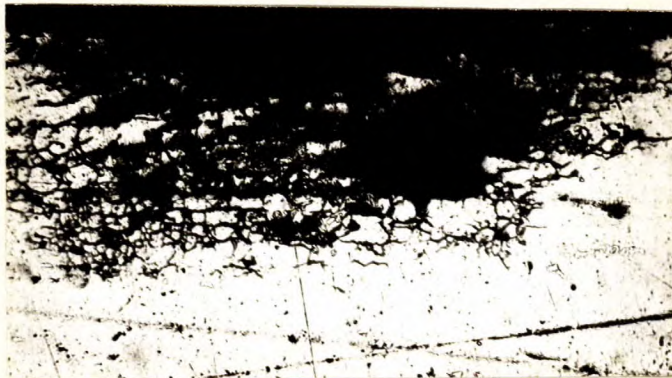
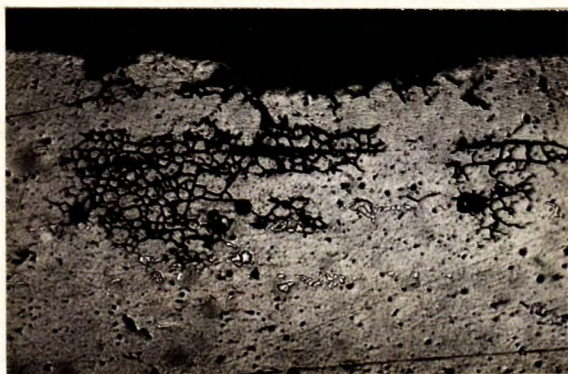
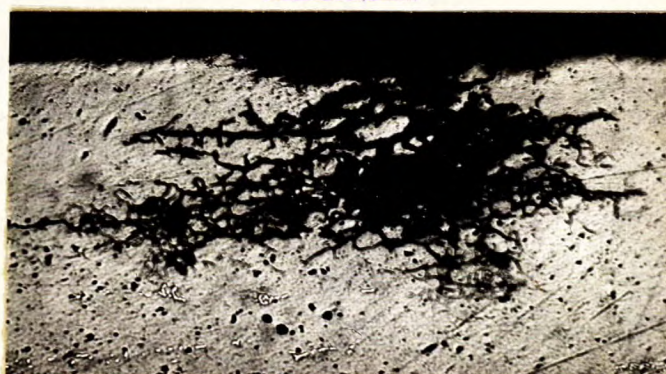
Microscopic examination showed that the examined surface pits were due to corrosion. Figures 3 to 8 show definitely the intercrystalline character of the corrosion failure.

Microscopic examination shows that the surface pits are due to intercrystalline corrosion attack. This type of corrosion is a most dangerous one, because the surface pits are mostly very small and therefore difficult to detect, while the corrosion proceeds along the grain boundaries deeply into the material.

advisable in the present case. The safer practice would appear to be to scrap the propellers.

5. Every effort should be made to eliminate alkalic corrosive agents, such as cleaning solutions, etc., from the fabrication plant and to maintain closer control on heat-treatment operations.
