June 23rd, 1943.

ORE DRESSING AND METALLURGICAL LABORATORIES.

Investigation No. 1435.

Examination of a Broken Harvard Airscrew Blade.

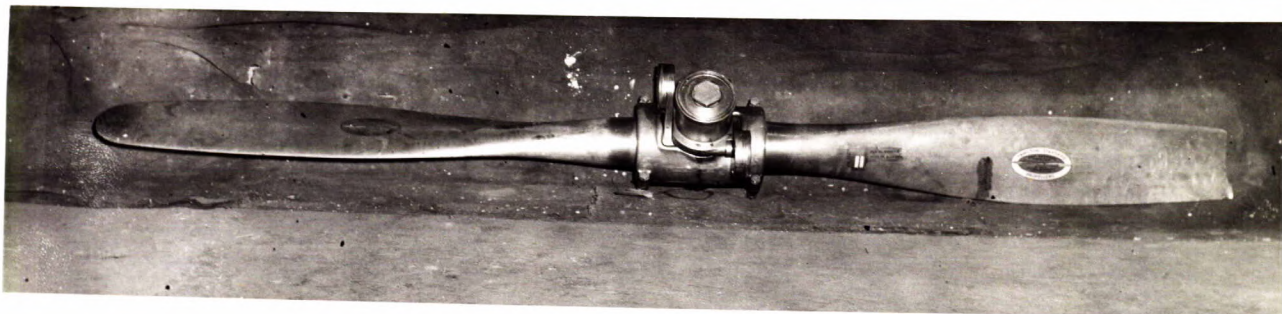
Figure 1.

Figure 1 shows the broken airscrew blade as submitted.

AIRSCREW AS SUBMITTED.

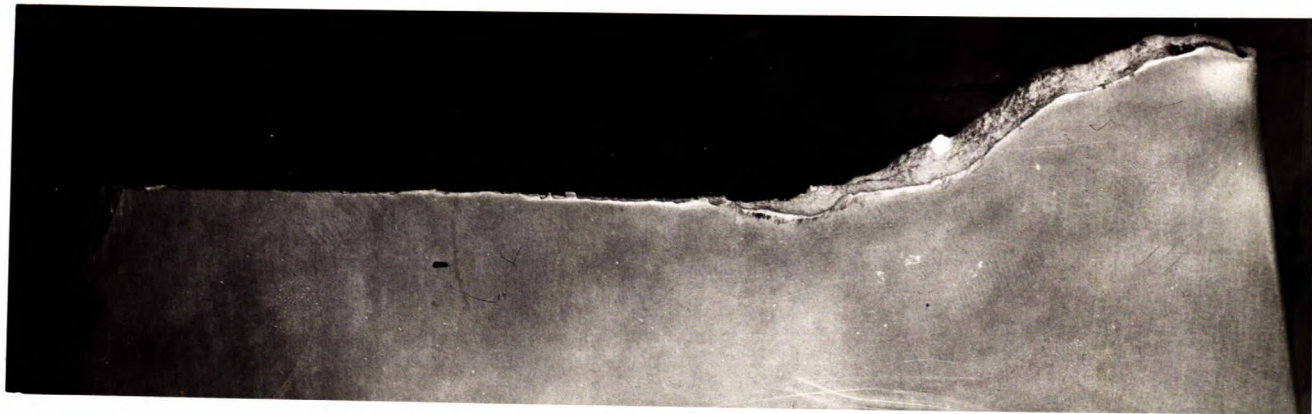
Figure 2.

Figure 2 shows the shape of the fracture in larger scale.

APPEARANCE OF THE FRACTURE.

The fracture occurred at a point six inches from the top of the blade. The tip was lost, probably in the snow.

It is evident (see Figure 2, top) that this airscrew

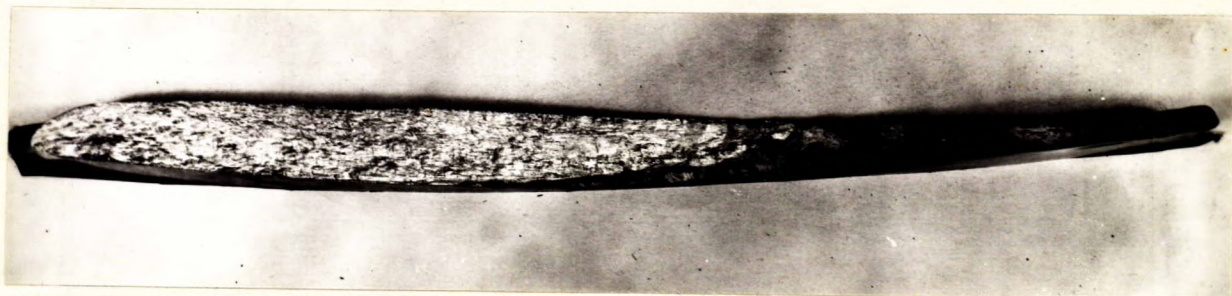
Figure 3.

blade has been dented and the dent smoothed out by filing and polishing. The appearance of the fracture (Figure 3) reveals that the failure started from this formerly repaired notch. The first part of the break (Figure 3, left side), about  $3\frac{3}{4}$  inches long, is a typical fatigue fracture. The other part of the break was due to a sudden overstressing and shows that this part was strongly bent before it broke.

APPEARANCE OF FRACTURE.

The appearance of the fracture indicates that the failure was due to insufficient care in smoothing-off the previous damage (dent) on the edge of the blade.

The examination revealed no metallurgical defect in the propeller. Failure, which started from a carelessly repaired notch, is considered to be "an isolated case". This conclusion is in agreement with R.C.A.F. Report of Defect No. 9822.
