June 24th, 1943.

### ORE DRESSING AND METALLURGICAL LABORATORIES.

Investigation No. 1436.

Examination of Welded Universal Carrier Nose.

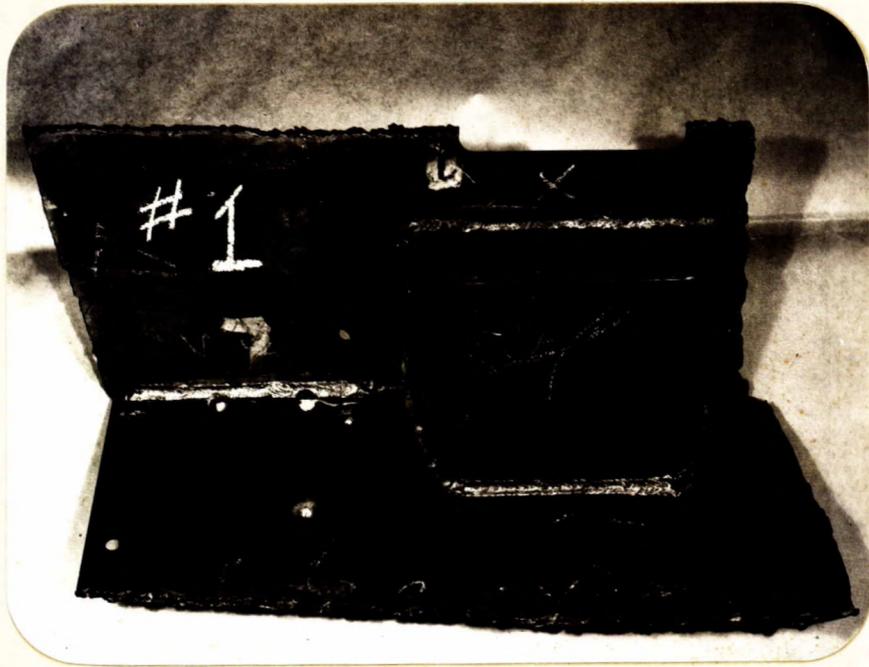
Figure 1.

The sections submitted for examination revealed that ball ammunition striking near the edge of the weld had passed completely through the 5-mm. plate. Where the ball struck approximately one inch from the edge of the

SECTION 1 OF CARRIER NOSE AS RECEIVED,  
SHOWING GENERAL AREAS OF BALLISTIC  
ATTACK.

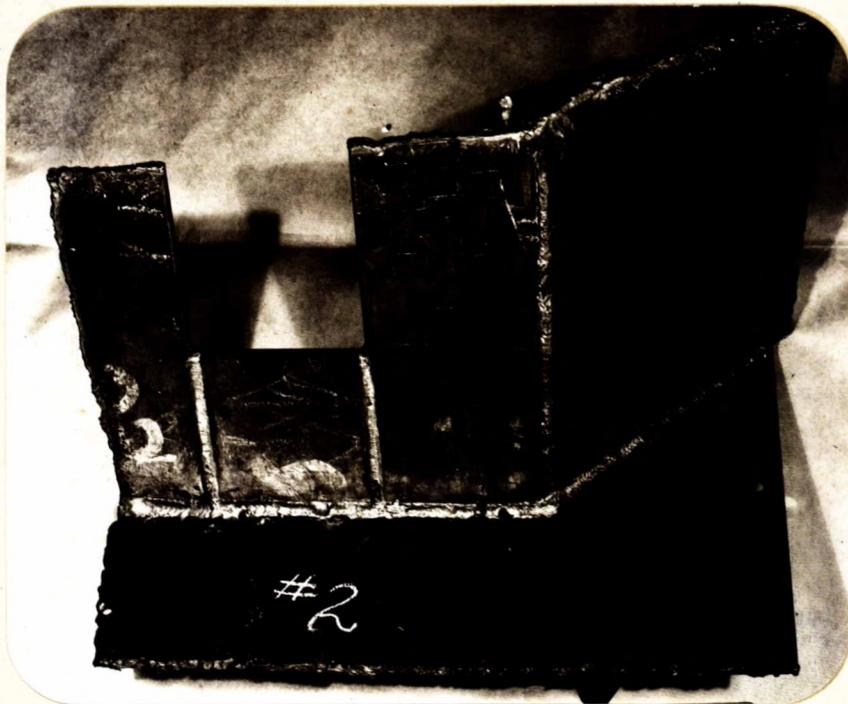
Figure 2.

SECTION 2 OF CARRIER NOSE AS RECEIVED,  
SHOWING GENERAL AREAS OF BALLISTIC  
ATTACK.

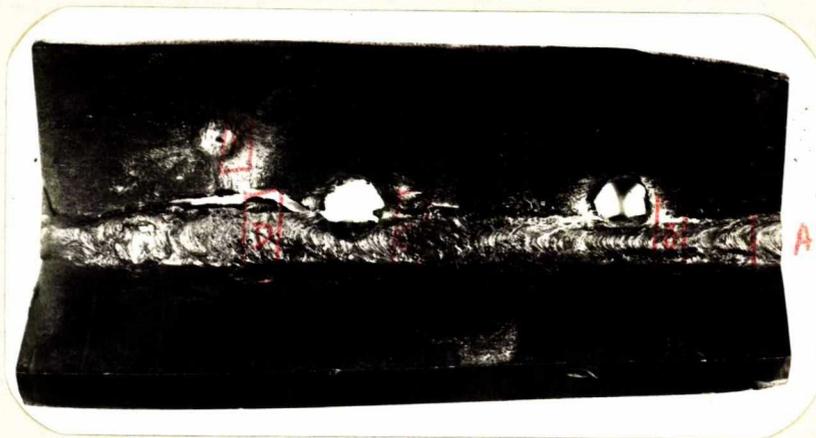
Figure 3.

It will be noted from our examination of Figures 3 and 4 that the ball has penetrated the 5-mm. plate but the weld metal itself has not cracked. An examination of Figure 5 confirms that the failure is confined to the thinner plate and, in main, the fractures occur outside of the heat-affected zone.

CLOSE-UP OF TYPICAL AREA OF BALLISTIC FAILURE IN SECTION 1.

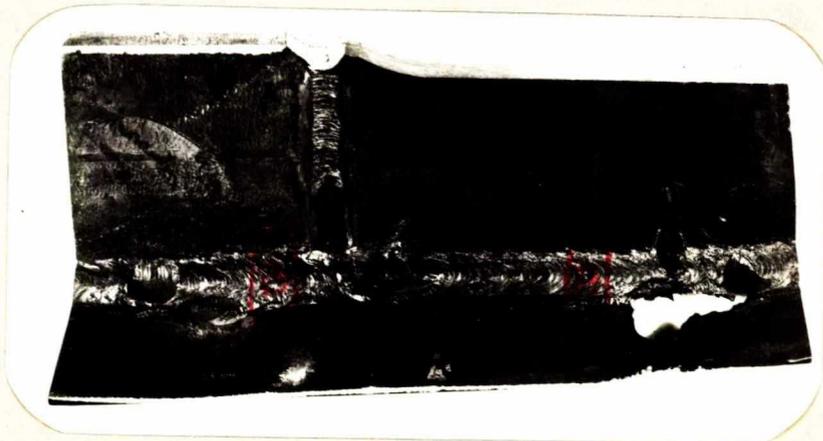
Figure 4.

CLOSE-UP OF TYPICAL AREA OF BALLISTIC FAILURE IN SECTION 2.

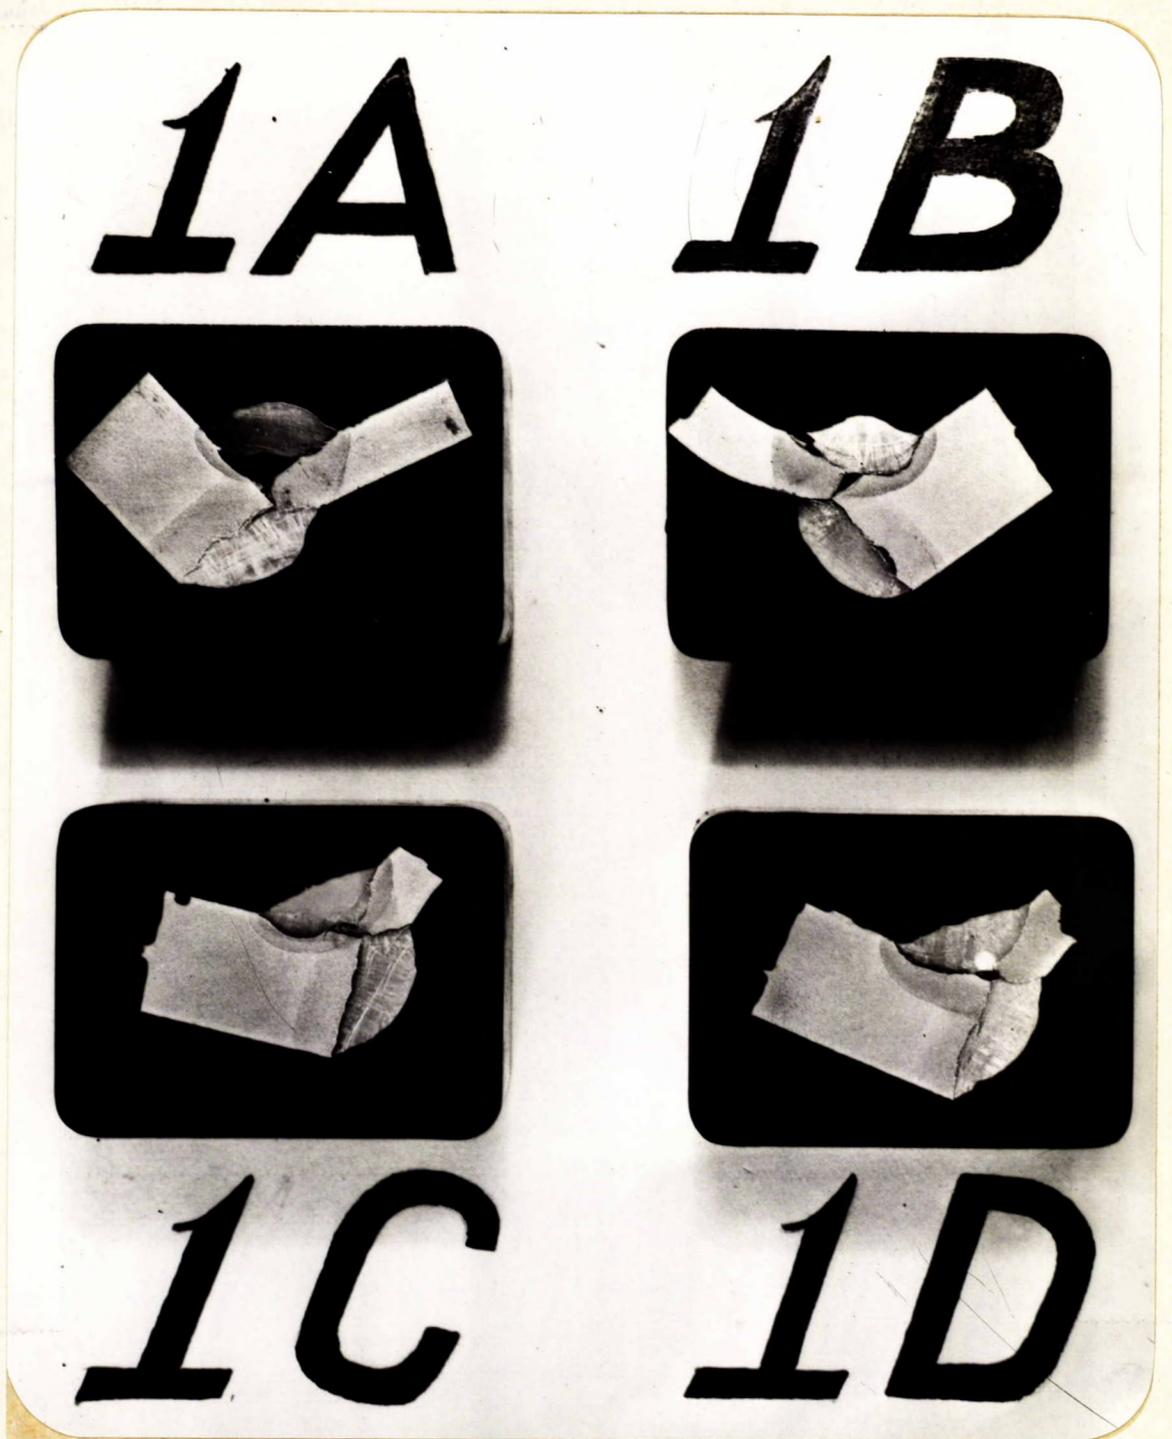
Figure 5.

technique. The following defects were found. High piled-up beads (Figure 5, sample 1A), undercutting (Figure 5, sample 1D), poor penetration and gas holes. In addition, all samples in Figure 5 show extensive incomplete fusion at the root gap. It is also apparent that the welds are made in three passes at the most and not seven as reported.

The presence of undercutting, high beads, and incomplete fusion at the root gap might very probably lead to fatigue failure in service, since all of these welding defects act as stress raisers. It is our understanding that such service failures have already been reported in welded vehicles.

MACRO SAMPLES SHOWING TYPICAL WELDS.  
ETCHED IN 1 PER CENT PICRIC ACID,  
5 PER CENT HYDROCHLORIC ACID IN  
ALCOHOL.

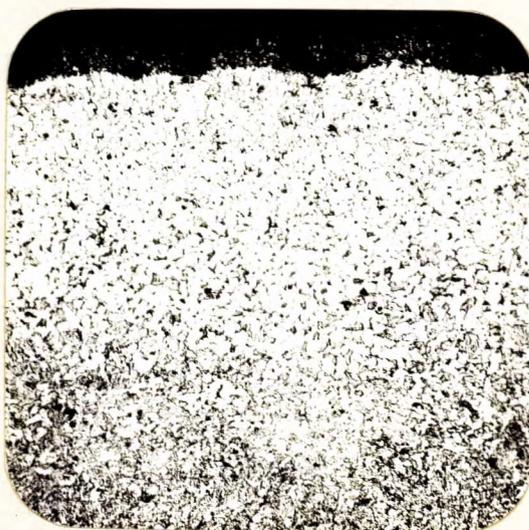
(7) Sample 1E was examined under the microscope. Figure 7 shows the structure of the 5-mm. plate from the edge towards the centre.

It is worthy of note that the 5-mm. plate shows a band of decarburized metal along each surface, approximately 0.017" in depth (Figure 6). While this has probably not contributed to the failure of this plate, it is an undesirable condition which would be expected to lower both ballistic properties and fatigue strength.

100X. ETCHED IN 20% NITAL. STRUCTURE  
OF 5-MM. PLATE FROM EDGE TOWARDS  
CENTRE. LAYER OF DECARBURIZED METAL  
APPROXIMATELY 0.017" IN DEPTH.
