ORE DRESSING AND METALLURGICAL LABORATORIES.

Investigation No. 1444.

Examination of Four New Volute Springs
Manufactured by the American Automotive Company
(Railway Spring Division), Latrobe, Pa.

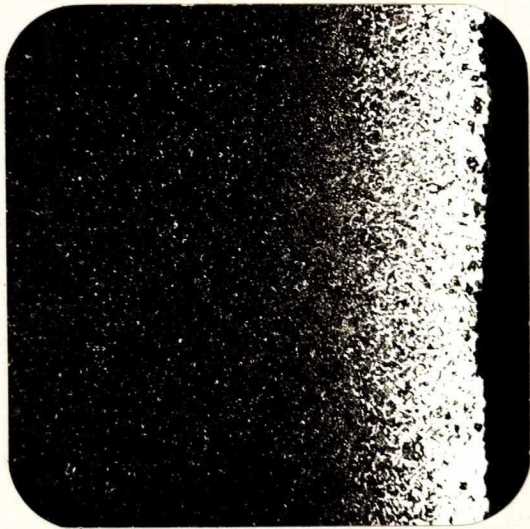
Figure 1.

SPRING NO. 1.

Depth of decarburization,
0.005 inch.

A decarburized layer 0.005 to 0.012 inch thick is present on the springs. Decarburization is known to reduce the fatigue life of springs by 50 per cent or more.

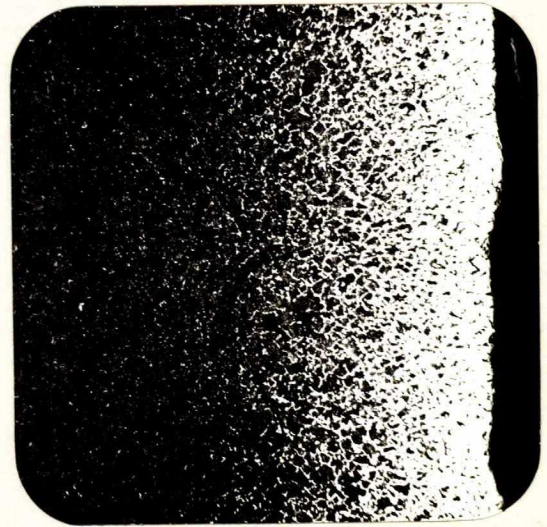
Figure 2.

SPRING NO. 2.

Depth of decarburization,
0.012 inch.

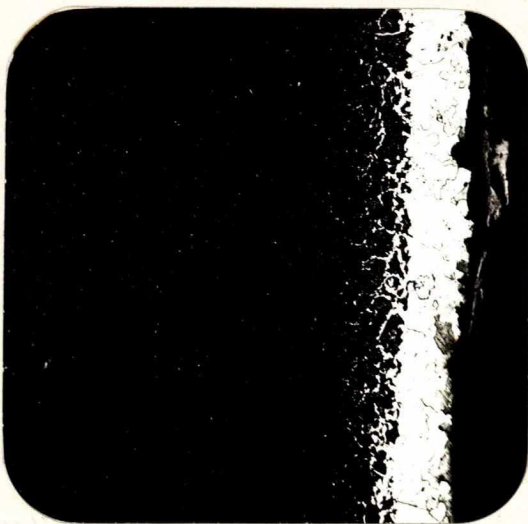
Figure 3.

SPRING NO. 3.

Depth of decarburization,
0.005 inch.

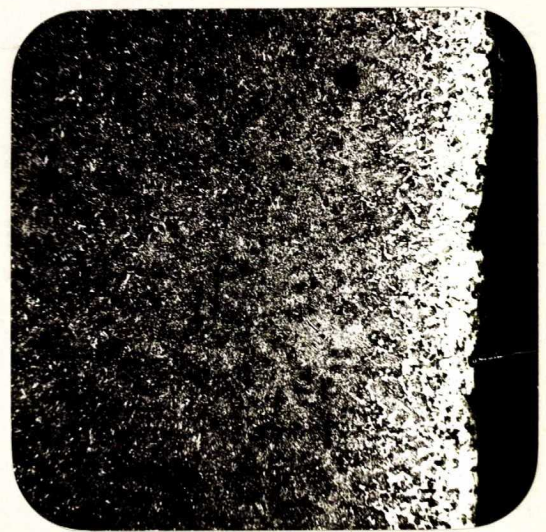
Figure 4.

SPRING NO. 4.

Depth of decarburization,
0.005 inch.
