ORE DRESSING AND METALLURGICAL LABORATORIES.

Investigation No. 1451.

Examination of a Broken Spider Arm taken from a Hamilton
Standard Propeller, Type 12D40-211, Serial No. 76762.

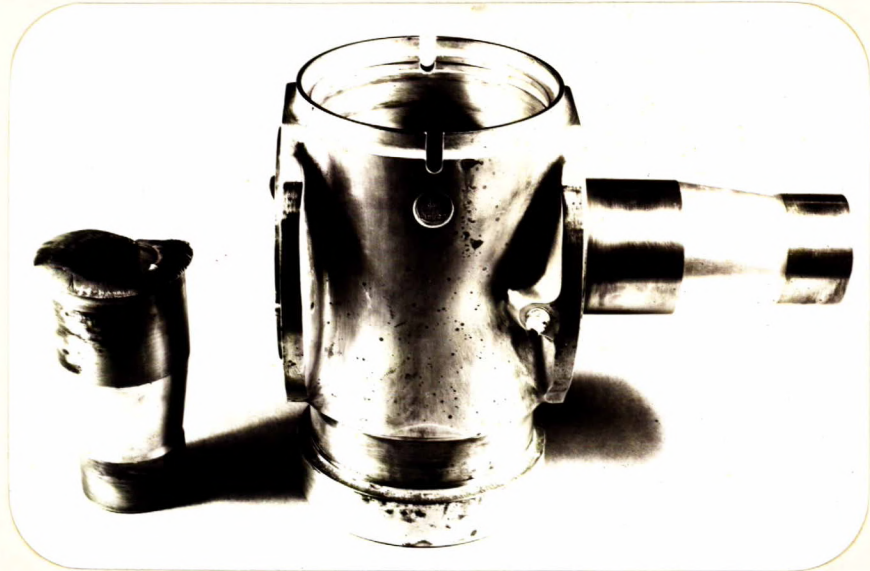
Figure 1.

Figure 1 is a photograph showing the broken spider as received at these Laboratories.

BROKEN SPIDER AS RECEIVED.
(Approximately 1/3 actual size).

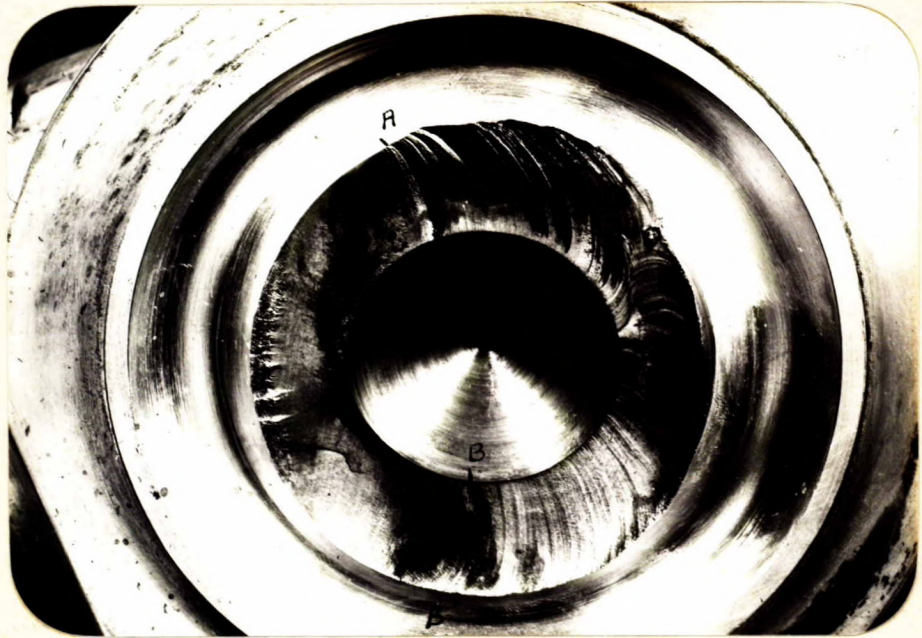
Figure 2.

The fracture was of the duplex type. In Figure 2, the break is seen to show concentric circles originating from lines marked AA and BB. In Figure 3, a fairly sharp tool mark may be observed at "A". Another sharp tool mark can also be seen (see "B" on Figure 4) on the opposite inner side of the shaft, about a quarter of an inch from the fracture.

The fracture definitely is of the fatigue type. As surfaces always are weaker, the probability is, then, that failure originated from the two points AA and BB. However, it is not possible to say whether the fracture started from the outside or from the inside surface. In the absence or equality of stress raisers one would expect the former to be the case, as the outer fibres would be more heavily stressed. Shot-blasting of the spider would definitely improve its resistance to alternating stresses, as it would ensure a much better stress distribution.

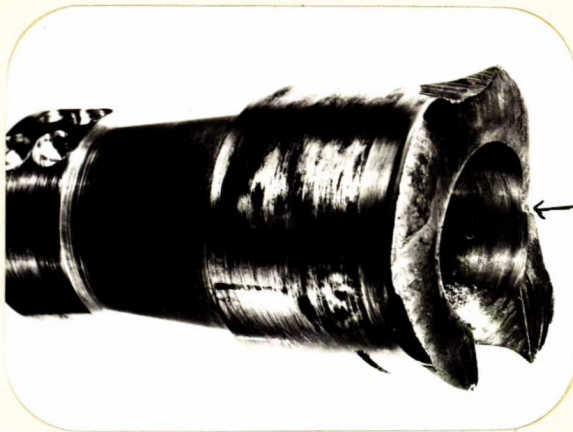
Figure 3.

The flow lines in the forging do not parallel the surface at the point of fracture. Fatigue life would have been improved had they done so, but in forgings of this type perfection in flow lines at all sections is not to be expected. The fatigue, therefore, is not attributed to poor forging practice. However, the deep tool marks shown in the inside surface would most certainly have acted as stress raisers, especially in such a hard material as the steel under examination, and may possibly have contributed to failure.

1. Machine practice should be checked, so as to eliminate deep tool marks.
2. The part should be shot-blasted.
3. The quenching rate should be increased in order that a uniform structure may be obtained.

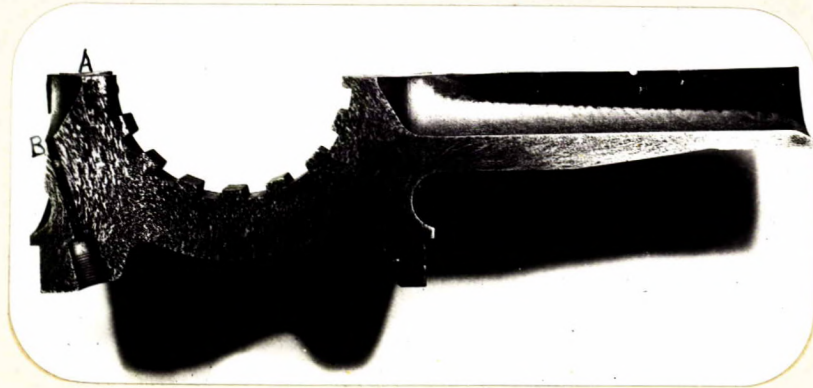
Figure 5.

Figure 5 shows a section of the spider which was given a macro etch, at 160° to 180° F. for 1½ hours, in a solution of 50 per cent HCl in water. It will be observed that the flow lines cut into the fracture which occurred along AB.

SECTION OF SPIDER, MACRO-ETCHED.
(Approximately 1/3 actual size).

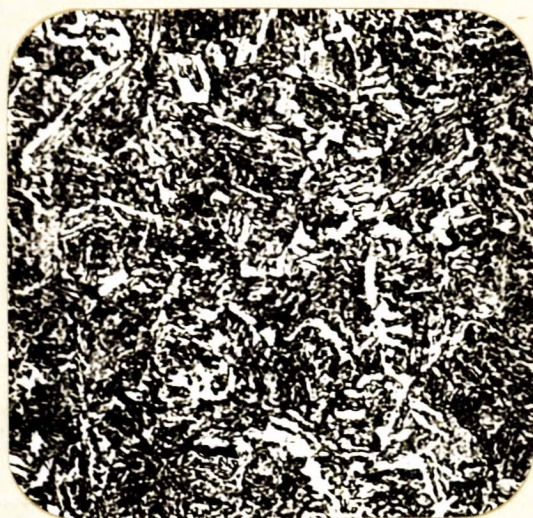
Figure 6.

X1000, picral etch.
STEEL IN THE "AS RECEIVED" CONDITION.

The free ferrite revealed by the microscopic examination of the "as received" material is of the type that precipitates when the cooling rate is just under the critical value. This investigation shows that this free ferrite can be eliminated by a standard oil-quenching procedure. The free ferrite present would probably have an unfavourable effect on both the fatigue and the impact strengths.

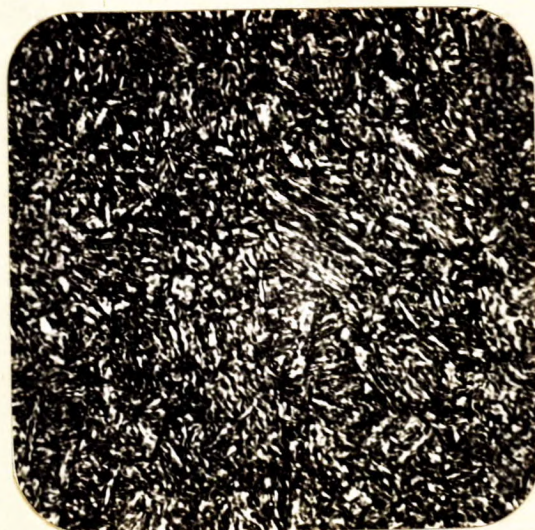
Figure 7.

A section of the steel was cut from the broken shaft at the point of fracture, mounted in bakelite, polished, and then examined under the microscope in the unetched condition. The steel was found to be fairly clean. The specimen was next etched in a solution of 4 per cent picric acid in alcohol and re-examined. Figure 6, a photomicrograph at X1000 magnification, shows the etched structure of the steel in the "as received" condition, the structure consisting of drawn martensite. Small areas of ferrite (the white constituent) are interspersed in this matrix. Figure 7 shows the etched structure of the steel after quenching in oil from 1525° F. and drawing at 800° F., the steel being quenched from the draw temperature. It will be observed that the free ferrite has been eliminated.

X1000, picral etch.
CONDITION OF
STEEL AFTER HEAT TREATMENT.
