ORE DRESSING AND METALLURGICAL LABORATORIES.

Investigation No. 1453.

An Examination of Engine Mount Fork Ends
Fabricated by Various Methods.

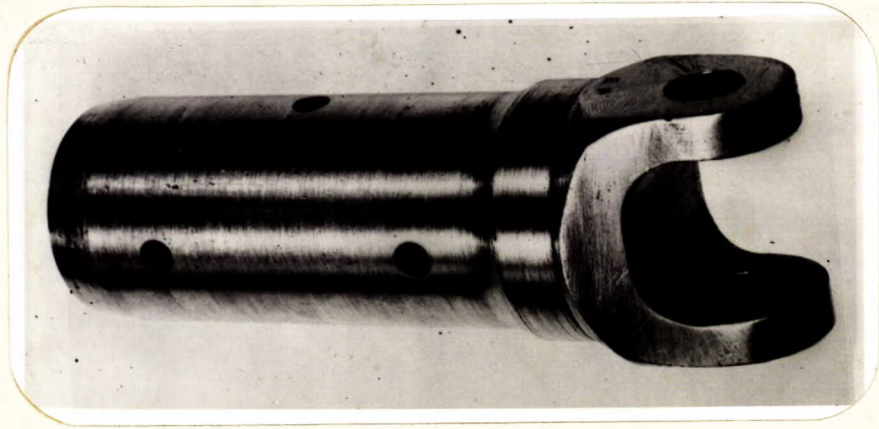
Figure 1.

Four engine mount fork ends, as shown in Figure 1, were submitted^o on July 9th, 1943, by A/C A. L. Johnson, for Chief of the Air Staff, Department of National Defence, Air Services, Ottawa, Ontario.

Probably because of the design of the part, it was not possible to drill the lug holes perfectly round. Two methods of correcting this condition have been developed. In the first the holes were made round by cold deformation. The second method involved heating of the lugs before forming to shape.

PHOTOGRAPH OF ENGINE MOUNT FORK END.

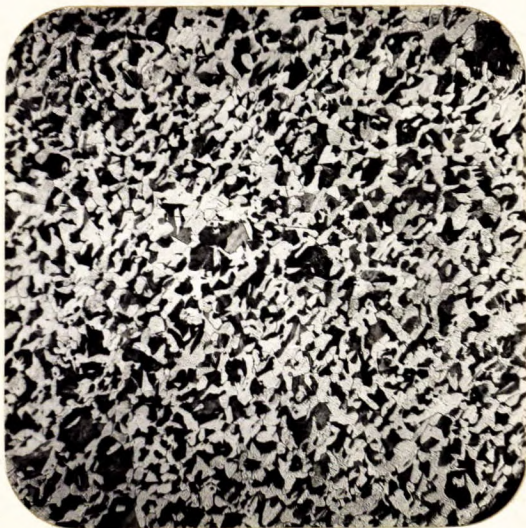
Figure 2.

A lug from a heated and one from an unheated fork end were prepared for the microscope. The structures are shown, at magnifications of 200 diameters, in Figures 2 and 3. These show no significant difference in microstructure.

X200, picral etch.
PHOTOMICROGRAPH SHOWING
STRUCTURE IN UNHEATED LUG.

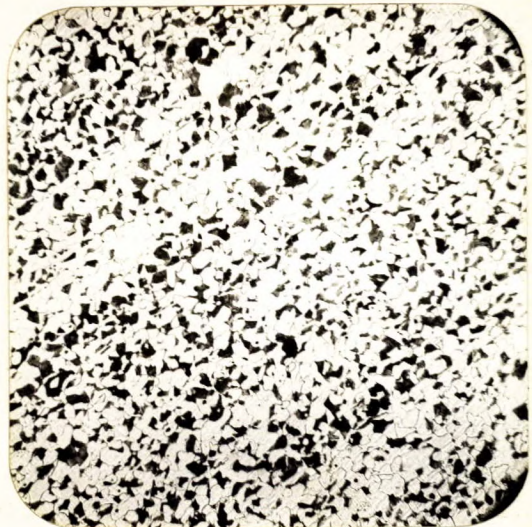
Figure 3.

The temper colours on the heated lugs indicated that the maximum temperature reached was about 200°F.

X200, picral etch.
PHOTOMICROGRAPH SHOWING
STRUCTURE IN HEATED LUG.
