July 21, 1943.

ORE DRESSING AND METALLURGICAL LABORATORIES.

Investigation No. 1458

Examination of Brass Tubes.

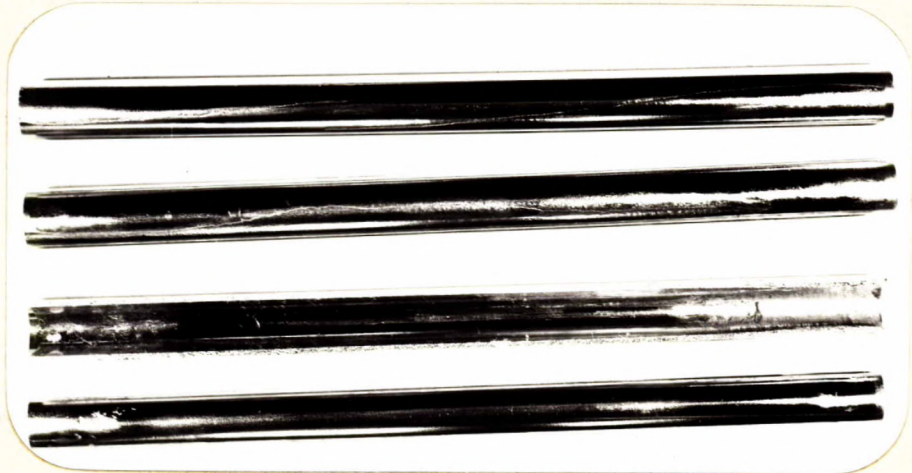
FIGURE 1.

All samples showed considerable cracking along the full length of the tubes. Fig. 1 shows the character of the cracks. After light hammering, one tube split (Fig. 1, bottom).

Samples after Mercurous Nitrate test.  
(Approx.  $\frac{1}{2}$  size.)

The examination showed that the submitted tubes conform to the chemical composition and physical requirements but failed in the mercurous nitrate test.

This failure is due to lack of proper stress-relief heat treatment of the finished brass tubes.
