ORE DRESSING AND METALLURGICAL LABORATORIES.

Investigation No. 1462.

Welded Packard Merlin Engine Exhaust Stubs
for Mosquito Aircraft.

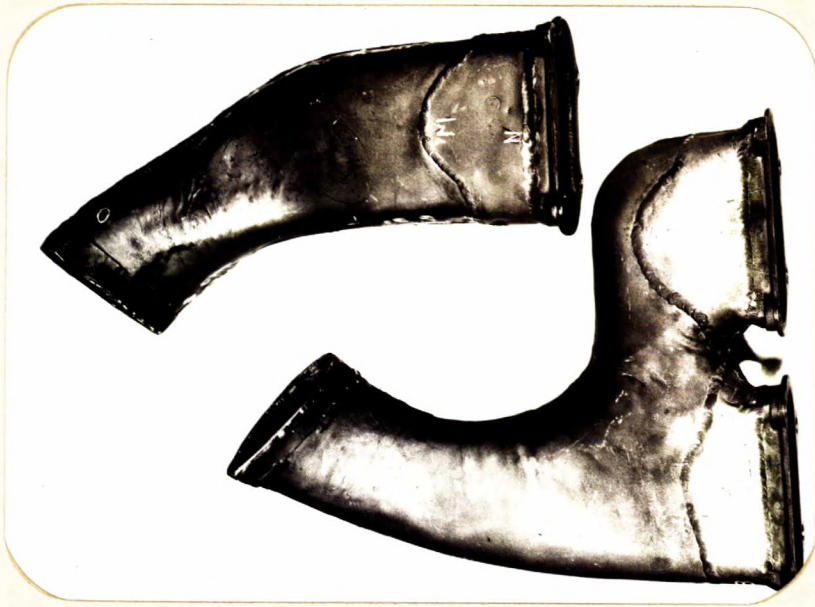
Figure 1.

GENERAL SHAPE OF SINGLE AND DUAL STUBS.

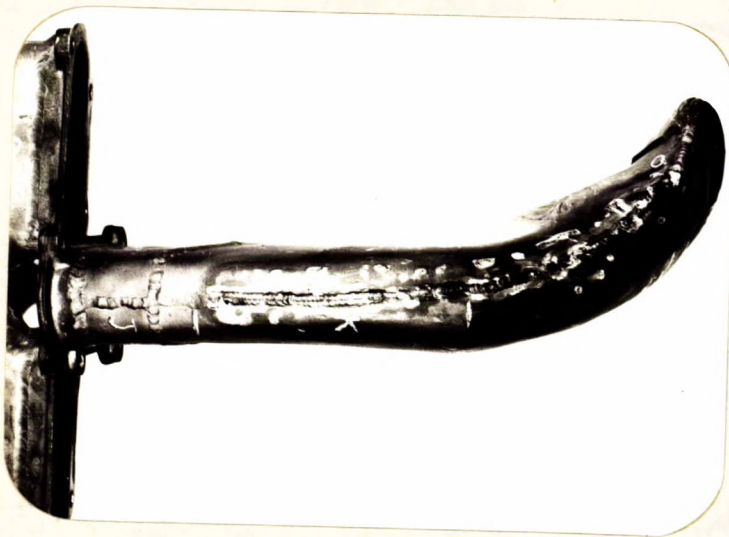
Figure 2.

Both photographs and exographs show very irregular thickness of welds. Set No. 2 has been re-welded, this set shows the maximum variation in this respect. The high, piled up weld resulting from re-welding merely acts as a stress-raiser and only increases the probability of failure in service. Welding over a defect only masks the defect and does not correct it.

CLOSE-UP OF WELD.

Note irregular thicknesses.

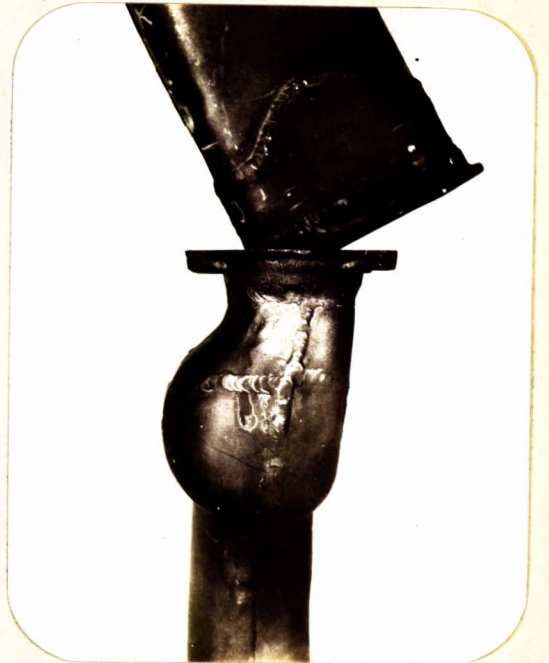
Figure 3.

CLOSE-UP OF WELD.

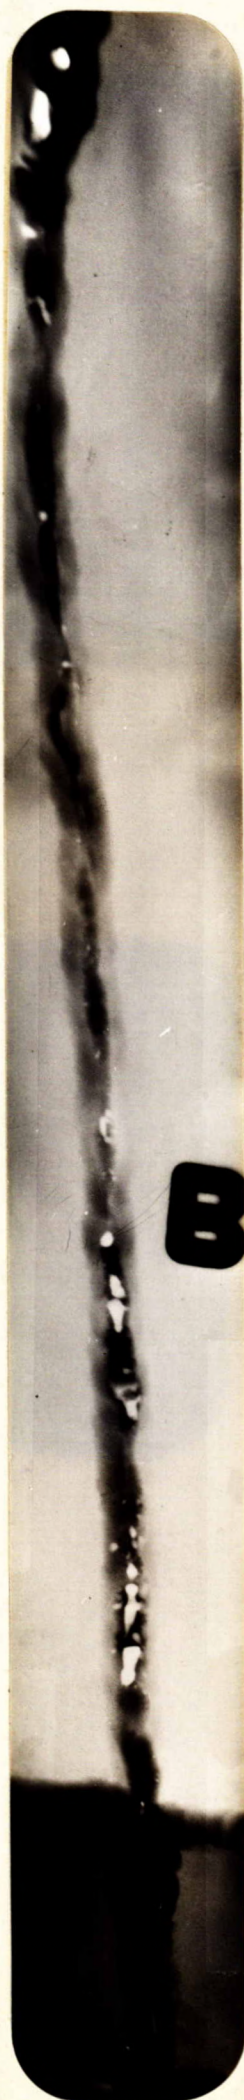
Figure 4. Set No. 1.

PRINT OF EXOGRAPHS OF A
LONG WELD. WHITE SPOTS
ARE GAS INCLUSIONS.

Note irregular thickness
of weld shown by varying
shades of grey.

4. To prevent gas inclusions, puddling of the molten pool should be forbidden.

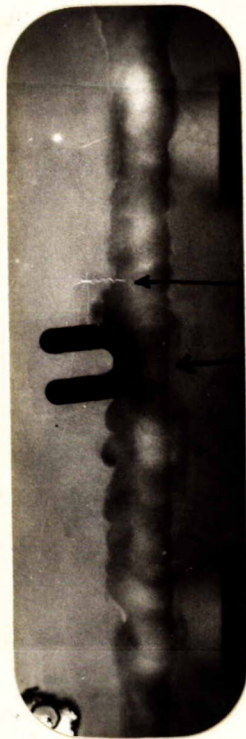
Figure 5.

Crack.

Unfused edge of sheet. Lack of penetration.

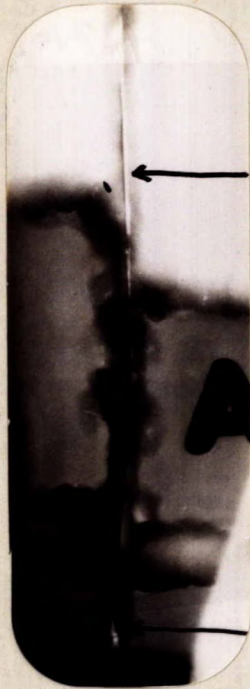
Figure 7.

Unfused sheet edges. Lack of fusion and penetration.

Crack.

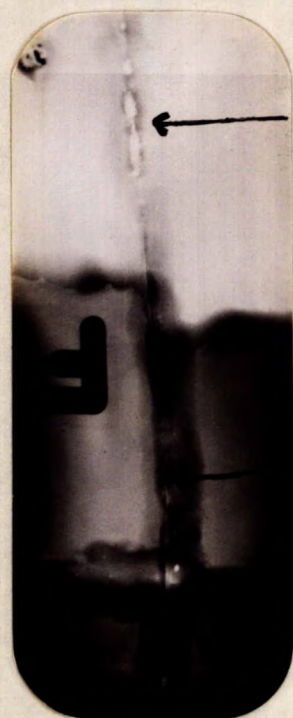
Figure 8.

Lack of penetration.

Crack.

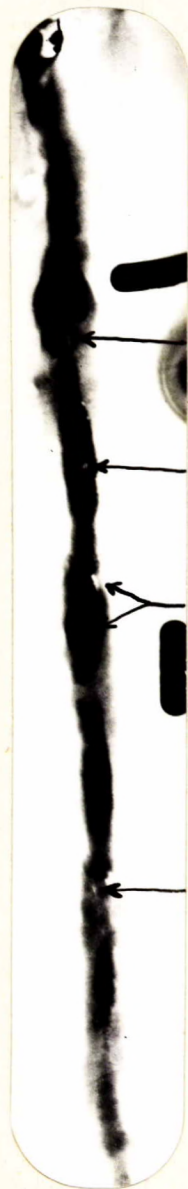
Figure 9.

Lack of fusion.

Gas inclusion.

Crack.

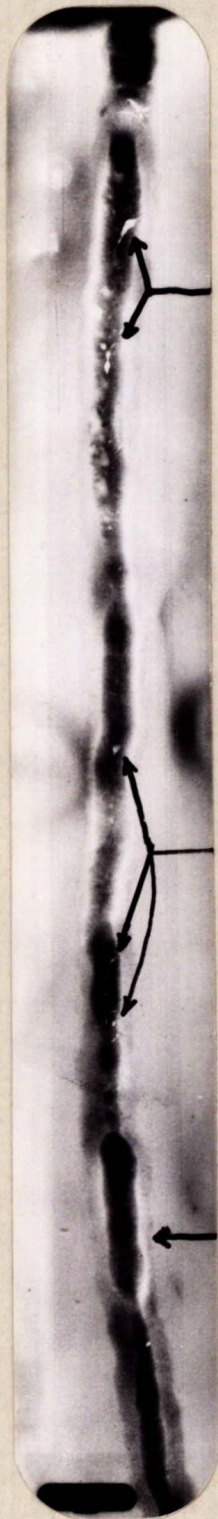
Figure 10.

All white spots are gas inclusions.

Gas inclusions.

Severe reduction of plate thickness
adjacent to a high-piled up weld.

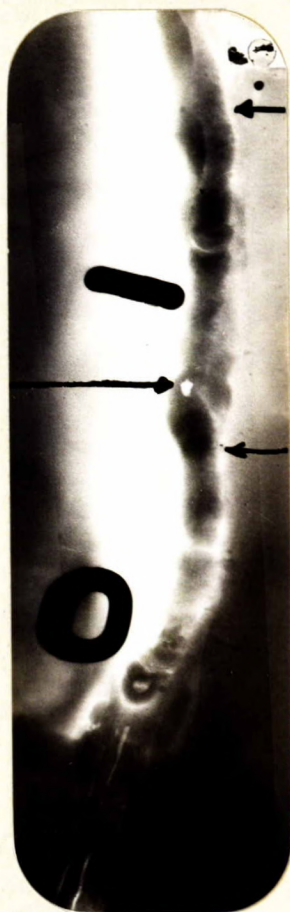
Figure 11.

Lack of fusion.

Gas inclusion.

Severe reduction in plate thickness adjacent to a high, piled-up weld.

Unfused sheet edges - lack of penetration.

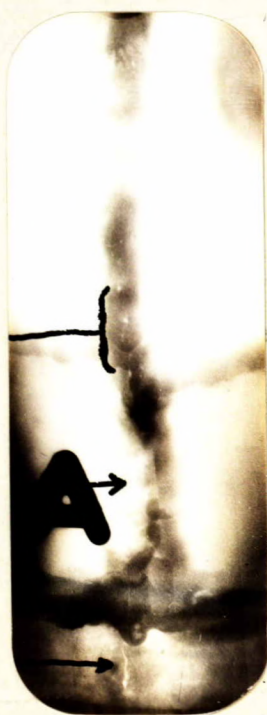
Figure 12.

Gas inclusions.

Lack of fusion.

Crack.

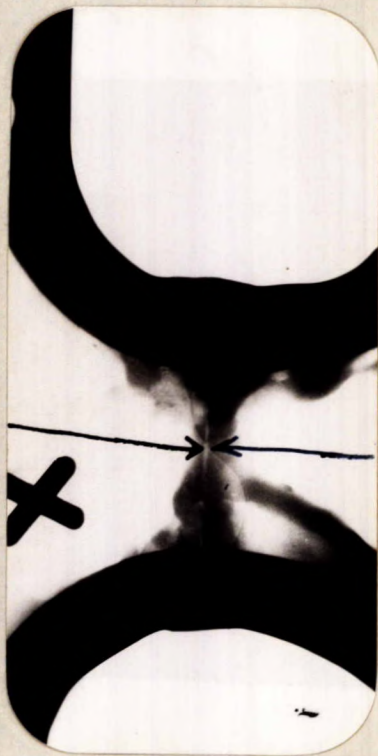
Figure 13.

Mechanical gouge under weld.

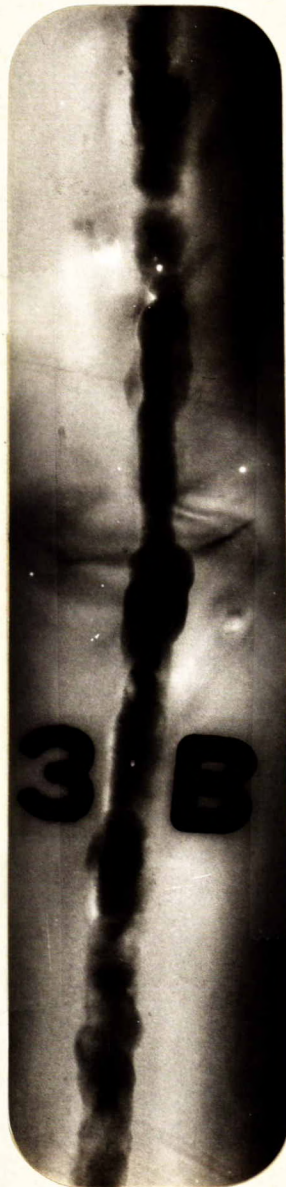
Figure 14.

partly to welding both sides of the joints and partly to better alignment. However, some gas inclusions are evident and it is our opinion that these constitute a borderline condition. As a standard, Set No. 3 would be representative of the absolute minimum of acceptability.

White spots are gas
inclusions. Weld fairly
irregular in thickness.

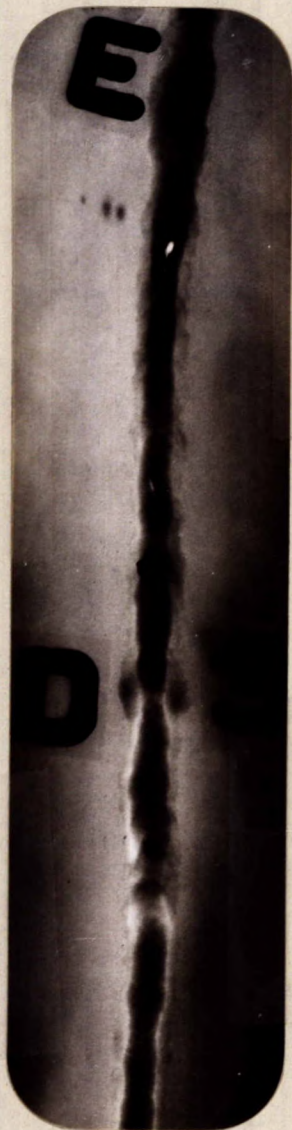
Figure 15.

9. Severe reduction of plate thickness adjacent to welds is due to the "sucking in" of too much metal into the weld.

White spots are gas inclusions. White lines along edges of weld (towards bottom of print) indicate "sucking in" of too much plate metal into weld.

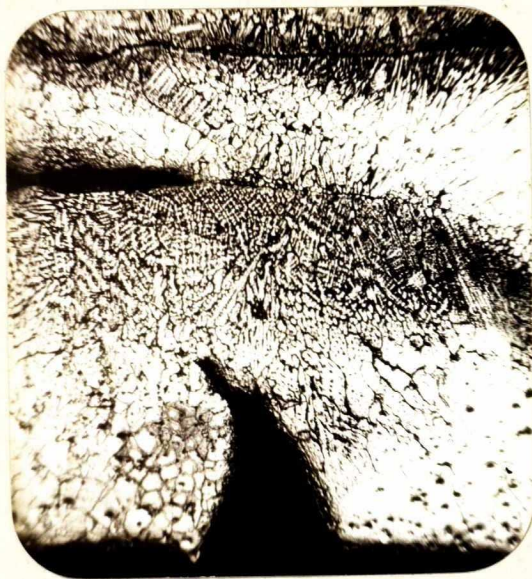
Figure 16.

10. Mechanical gouges are the result of careless handling of the material either before or after welding.

MECHANICAL GOUGE IN SHEET MATERIAL.

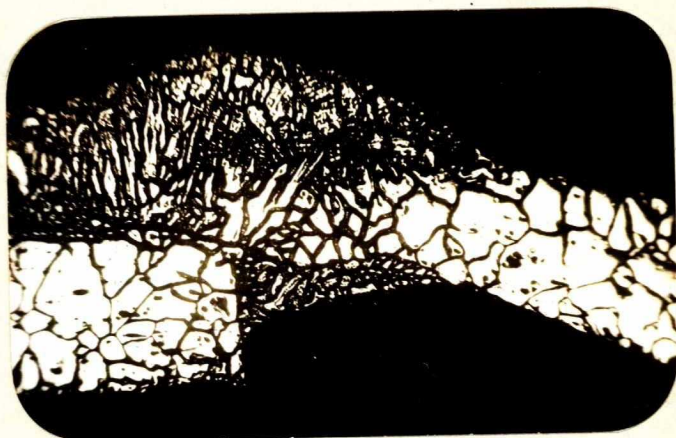
Figure 17.

3. Misalignment of welded plate edges indicates that the jiggling is insufficiently rigid. A visual examination of the stubs reveals that the weld metal on the inside may vary from a thin, sharp film to a broad puddle. If the sections are stamped out of large sheets, this may be due to insufficient allowance for spring-back.

MISALIGNMENT OF SHEET EDGES AND INCOMPLETE PENETRATION.

1. The stubs should be rigidly jiggered for welding, to prevent misalignment of sections and to reduce warpage.

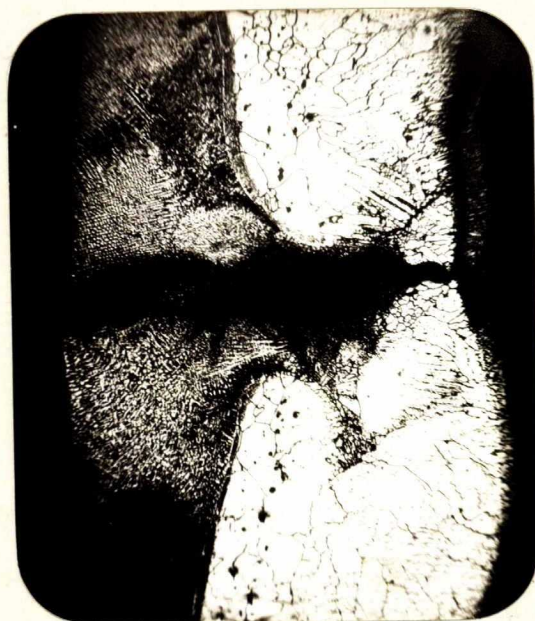
Figure 18.

8. Cracks are due to contraction stresses of cooling weld metal, and originate in weak areas such as those showing lack of fusion or penetration.

CRACKED COMPLETELY THROUGH WELD AND SHEET MATERIAL.

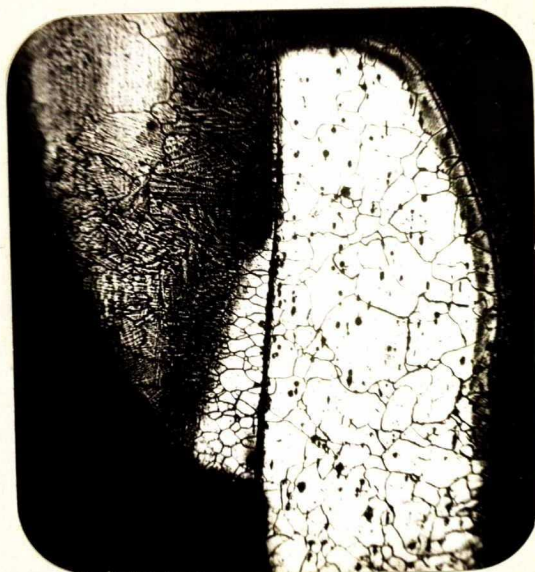
Figure 19.

5. Lack of fusion is probably due to incomplete removal of the oxide from the surfaces to be welded, or to insufficient heat input.

LACK OF FUSION BETWEEN WELD AND SHEET MATERIAL.

3. Sheet edges to be welded should be meticulously cleaned by mechanical means, to remove the tightly clinging oxide. This would eliminate the main cause of lack of fusion.

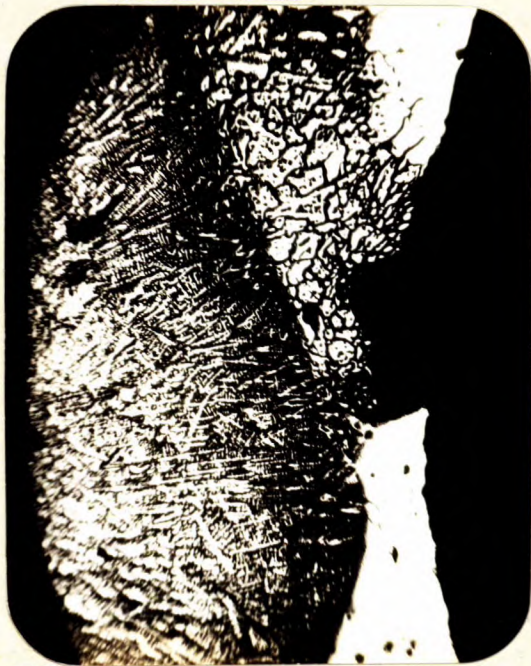
Figure 20.

6. Lack of penetration is due to insufficient heat input or to too high a welding speed.

INCOMPLETE PENETRATION,
RESULTING IN A NOTCH AT THE
BASE OF THE WELD. ALSO SMALL
GAS INCLUSIONS.

2. A root gap of 1/16 in. should be used to permit complete penetration of the weld metal, using a back-up bar if necessary.

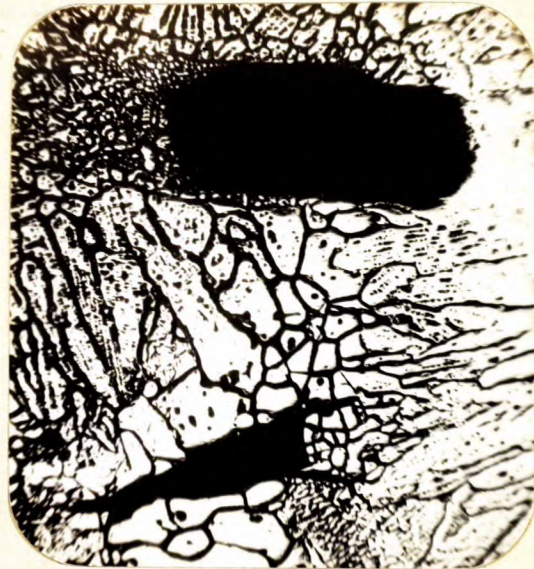
Figure 21.

COMPLETE LACK OF PENETRATION
SHEET EDGES UNFUSED. ALSO
CRACK.

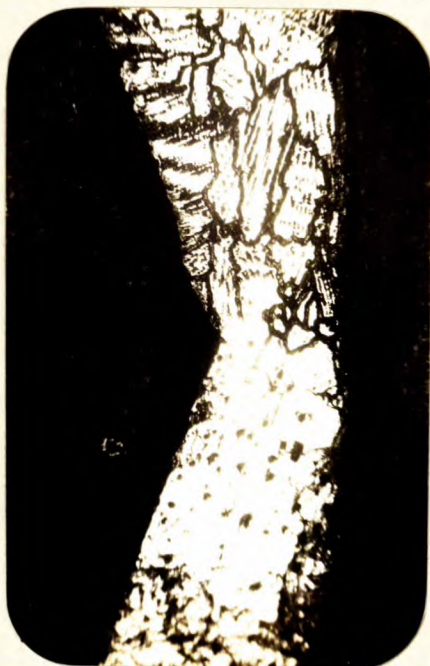
Figure 22.

SEVERE REDUCTION IN SHEET
THICKNESS ADJACENT TO A
WELD.

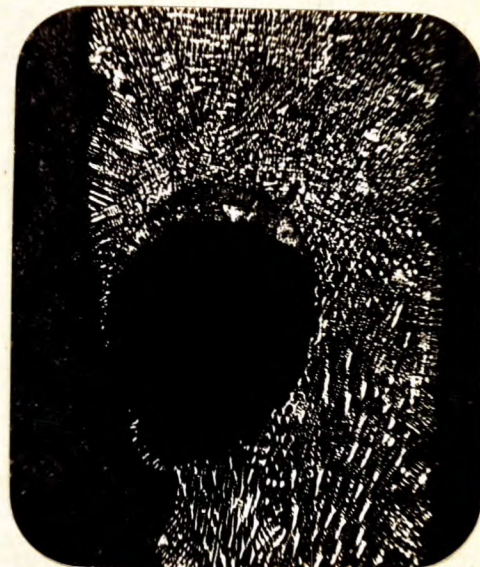
Figure 23.

7. Gas inclusions are due to "puddling" the molten metal, which burns out the deoxidizing elements and results in brittle and gassy welds.

GAS INCLUSION IN WELD .
