CANADA
DEPARTMENT
OF
MINES AND RESOURCES
Mines and Geology Branch

Investigation No. 1463.

Examination of British Maddock Malleable
Iron Universal Carrier Track.

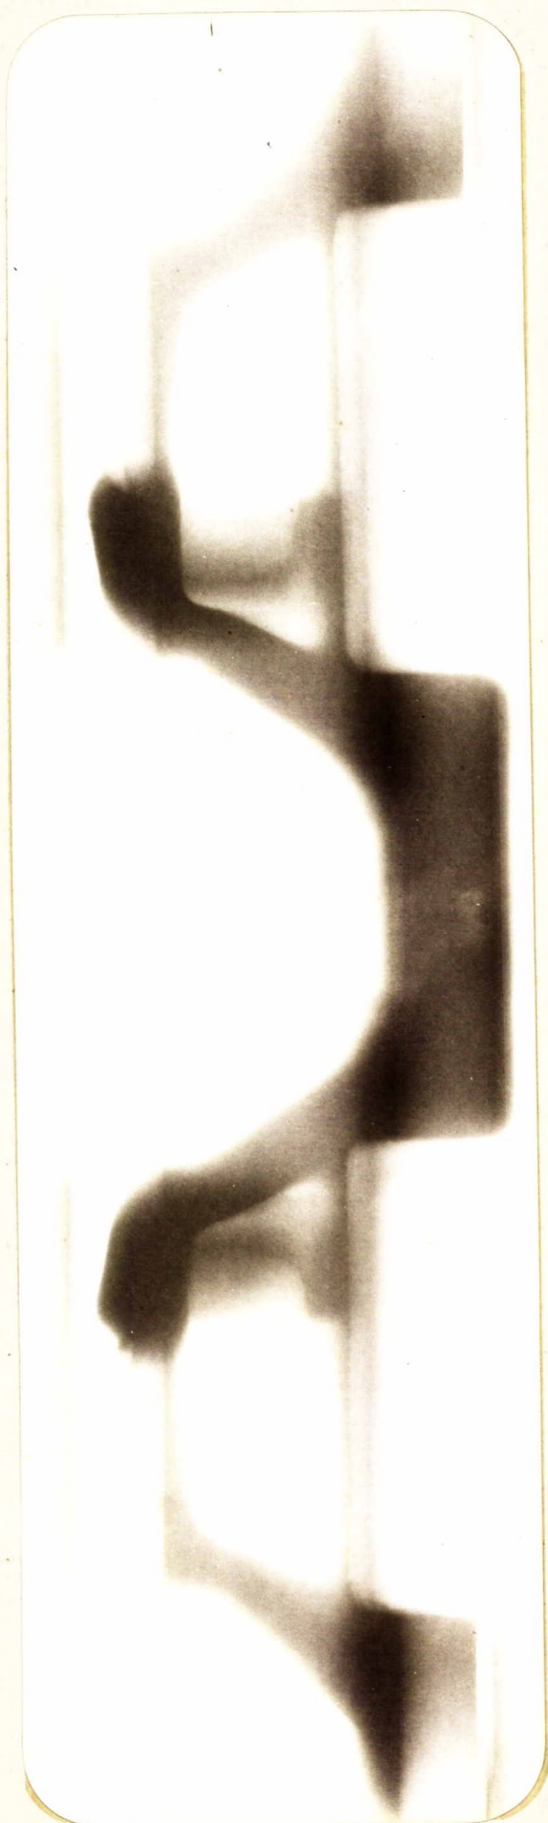
Figure A.

Three links were X-rayed at the National Research Council (Ottawa). Several small cavities were present in the base of the eye-hole wall of the middle eye on the three-eye side of the link. Figure A is a positive of one of the X-ray pictures, illustrating the small cavities.

Some small cavities are present in the upper part of the grouser at the centre eyehole on the three-eye side of the link. This, however, should not have any deleterious effect on the service of the link.

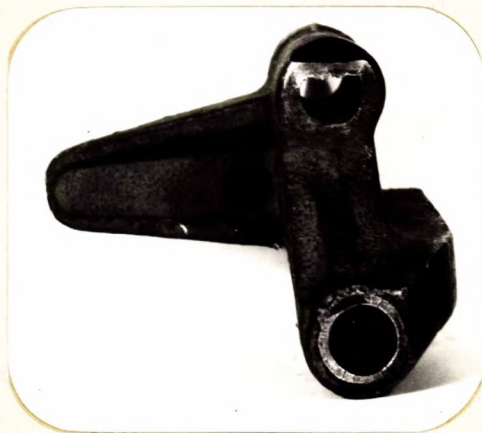
Figure 3.

A link is considered to have sufficient ductility and toughness when the eye-holes will withstand the blows of a hammer until they are two-thirds of their original diameter. Four out of five links tested passed. Figure 3 illustrates the eye-hole of a link after it has been subjected to this test.

EYE HOLE OF LINK - AFTER HAMMER TEST.

One link failed in the hammer test out of five tried. It would appear from these results that in the process of manufacture a certain number of brittle links are produced.

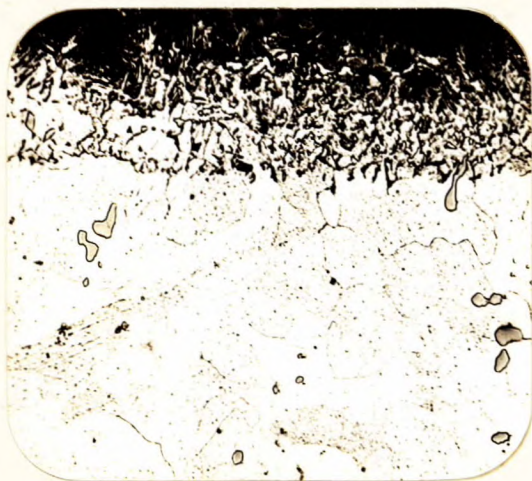
Figure 4.

Transverse microspecimens were cut from several shoes and polished. The unetched specimens indicated the presence of inclusions. Figure 4, photomicrograph at X200 magnification of the nital-etched specimen, illustrates the cyanided case at the eye-hole surface and also the decarburized area immediately below the case. Figure 5 (X200) shows the structure of the link at the centre of its thickest section.

X200, nital etch.
EYE-HOLE SURFACE-CASE AND
DECARBURIZED AREA.

Microscopic examination of the links indicated that the thin sections were almost completely decarburized under the thin cyanided case. The thicker section, such as the internal portion of the grouser, consisted of a higher-carbon area. This part showed a much higher hardness, 321-371 Brinell.

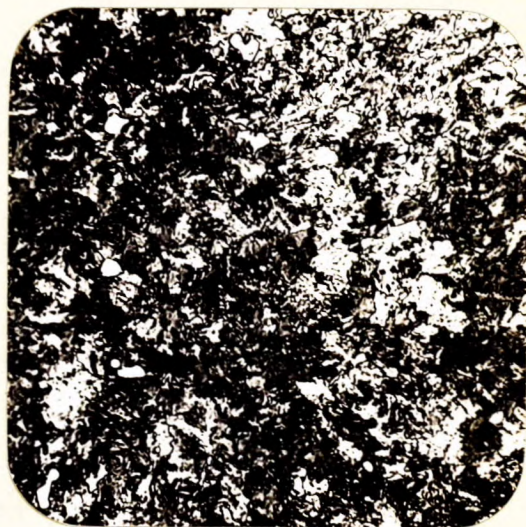
Figure 5.

X200, nital etch.
CORE OF LINK

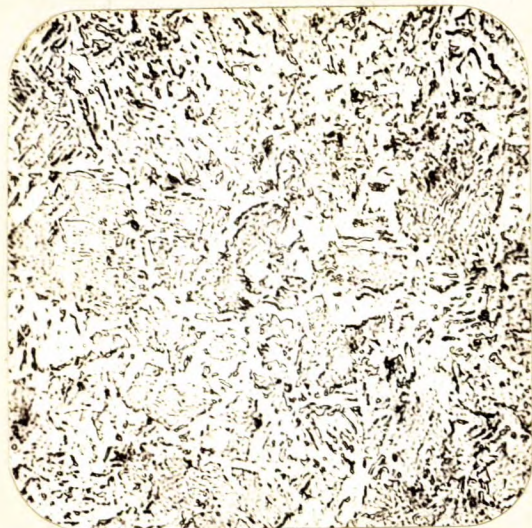
Figure 6.

X500, nital etched.
CORE OF PIN.

The core structures given in Figures 6 and 7 show the differences, both in the amount and the dispersion of the ferrite encountered in the investigation of these pins. Fineness of core structure as well as of case structure is desirable to produce the strongest type of pin. The case structure shown in Figure 8 is well-refined tempered martensite.

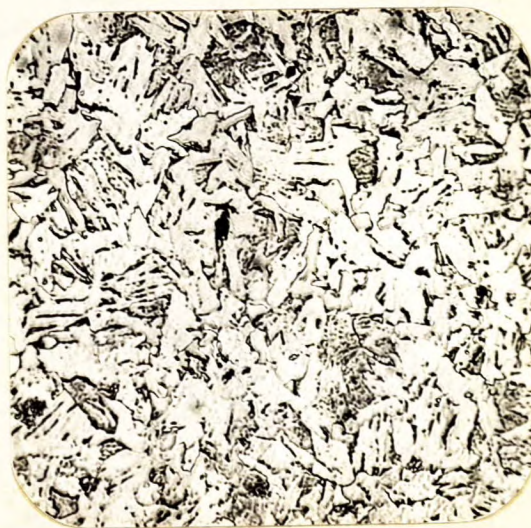
Figure 7.

X500, nital etched.
CORE OF PIN.

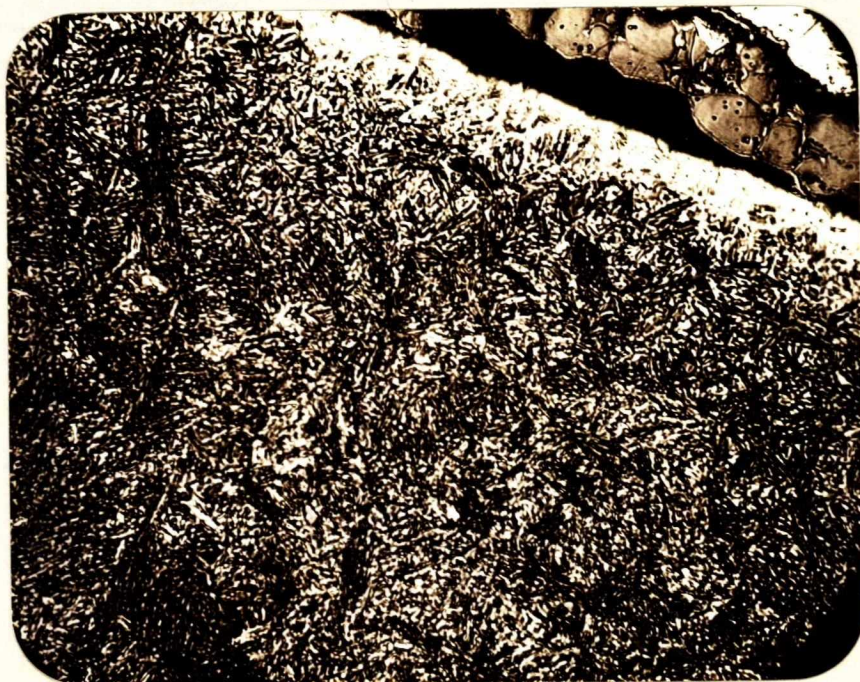
Figure 8.

CASE OF PIN.

Tempered Martensite.
