R E P O R T
of the
ORE DRESSING AND METALLURGICAL LABORATORIES.

Investigation No. 1465.

Examination of Aluminum Alloy Screws.

CANADA
DEPARTMENT
OF
MINES AND RESOURCES
Mines and Geology Branch

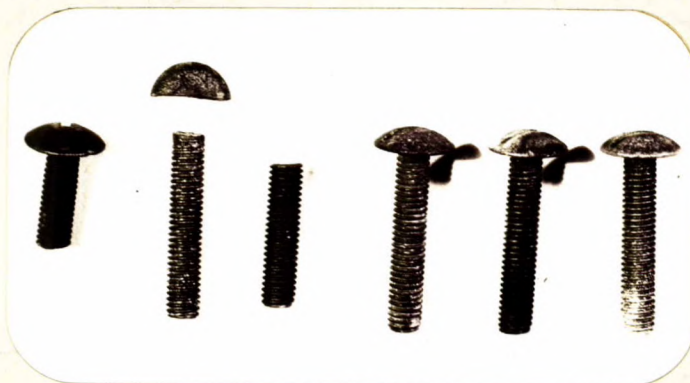
Figure 1.

after heat treatment but before anodizing. These samples included whole, but defective, screws and also broken parts of screws in the condition as released from Precision Heat Treatment Company. Figure 1 shows some of these samples.

HEAT-TREATED SCREWS - AS RECEIVED
(Boxes Nos. 1 and 2)

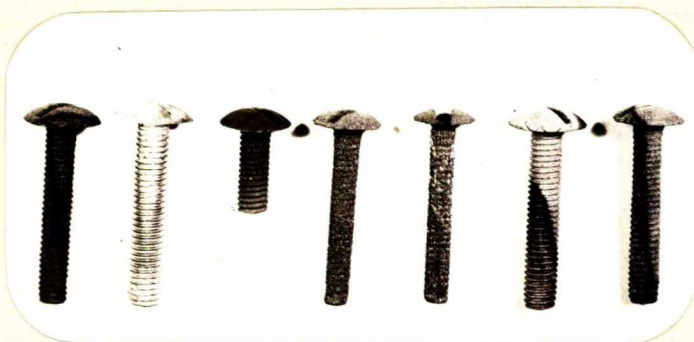
Figure 2.

The remaining part of the samples (Boxes 3 to 10) were submitted after anodizing and as received at Canadian Vickers Limited, as released by the Stowell Screw Company. Many of these screws showed evidence of overheating and were badly corroded in the course of anodizing. Figure 2 shows some of the anodized

HEAT TREATED AND ANODIZED SCREWS - AS RECEIVED.
(Box No. 3)

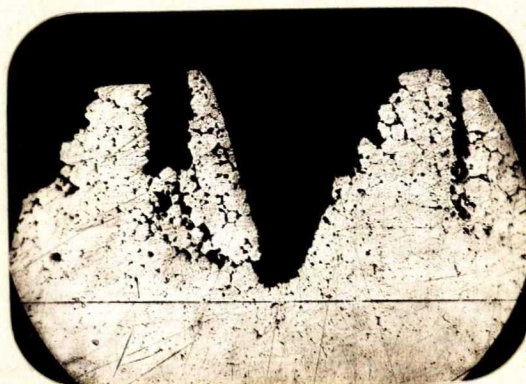
Figure 3.

Figures 3 and 4 show the intercrystalline corrosion
on the surface of the threads of overheated screws (Box No. 2).

OVERHEATED SCREW.
(Box No. 2)

Overheated (burnt) material is useless and can be used only as scrap for remelting purposes.

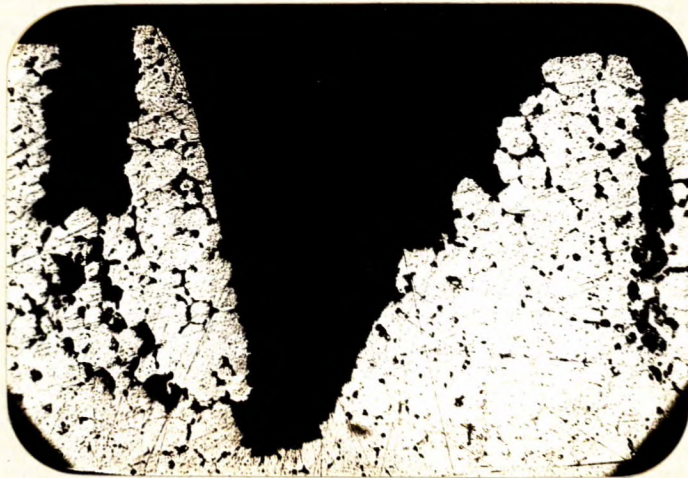
Figure 4.

THREADS OF OVERHEATED SCREW.
(Box No. 2)

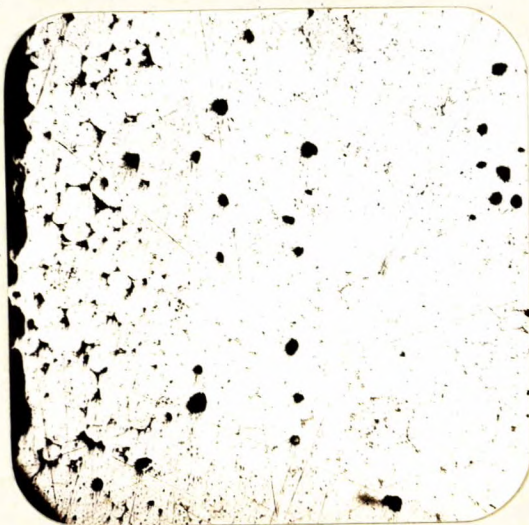
Figure 5.

Figures 5 and 6 show the typical structure of overheated ("burned") material of the duralumin type, as found on screws from Box No. 2.

EDGE OF SCREW HEAD.
(Box No. 2)

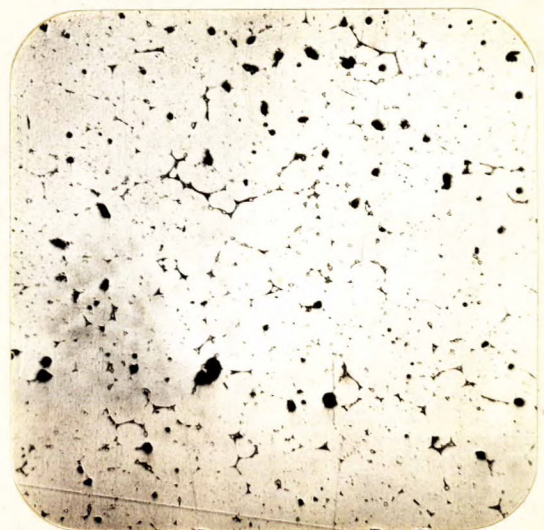
Figure 6.

INSIDE STRUCTURE OF OVERHEATED SCREW.
(Box No. 2)

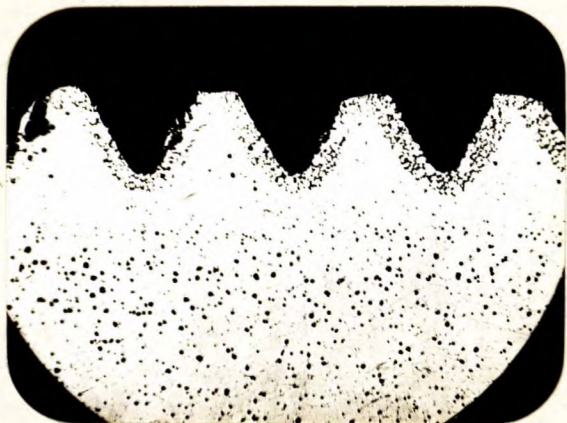
Figure 7.

Figures 7 and 8 show cross-sections of overheated and subsequently anodized screws.

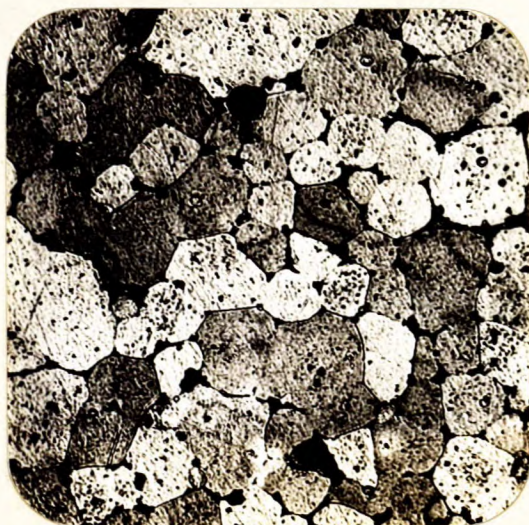
Figure 9.

Figure 9 shows the microstructure of an overheated screw from Box No. 2, Figure 10 the microstructure of overheated and anodized material (near the edge).

X250, Keller's etch.
OVERHEATED SCREW HEAD.

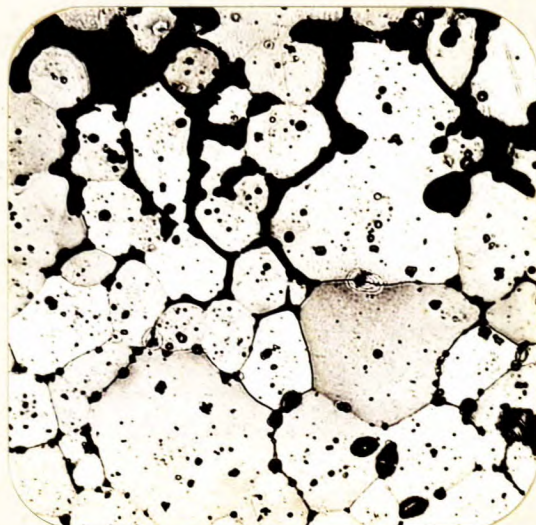
Figure 10.

X250, Keller's etch.
OVERHEATED ANODIZED SCREW.
