R E P O R T  
of the  
ORE DRESSING AND METALLURGICAL LABORATORIES.

Investigation No. 1474.

Examination of Defective Canadian  
Dry Pin Track Shoes.

August 12, 1943.

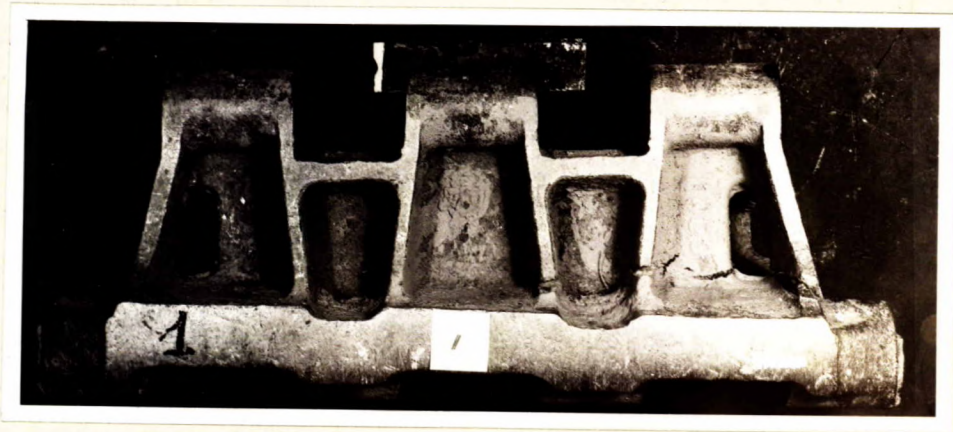
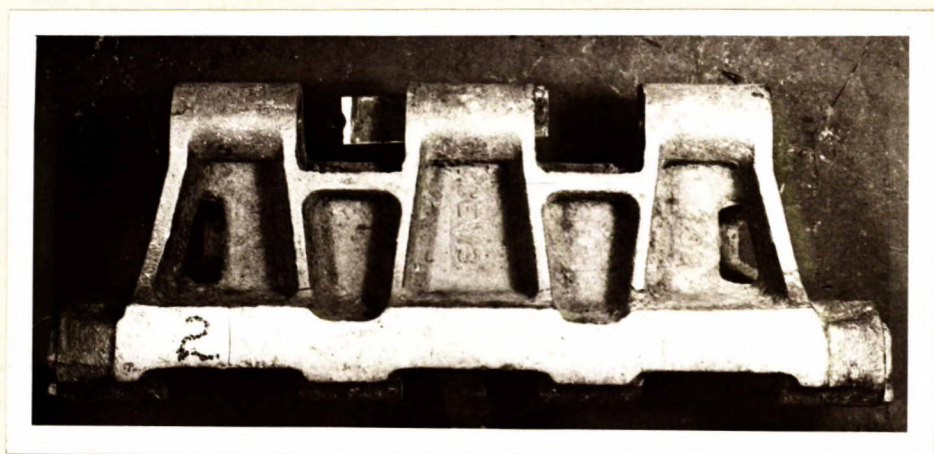
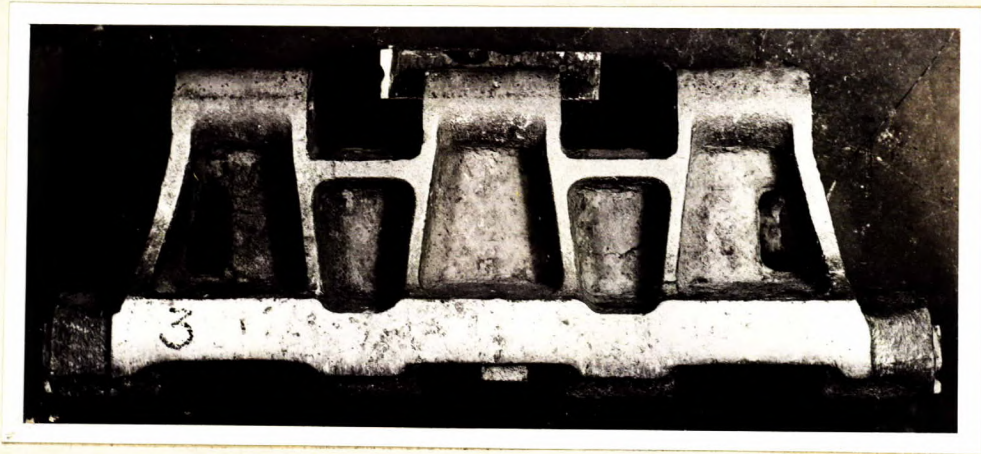
Figure 1.

Failure occurred in the ribbed sections of all the links close to the grouser. Figures 1,2,3, and 4 illustrate the cracks in each of the five links. Figure 5 shows a crack which has opened up considerably in the outside rib of one of the links. A link which had cracks in all the ribs

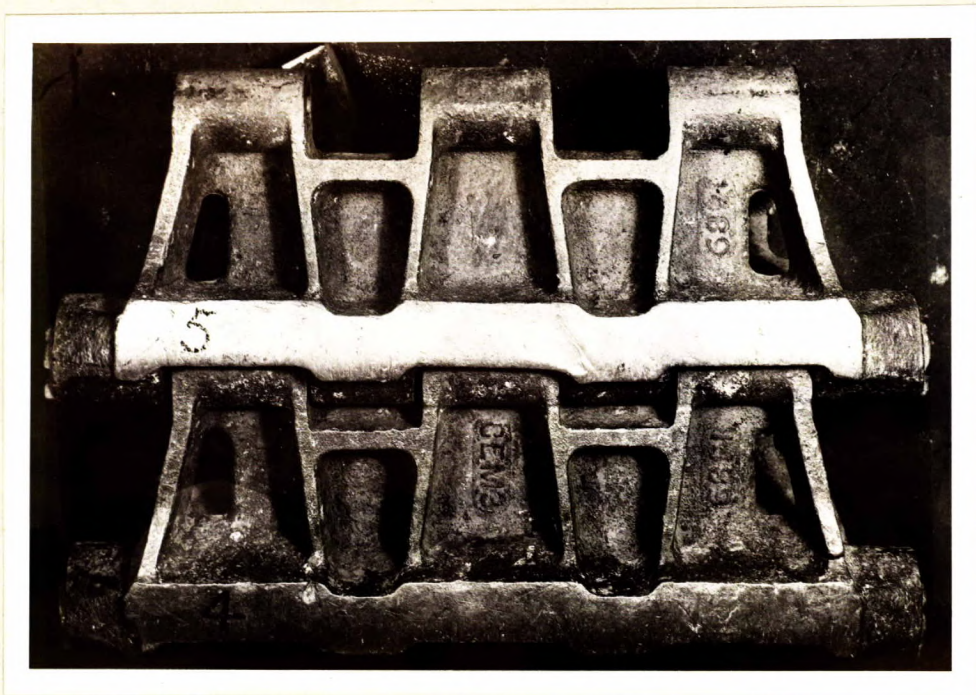
Figure 4.

Links numbers 4 and 5 (Figure 4) were X-rayed at the National Research Council. No abnormalities were observed in the ribs which could not be seen visually.

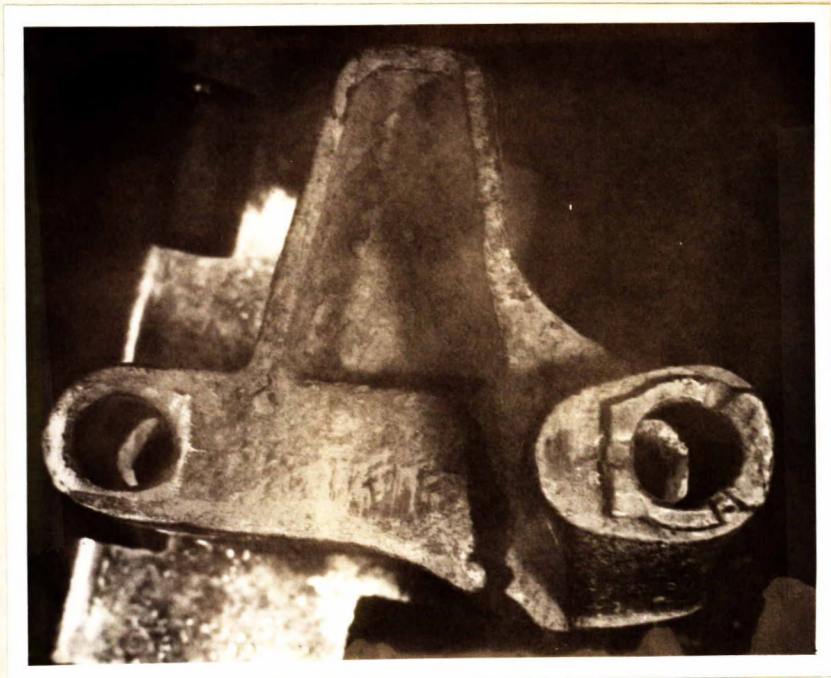
Figure 6.

but one was subjected to a pull test. Figure 6 shows the fractured surfaces of the ribs after this test. The ribs having the cracks in them prior to the test show the metal to be dendritic at the point of fracture. The one which was not cracked has a uniform structure. The pictures are approximately 1/3 the normal size of the links.

The chemical analysis shows that these links were cast in austenitic manganese steel of satisfactory composition. The dendritic structure at the point of fracture illustrated in Figure 6 suggests that an unsatisfactory foundry condition exists, since the abnormal portion of the fracture exhibited a dendritic structure. This would be caused by either shrinks or hot tears. Due to the position at which these occur it is felt that hot tears are the most likely cause. Hot tears are usually produced by cores with insufficient collapsability.

1. Austenitic manganese steel of a satisfactory composition was used in casting the links.
2. A dendritic structure is present in the ribs where failure occurred. This indicates that the rib fractures may be hot tears.
3. Cores which have too great strength at high temperatures cause hot tears.
4. Possibility of cracks produced by severe quenching or improper time temperature cycle in the furnace must not be ruled out as only a few links were investigated.
5. The links received an unsatisfactory heat treatment as free carbides were present.

1. Close inspection in the foundry should be initiated to determine whether rib cracks occur in casting in heat treatment.
2. Elimination of the hot tears should be effected by control of core manufacture.

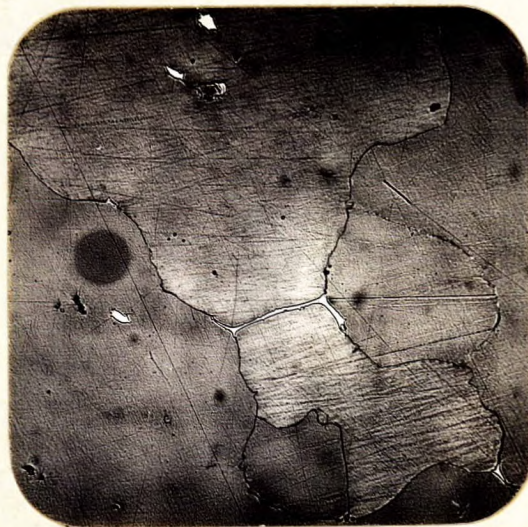
Figure 7.

Samples for microscopic examination were cut from several links. Sections were cut transversely across the grouser and also through the ribs. Free carbides were evident in all the nital etched specimens examined. Figure 7, taken at X100, of a section through the grouser shows carbides both in the grains and at the grain boundaries. Figure 8 (X500) shows carbides in a section taken from a rib.

X100. Nital Etched.  
Grouser Section.  
(Note free carbides-white constituent)

evident both around the grain boundaries and in the grains themselves. These were more prevalent in the thicker section (e.g. grouser, Figure 7). This precipitation of free carbides may be due to:

- (1) Insufficient soaking time at the proper temperature, 1830°F-1940°F.
- (2) Too low a temperature in the heat-treat furnace.
- (3) Improper quench.
- (4) Links being allowed to cool prior to the quench.

Elimination of free carbides (especially at the grain boundaries) is essential in order to produce a satisfactory link. It is well known that free carbides produce brittleness.

3. The heat treatment should be checked in order to eliminate the precipitation of free carbides.

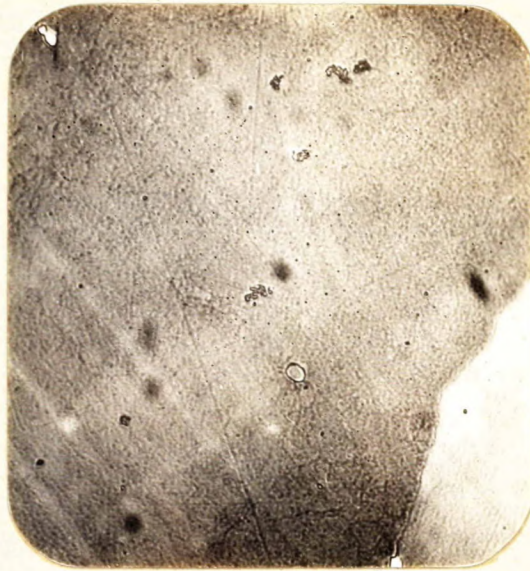
Figure 8.

X500. Nital Etched.  
Rib Section.  
(Note showing of free carbides at two points)
