O T T A W A August 17th, 1943.

R E P O R T
of the
ORE DRESSING AND METALLURGICAL LABORATORIES.

Investigation No. 1476.

Examination of Cracked Gun Steel Ingots from
the Dominion Foundries and Steel Limited,
Hamilton, Ontario.

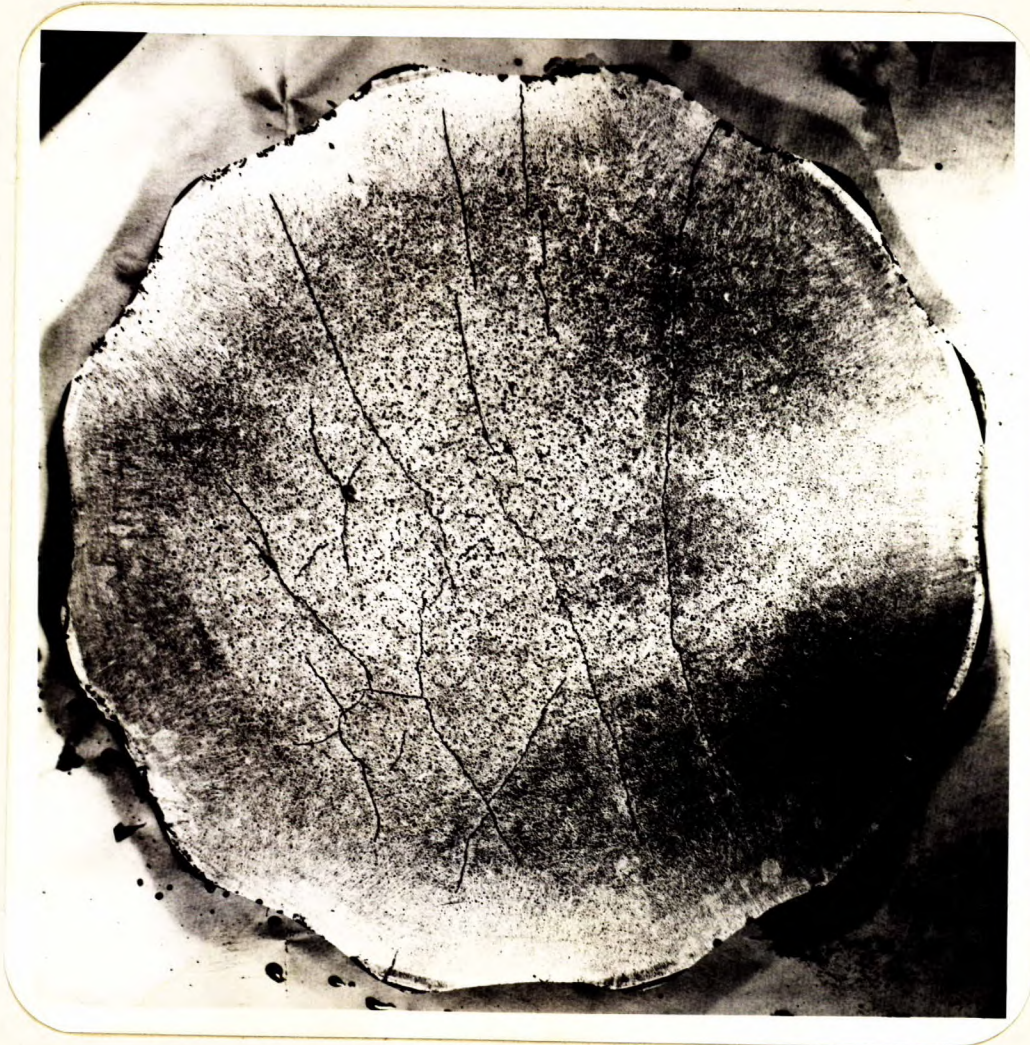
Figure 1.

1. The two smaller sections were deep-etched with 50 per cent muriatic acid, 10 per cent nitric acid in water for 24 hours. Figure 1 is a photograph typical of the two sections after etching.

A visual examination of the sections (see Figure 1) would seem to indicate that there is more than one cause of cracking in the ingots. A great many cracks are confined to the central two-thirds of the ingots. This is typical of

cracks resulting from too rapid cooling or too rapid reheating to rolling temperatures, producing high thermal stresses. In addition, the ingot surface is very rough, indicating the use of a fire-checked mould. The impeded contraction on cooling, caused by the metal being locked in the mould surface depressions, results in cracks in the centre of the flutes. Unless the metal is free to contract away from the mould walls, the contraction stresses will readily tear the hot metal.

SMALL SECTION OF INGOT AFTER DEEP ETCH;
TYPICAL OF BOTH SECTIONS.

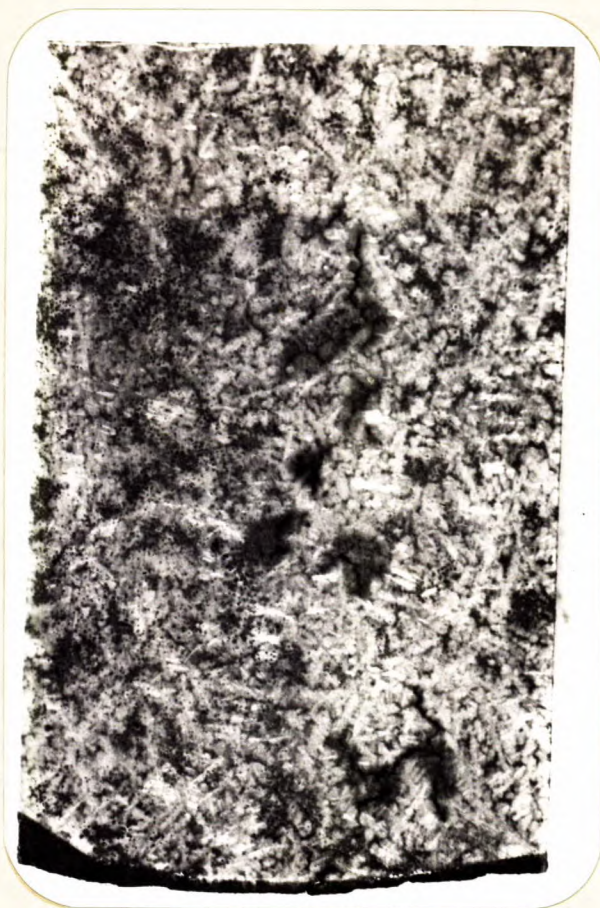
Figure 2.

3. A small section, half-way to centre, was polished and given a light deep etch. Figure 2 shows this section after etching.

The light deep etch shows intercrystalline cracking. A microscopic examination of the central and half-way-to-centre specimens reveals gas segregation at the boundaries of the primary austenite grains. In a great number of cases these gas holes have linked up to form cracks which, of course, follow the grain boundaries. These gas holes occur only inside the area rapidly chilled by the ingot mould. This is to be expected from the mechanics of cooling. The outer layers of the ingot are cooled rapidly and the gases are entrapped in the rapidly cooling steel and have no opportunity to segregate. As shown by the fracture tests, hydrogen in the outer layers has had no chance to diffuse away. In the central regions of the ingot the rate of cooling is slower and the gases, coming out

X3, etched in 50 per cent hydrochloric acid.
LIGHT DEEP-ETCHED SECTION, HALF-WAY TO CENTRE.
Note numerous intercrystalline cracks.

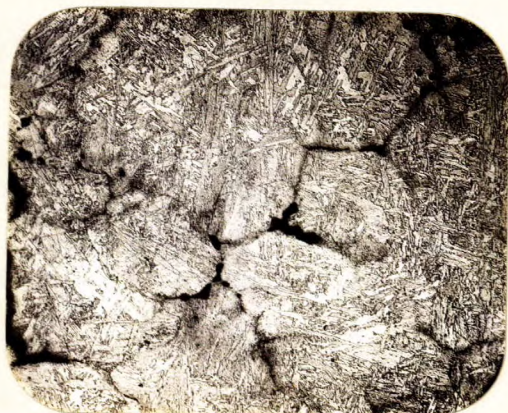
4. Specimens from the outside, half-way to centre, and centre, were polished and examined under the microscope. Figure 3 is a photograph of a condition common to the central and half-way-to-centre specimens. Figure 4 shows a fracture as a result of the condition shown in Figure 3. Figure 5 shows a sulphide stringer in a grain boundary, a frequent condition throughout the ingot.

1. The cracking of these ingots is not due to chemical segregation.
2. Gas occlusion and precipitation at grain boundaries is responsible for the intercrystalline cracking

X100, etched in
2 per cent nital.
GAS HOLES AT
GRAIN BOUNDARIES.

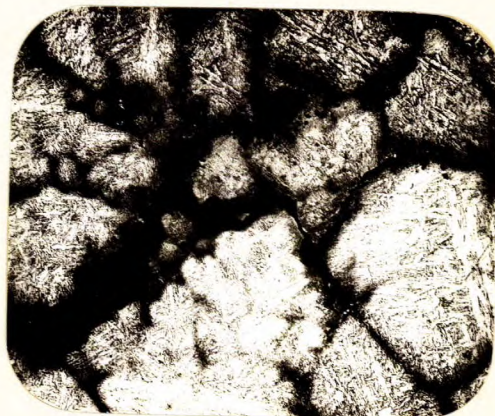
Figure 4.

X100, etched in
2 per cent nital.
CRACK RESULTING FROM
LINKING UP OF GAS HOLES.

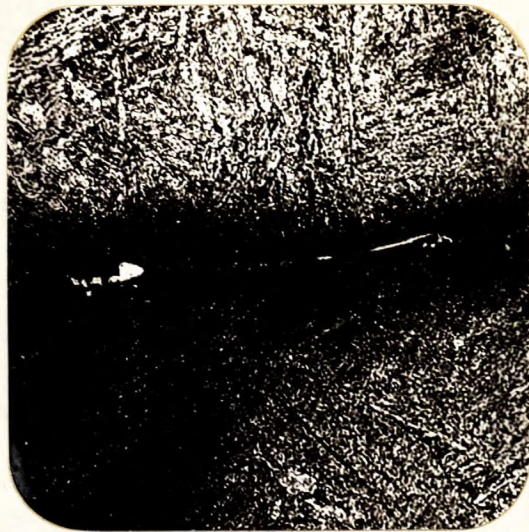
Figure 5.

In the central two-thirds of the ingot numerous long stringers of sulphides in the grain boundaries were found; these would reduce the impact strength at high temperatures. The fact that these sulphides appear as long stringers, and not as globules, indicates that the rate of cooling of the ingot in the ingot mould was fairly rapid.

X250, etched in 2 per cent nital.
SULPHIDE STRINGER IN GRAIN BOUNDARY.

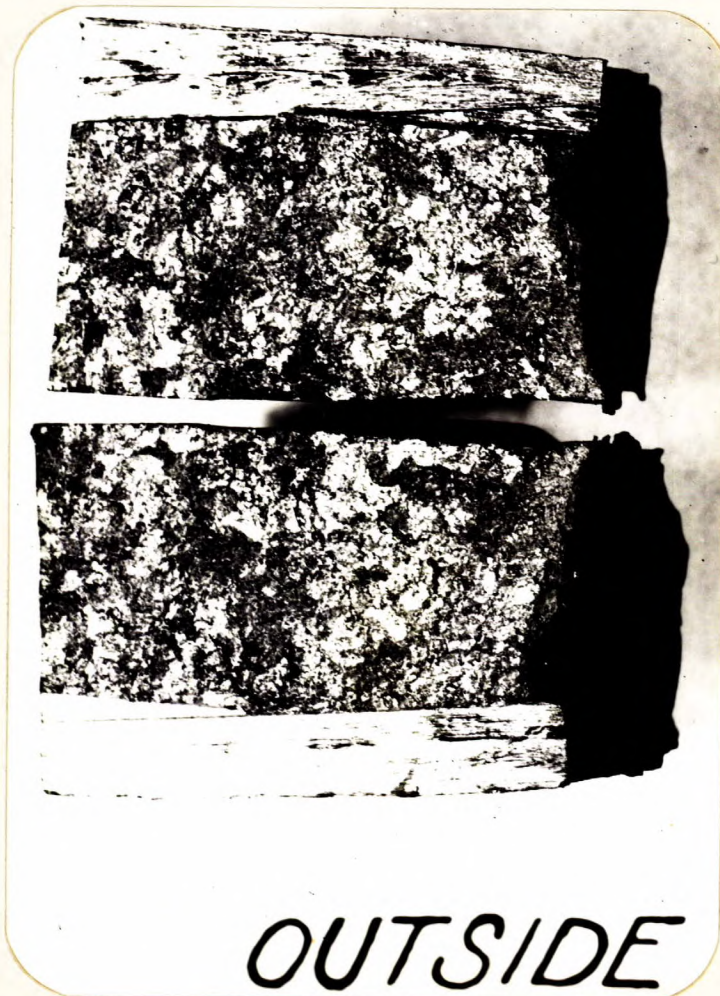
Figure 6.

5. Fracture tests were made on specimens machined from the above locations. Figures 6, 7, and 8 show the types of fractures obtained.

The fracture tests all show the bright areas of hydrogen occlusion. The hydrogen has probably resulted from accidental contamination in the furnace or, possibly, from pouring during high-humidity weather conditions. It is well recognized that steels of this type very readily absorb hydrogen and special precautions are necessary in their manufacture. The low gas contents shown by the gas analyses are not surprising in view of the badly cracked condition of the steel. Gases trapped in the cooling steel have numerous avenues of escape to the outside of the ingot. In addition, the flame-cutting of the samples would greatly assist the escape of the gases. It should also be recognized that the present-day method of gas analysis of steels is not consistently reliable and much work remains to be done in this field.

FRACTURED SPECIMEN SHOWING
TYPICAL BRIGHT AREAS DUE TO HYDROGEN.

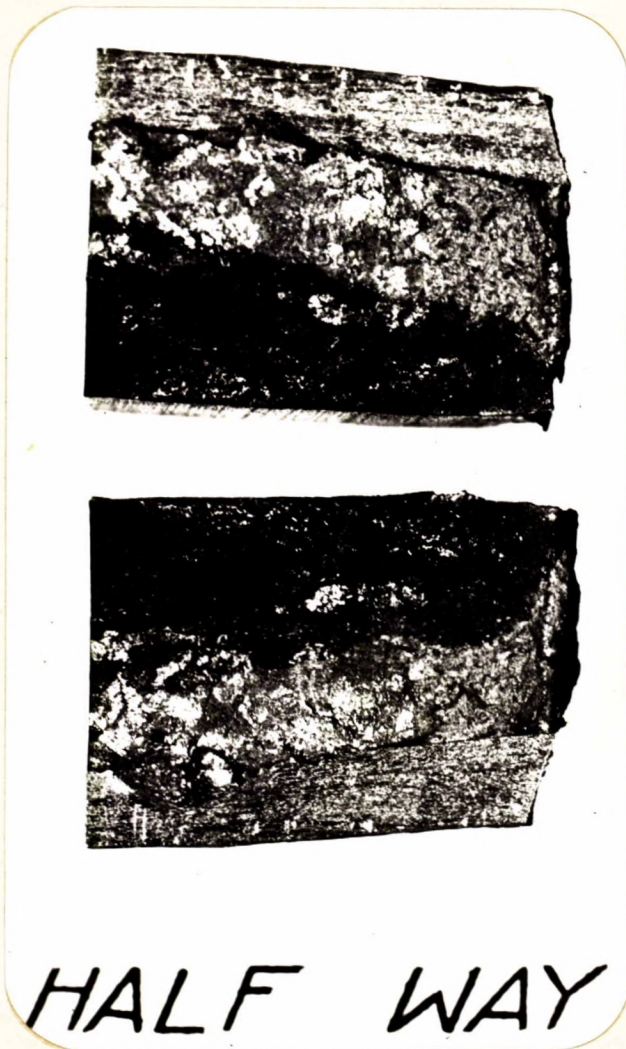
Figure 7.

FRACTURED SPECIMEN SHOWING
TYPICAL BRIGHT AREAS DUE TO HYDROGEN.

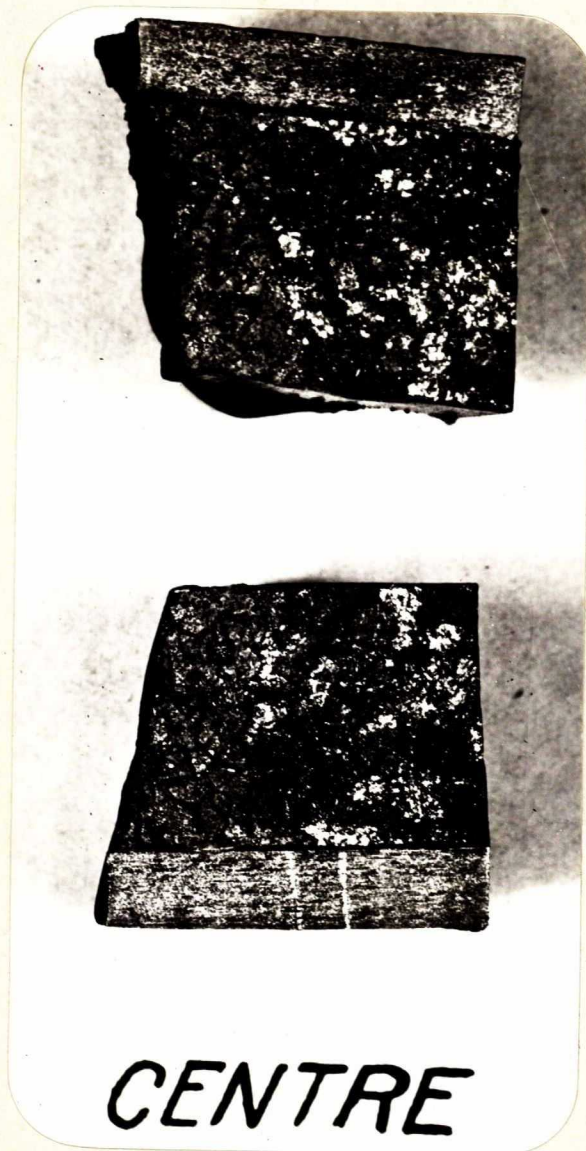
Figure 8.

FRACTURED SPECIMEN SHOWING
TYPICAL BRIGHT AREAS DUE TO HYDROGEN.
