ORE DRESSING AND METALLURGICAL LABORATORIES.

Investigation No. 1479.

Examination of Aluminium Alloy Rivets Suspected
of Having Been Overheated.

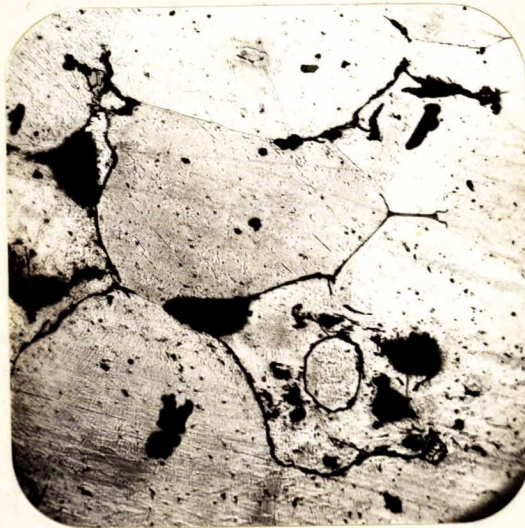
Figure 1.

By visual examination a rivet (of the same general size and finish as the others in that box) which appeared to be porous and rough-surfaced was found in each of Boxes Nos. 1 and 7. In Box No. 7 a porous ball of metal, which was evidently a melted rivet, was seen. A very small rivet in Box No. 4, not at all comparable in size to the others in that box, also appeared to be burnt.

<u>Lot No.</u>	<u>V.H.N.</u>
1 (Porous rivet)	- 45.8
(Normal ")	- 76.6
2 -	- 74.5-79.2
3 -	- 78.3
4 -	- 77.6
5 -	- 76.6
6 -	- 76.8
7 (Porous rivet)	- 45.4
(Normal ")	- 72.5

The rivets from Boxes Nos. 1 and 7, described under "Macro-Examination" as having rough surfaces, were very porous and large-grained. Figure 1, a photomicrograph at 100 diameters of the rivet from Box No. 7, is typical of both. Note evidence of burning (darkly outlined grains).

X100, Keller's etch.

OVERHEATED RIVET FROM BOX NO. 7.

The burning revealed by the examination occurred as a result of heating above the liquidus temperature in the heat-treatment operation.

The great majority of the rivets selected for examination had been heat-treated satisfactorily, but two which had been severely overheated were found (in Boxes Nos. 1 and 7). Whether this is a cause for rejection is the responsibility of the inspection body concerned, but it is thought that the presence of the defective material is sufficient cause for rejection.

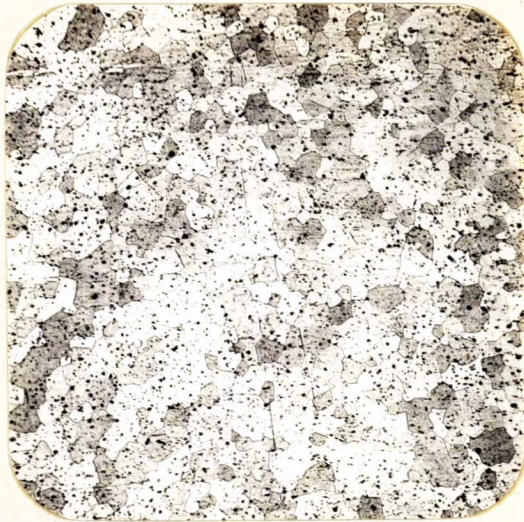
Figure 2.

The other rivets from these two boxes and from all others appeared to have been satisfactorily heat-treated. Figures 2 and 3 are photomicrographs of the head and body, respectively, of a rivet from Box No. 5. These are representative (grain sizes vary from lot to lot) of other rivets having acceptable heat treatments. The grain size of the head, in all cases, was smaller than that of the body.

X100, Keller's etch.
HEAD OF RIVET FROM BOX NO. 5.

The smaller grain size of the heads of the rivets as compared to the bodies was undoubtedly caused by more

working of that portion during fabrication, resulting in a finer grain size on heat treatment.

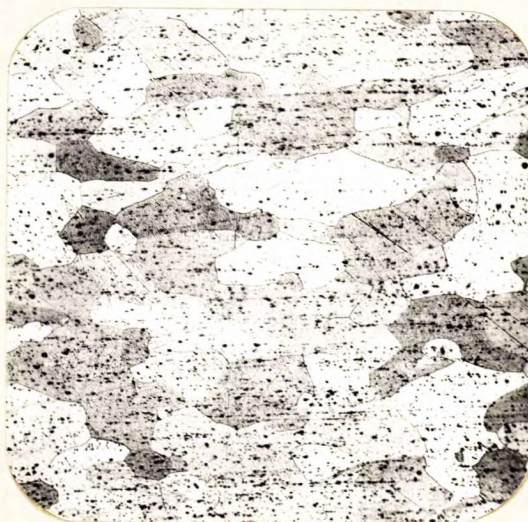
Figure 3.

X100, Keller's etch.
BODY OF RIVET FROM BOX NO. 5.
