O T T A W A August 20th, 1943.

ORE DRESSING AND METALLURGICAL LABORATORIES.

Investigation No. 1480.

Examination of Defective Cheetah
Engine Crankcases.

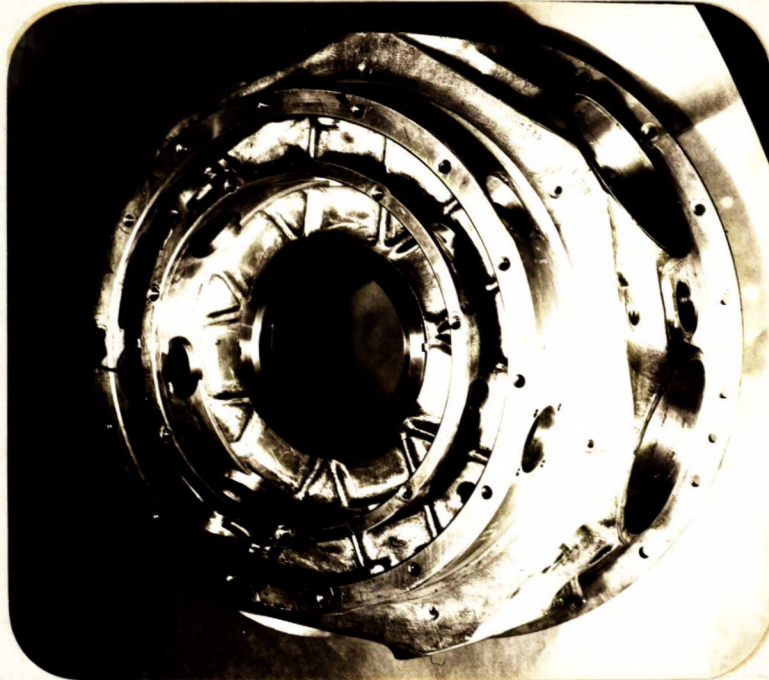
Figure 1.

CAST CRANKCASE NO. AS32000, AS RECEIVED.

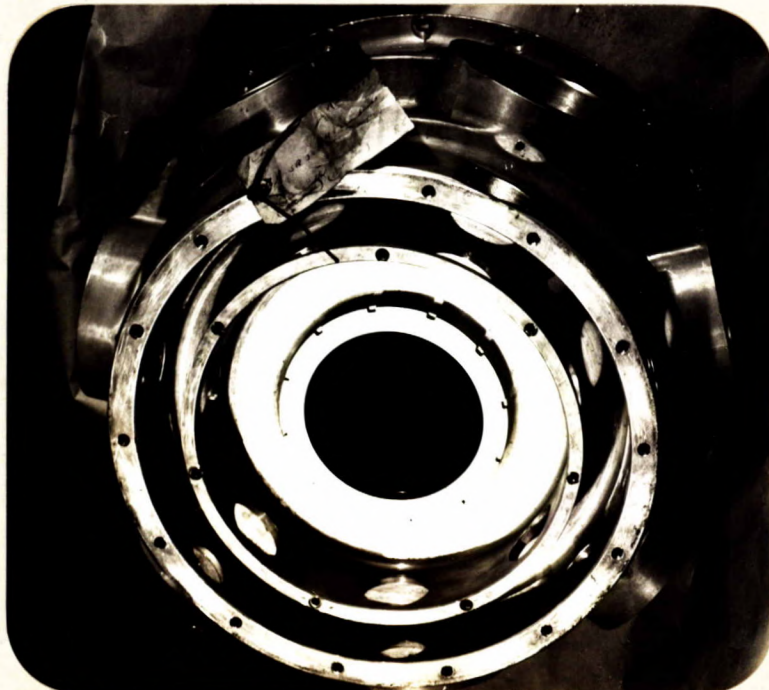
Figure 2.

FORGED CRANKCASE NO. AS13117, AS RECEIVED.

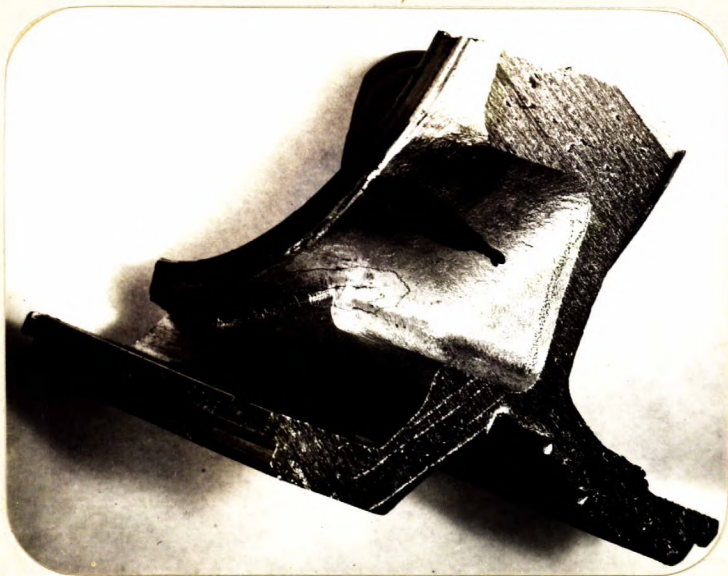
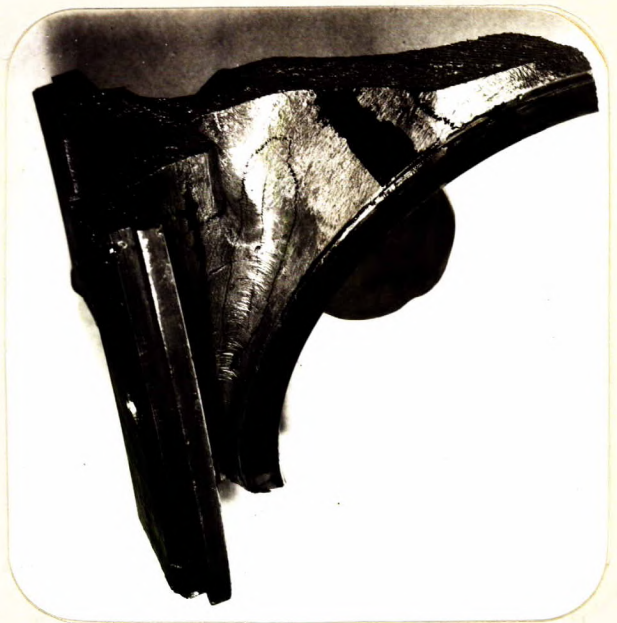
Figure 4.

CRACKS IN CAST CRANKCASE.
(Approximately 1/2 size).

The failures were probably due to mechanical over-stressing or to improper design which might have resulted in subsequent stresses during casting or heat treatment.

Repairing the cracked casting at the surface by means of welding would merely seal the outlet of the crack; it could not prevent the existing crack from extending further.

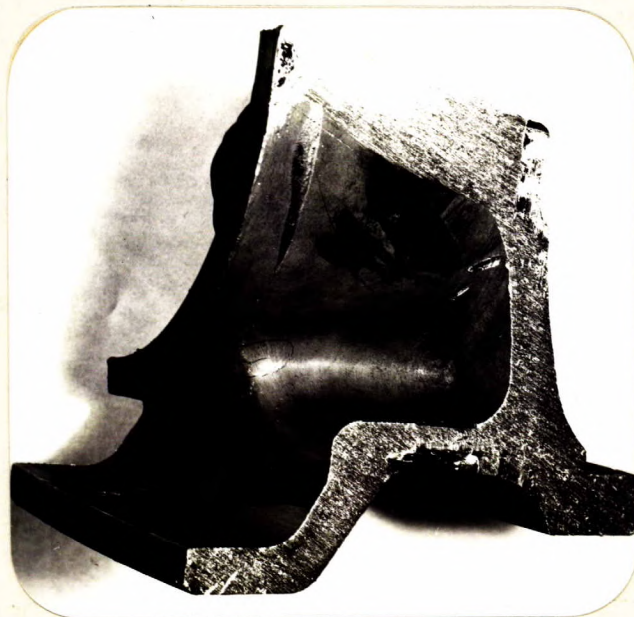
Figure 5.

CRACK IN FORGED CRANKCASE.
(Approximately 1/2 size).

Microscopic examination showed that the crack in the cast crankcase extends quite deeply (approximately 0.1 inch). The crack in the forging is rather shallow but shows some intercrystalline disintegration, probably due to beginning of stress-corrosion.

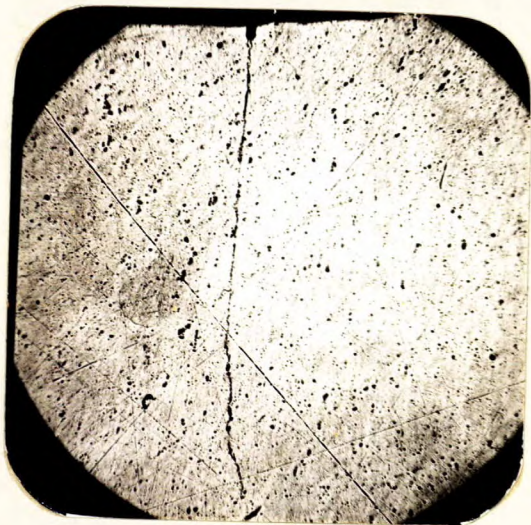
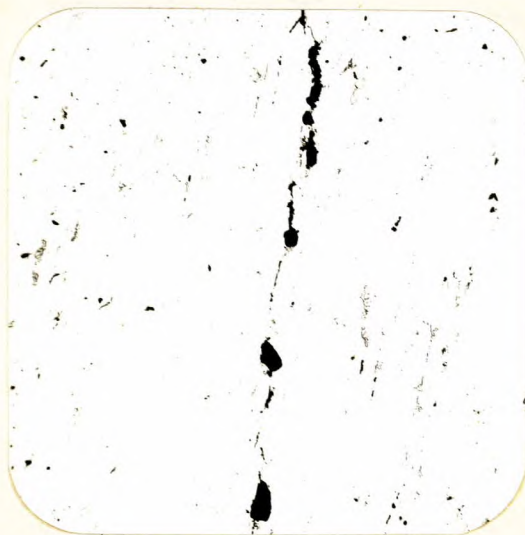
CAST CRANKCASE.

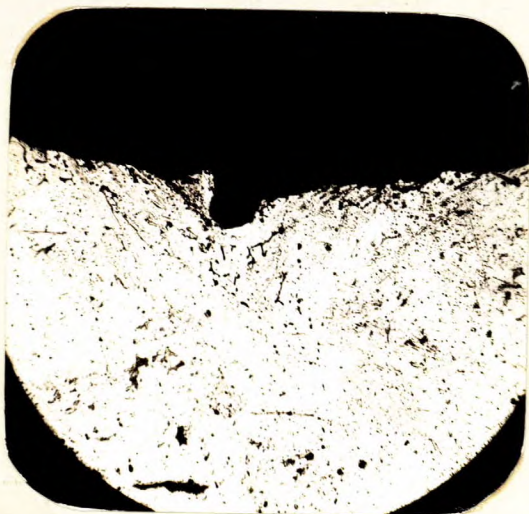
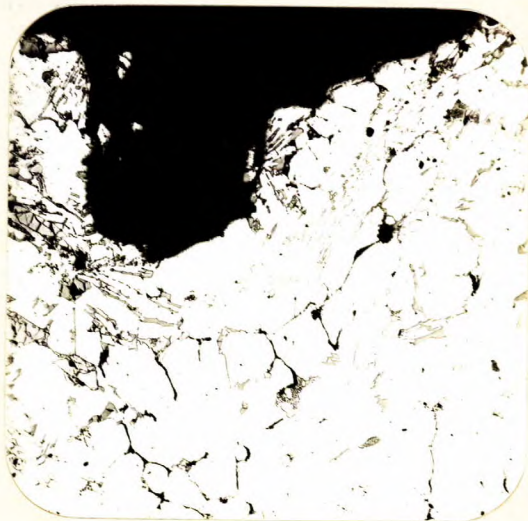
FORGED CRANKCASE.
