August 23rd, 1943.

ORE DRESSING AND METALLURGICAL LABORATORIES.

Investigation No. 1481.

Investigation to Determine Cause of
Defects Found in 20-mm, Hispano-
Suiza and Oerlikon Shell Cases.

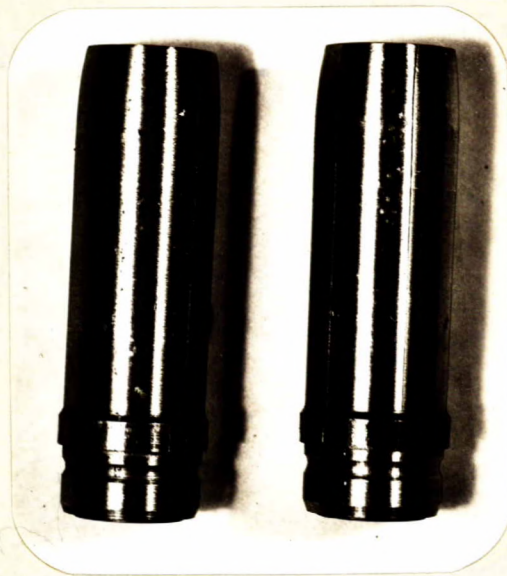
Figure 1 shows two of the shells. Note that one of these shells has a longitudinal split down its entire length. This type of defect is characteristic of all the shells but one. This exception is also shown in Figure 1. Note the shell with the longitudinal line of surface markings.

The cracks shown in the specimen shells submitted are not fresh cracks. It is evident, from their oxidized condition, that they originated at some early stage in the fabrication of the bars.

PHOTOGRAPH, ACTUAL SIZE, SHOWING
DEFECTIVE 20-MM. SHELLS.

Note crack in right-hand shell and
line of surface markings in left-hand shell.

More careful inspection and scarfing of ingots might minimize the occurrence of these defects. Attention should also be paid to the careful control of rolling mill practice, in view of the tendency of this steel toward hot shortness.

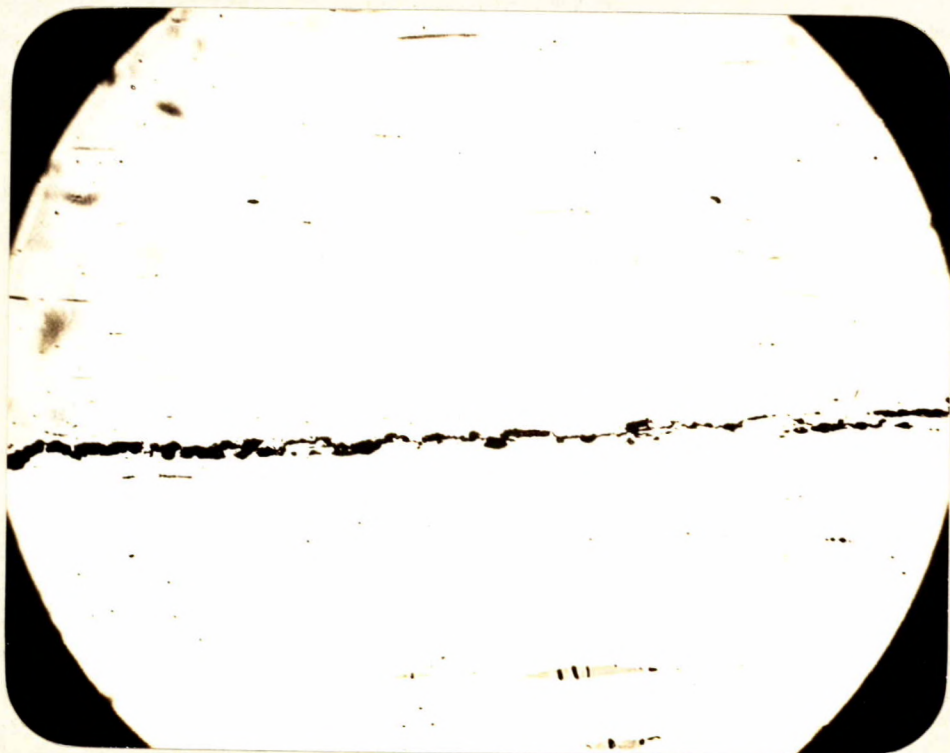
Figure 2.

Sulphides are found in the lap shown in Figure 4. Similar sulphides were found in some of the radial cracks, although Figure 2 does not show this. These cracks also appear to contain oxides.

PHOTOMICROGRAPH, X100, UNETCHED, SHOWING
A LONGITUDINAL SECTION OF CRACK.

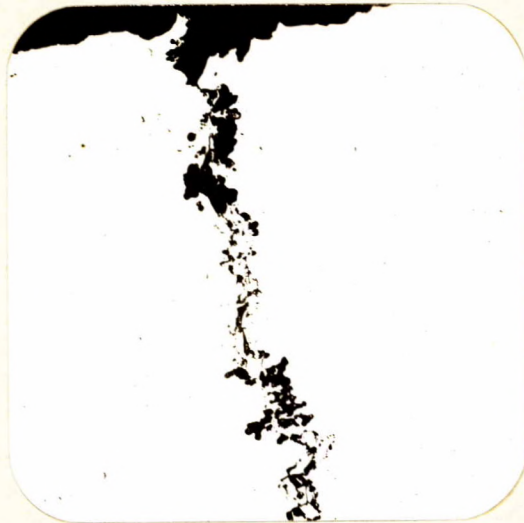
Figure 3.

PHOTOMICROGRAPH, X100, UNETCHED,
SHOWING A TRANSVERSE SECTION OF A CRACK.

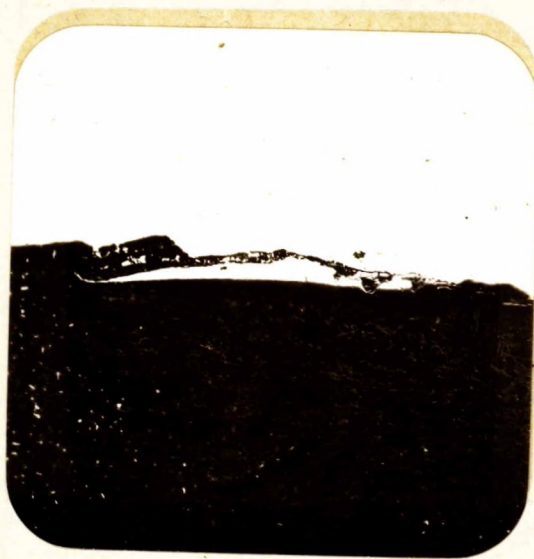
Figure 4.

PHOTOMICROGRAPH, X100, UNETCHED, SHOWING
CROSS-SECTION OF SURFACE OF SHELL ON
LEFT-HAND SIDE OF FIGURE 1 AT
LINE OF SURFACE CRACKS.

Note sulphides in crack.
