August 23rd, 1943.

ORE DRESSING AND METALLURGICAL LABORATORIES.

Investigation No. 1482.

Examination of a Cast Steel Muzzle Brake
for a 6-Pdr. Gun.

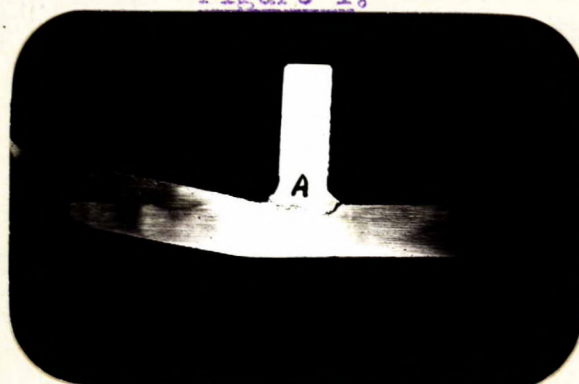
Figure 1.

The casting appeared to be sound and free from surface imperfections. The brake was sectioned in order to check the porosity observed in the X-ray films. Figure 1 shows a crack between the central baffle and the cylindrical portion of the casting.

(Approximately $\frac{1}{2}$ size)

The steel was found to have a chemical composition similar to that of an SAE 4330 steel and had very satisfactory physical properties. The X-ray and macro-examinations showed the casting to be fairly sound except in the central section where slight shrinkage cavities and a crack were observed.

From the location and nature of the crack it would appear to be a hot tear.

1. Concave the outside so as to avoid mass concentration of metal at the section now porous. This would involve pattern changes and outside coring. However,

it is believed such a change would eliminate the hot spot at the junction of the outer cylindrical section of the casting and the central baffle.

2. There is a possibility that the expansion and contraction properties of the core may be at fault. In order to establish whether this is so, it will be necessary to have the core properties checked in a properly equipped sand laboratory.

3. Chill centre section. This procedure, which would bring about a more equal solidification of the central baffle, would, of course, be an expensive remedy because of the cost of chill handling.

4. Gate into central section of the casting through a blind riser. This would require extensive changes in pattern.

5. Central gate plus centrifugal casting. This method doubtless would produce good sound castings but would require changes in pattern and would also require additional equipment.

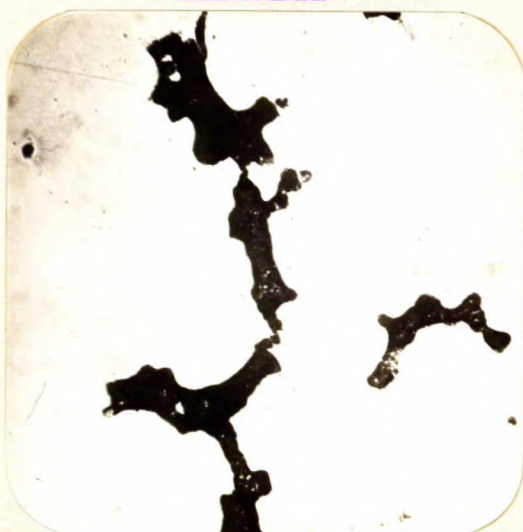
Figure 2.

A section of the casting, at the junction of the cylinder baffle and outside cylinder, was given a metallographic polish and then examined under the microscope in the unetched condition. The steel was fairly clean. Figure 2 is a photomicrograph, at X100 magnification, showing an area in the steel containing shrinkage cavities. Figure 3 shows, at X1000 magnification, the picral-etched condition of the steel. The structure consists of drawn martensite. Figure 4 gives, at X100 magnification, the nital-etched structure of a decarburized area adjacent to the crack shown at "A" in Figure 1.

X100, unetched.

The microscopic examination confirmed the presence of small shrinkage cavities shown in the X-ray films and also revealed that the casting had received a quench-and-draw heat treatment. In addition, a heavily decarburized area adjacent to the fracture was noted.

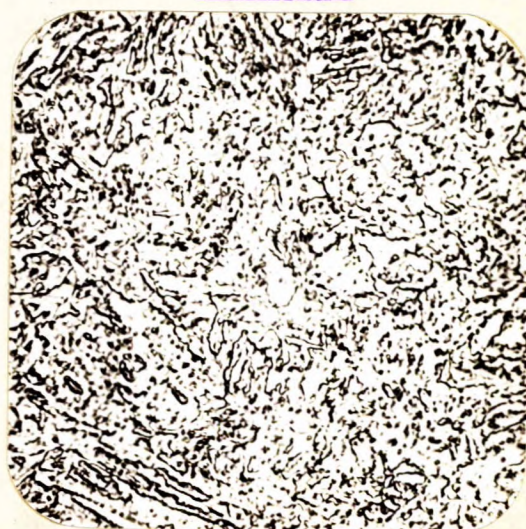
Figure 3.

X1000, etched in 4 per cent picric acid.

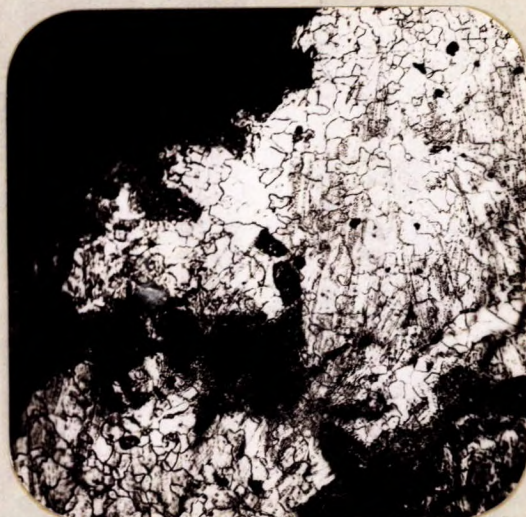
Figure 4.

X100, etched in 2 per
cent nital.
